POST-IRRADIATION EXAMINATION OF OVERHEATED FUEL BUNDLES

D.F. SEARS, M.F. PRIMEAU and D.A. LEACH

AECL, Chalk River Laboratories, Chalk River, Ontario K0J 1J0

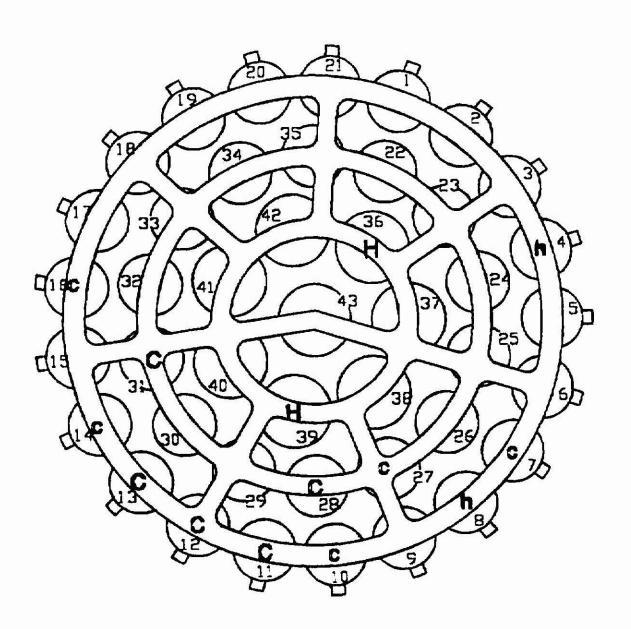
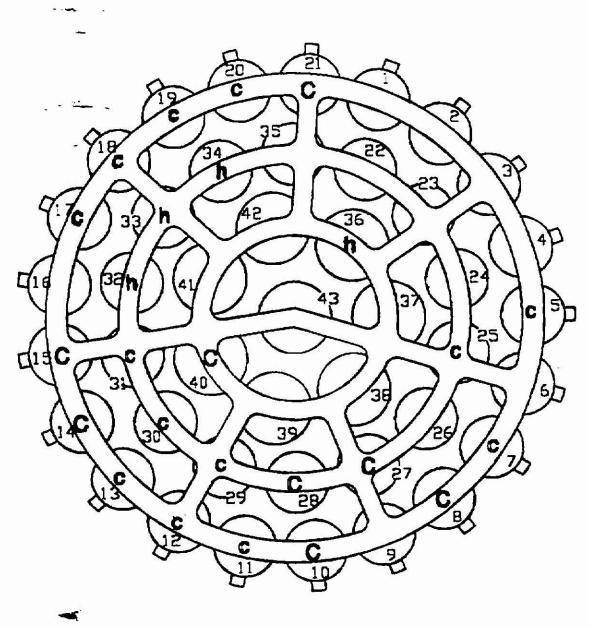
The damage in bundle AHL was mainly located in the segment of the bundle circumscribed by elements 8 through 16. Within individual elements most of the damage occurred near the reference end (RE) which was at the top during irradiation; however, there were also several instances of collapse near the bottom, or non-reference ends (NRE). In the outer ring (maximum element linear power 38-48 kW/m), 8 of the 21 elements contained areas with varying degrees of deformation, ranging from slight localized indentations to complete circumferential grooves. In the intermediate ring (maximum element linear power 24-31 kW/m), elements 27, 28 and 31 had crevices where the sheath collapsed into the gap between the pellet stack and the end caps at the reference end. The inner ring of 13.5 mm diameter elements (maximum element linear power 25-31 kW/m) contained two elements that had through-wall defects with fission-product stains flowing from the blisters.

The damage in bundle AHK extended to a larger segment of the bundle, compared to bundle AHL. In the outer ring (maximum element linear power 53-61 kW/m), 15 of the 21 elements were visibly damaged, some with severe collapse zones; i.e., deep circumferential grooves that were clearly visible through the cell window. In the intermediate ring (maximum element linear power 34-39 kW/m), six elements showed evidence of sheath collapse, and three had artifacts that may have been possible hydride blisters. In the inner ring of elements (maximum element linear power 35-40 kW/m), whitish oxide bands were observed at the edges of the braze heat-affected zones, and a possible hydride blister defect was observed.

BUNDLE AHL (2.59% Enriched UO₂) 48 kW/m Outer Ring 31 kW/m Intermediate Ring 31 kW/m Inner Ring

BUNDLE AHK (2.59% Enriched UO2) 61 kW/m Outer Ring 39 kW/m Intermediate Ring 40 kW/m Inner Ring

Figure 1. Schematic showing location of damage on bundles. C = complete collapse, c = partial collapse, H = confirmed hydride defect, h = possible hydride blister.

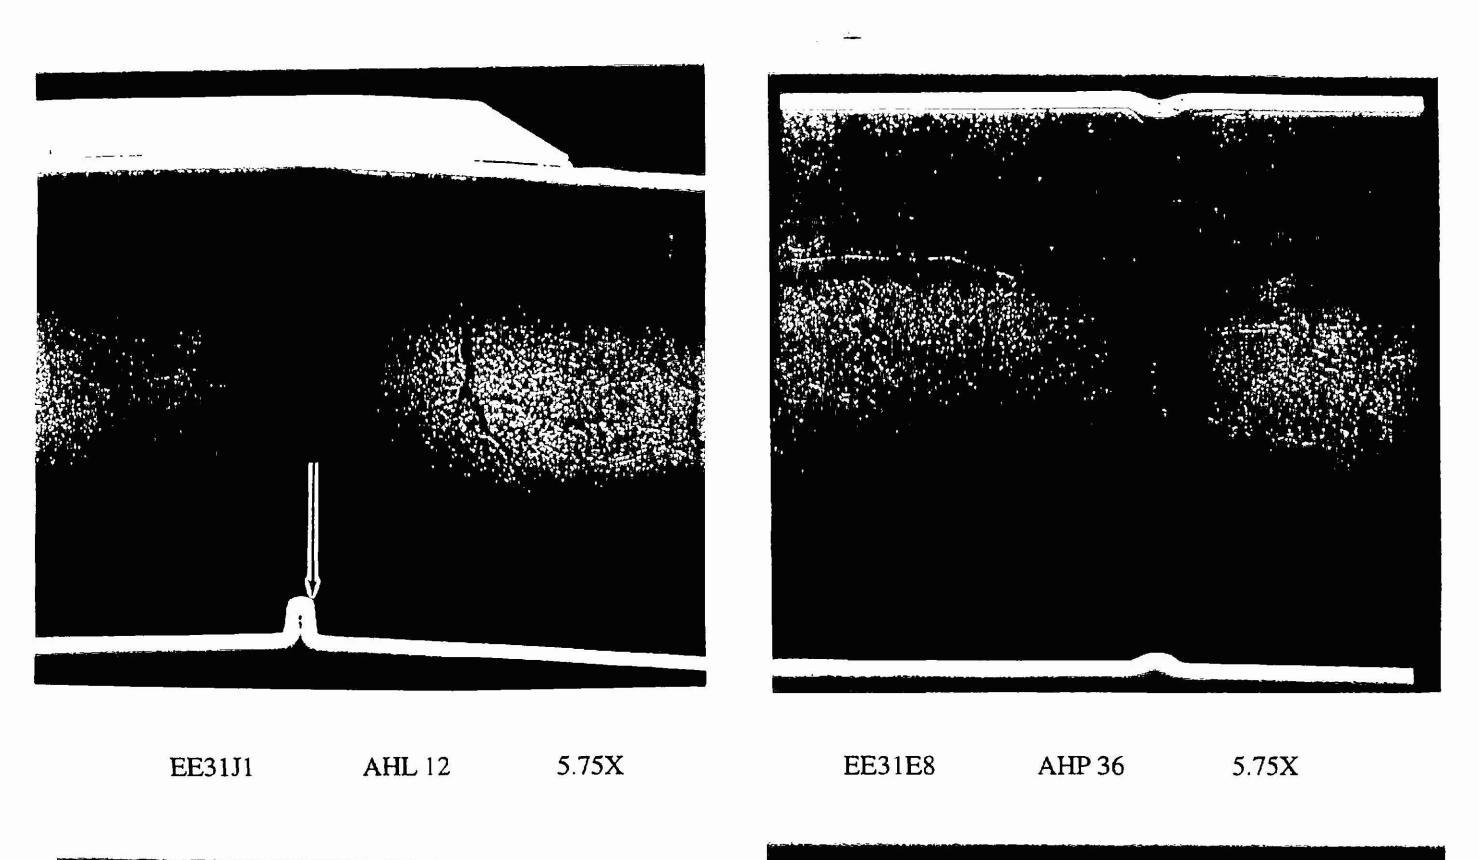
The outer elements of bundle AHL operated at a maximum linear power of 48 kW/m before the incident. The sheath collapsed into the gap between the first and second pellets under the RE bearing pad of AHL 12, as shown in Figure 3. The measured gap between the pellets at the collapsed zone was approximately 0.84 mm, but the depth to which the sheath inner diameter intruded was approximately 1.3 mm from the outer surface. The equivalent diametral strain would be -16.5% if the depth of the crevice was uniform around the circumference; however, the support provided by the bearing pad prevented complete collapse. There was minimal sheath wall thinning at the crevice. The polarized light image shows that the deformed sheath contained the large grains expected in the braze heat-affected zone, but there was a thin layer of smaller recrystallized grains on the inside surface of the sheath. The microstructure of the pellets at the collapse site revealed equiaxed grain growth at the centre of the fuel. Other than typical cracks and a missing pellet chip that may have resulted from sample preparation, there were no anomalous features.

The inner element in bundle AHP operated at a maximum linear power of 65 kW/m. Element AHP 36 contained 45° chamfered pellets, and as shown in Figure 3, the sheath collapsed into the space formed by the chamfers, which was approximately 1.0-1.4 mm wide at the pellet surface. The calculated diametral strain was approximately -3%. The micrographs show the expected equiaxed grain growth at the centre of the pellet, but there was also evidence of the onset of fuel coalescence and infilling of the dish at the hot centre of adjacent pellets.

The collapsed zone under the bearing pad in element AHK 12 contained a thin layer of small recrystallized grains on the inside surface of the sheath. Zirconium alloys start to recrystallize only when recovery is almost complete; i.e., after hours at 600° or minutes at 800°C. The presence of alpha grains remote from the collapse zone indicate that the sheath temperature did not exceed 815°C, the alpha-beta transformation temperature. Thus the recrystallized grains indicate that the sheath may have been in the 600 to 800°C range.

Figure 3. Micrographs showing sheath collapse under bearing pad of AHL 12, and into pellet chamfers in AHP 36. Top shows general fuel condition and bottom shows polarized light image of sheath at the corresponding collapse zones. Arrows show recrystallized grains on inside surface of collapsed sheath under bearing pad (braze heat-affected zone). Equiaxed grains in annealed tubing where sheath collapsed into pellet chamfers.
