Operational Support of a Safe Operating Envelope for Fuel

T. J. Chapman ALARA Research Inc. tchapman@nbpower.com

R.A. Gibb Point Lepreau Generating Station, P.O. Box 10, Lepreau NB, E0G 2H0 rgibb@nbpower.com

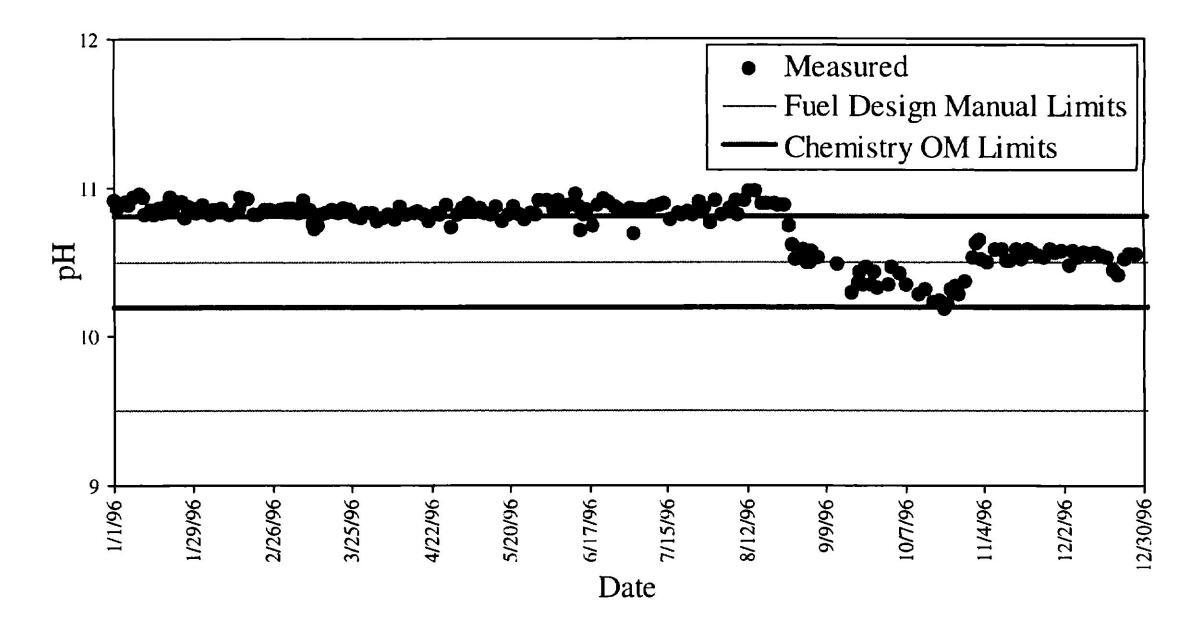
The discrepancy between the Fuel DM [1] and the Chemistry Control Operating Manual [11] was noted in the 1996 Fuel Performance Report [8] (refer to Figure 5). Presently AECL is reviewing the requirements for pH. When the review is complete, the range in the Fuel DM will be corrected as needed [14].

Figure 5: pH of the Primary Heat transport P4 Discharge & Inlet to the PHT Purification Filter FR1/2

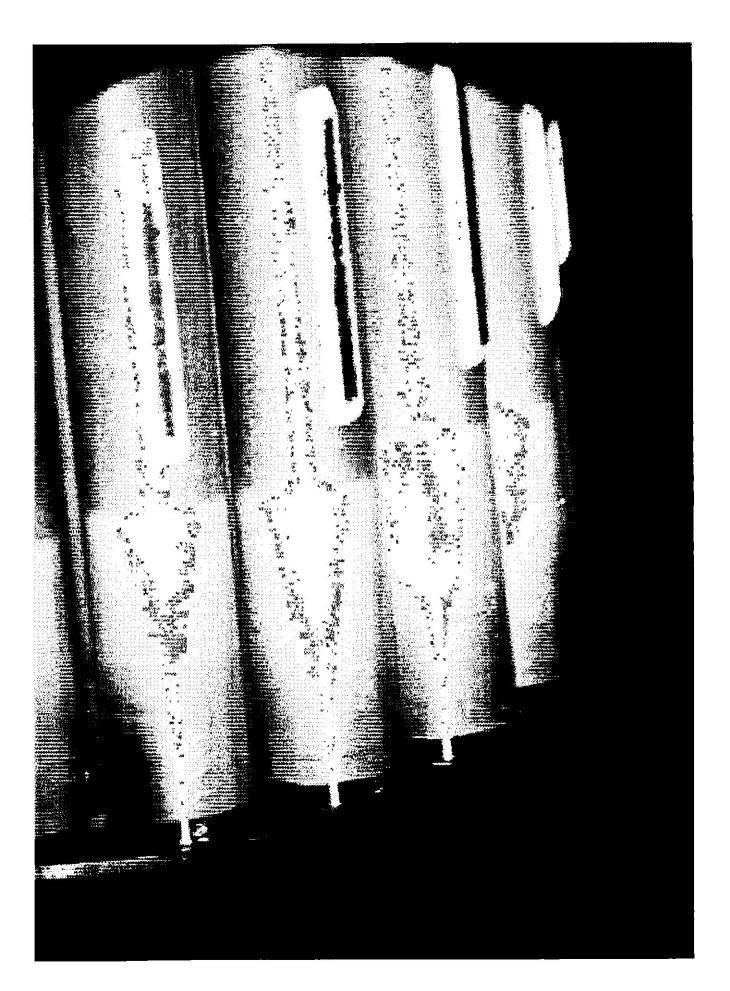
Figure 7: Debris between the Endcap and Endplate of Bundle A91532Z (P12)
