CORROSION OF ALLOY 800 IN PHWR PRIMARY AND SECONDARY CONDITIONS

A.J.G. Maroto, M.A. Blesa, M. Villegas, A.M. Olmedo, R. Bordoni, M.G. Alvarez, R. Saínz*

4. EXAMINATION OF A TUBE REMOVED FROM SG N° 4 OF EMBALSE NPP.

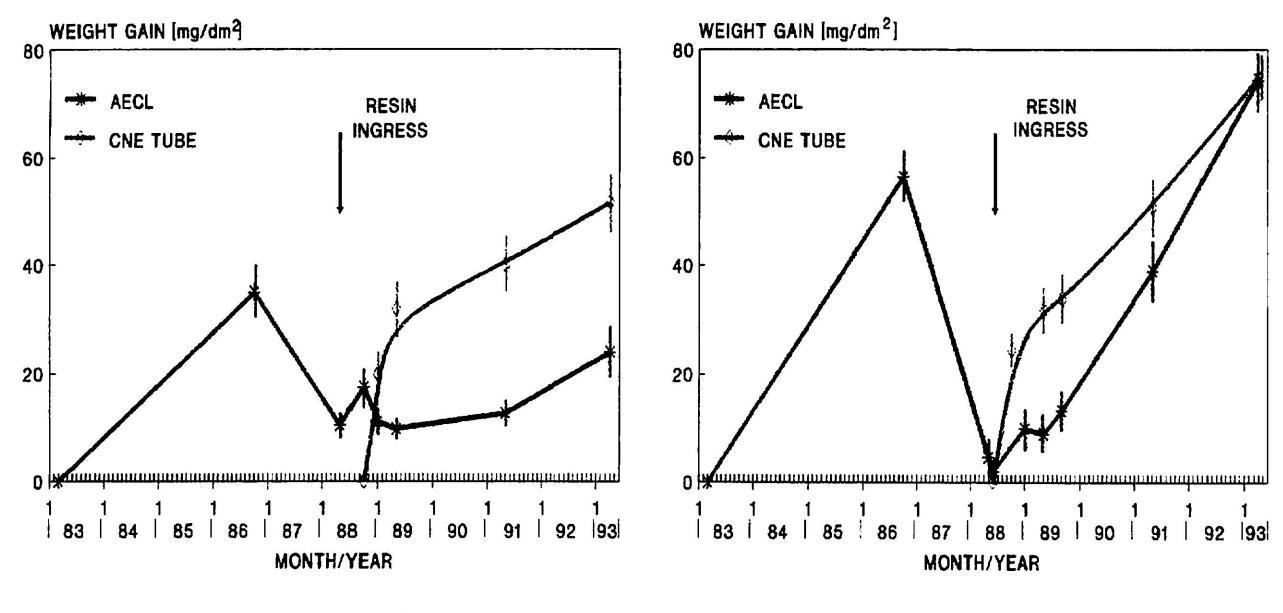
Figure 1: Weight-gain of corrosion test samples in autoclave Y1

Figure 2: Weight-gain of corrosion test samples in autoclave Y4

Figures 1 and 2 show the weight-gain of the samples in the hot leg autoclaves as a function of the exposure time. Up to 1986, the AECL coupons showed a weight-gain in both autoclaves. In May 1988, the degradation of the mixed resins in the coolant led to a large defilming effect reflected by the weight-loss of the samples.

The following inspections indicated the instability of the corrosion film growing on the AECL coupons, while the plant test samples inserted in 1988 reproduced the corrosion behaviour found up to 1986, i.e. increasing weight-gain with increasing exposure time. After 1989, the weight gain of all test samples showed an increasing trend.

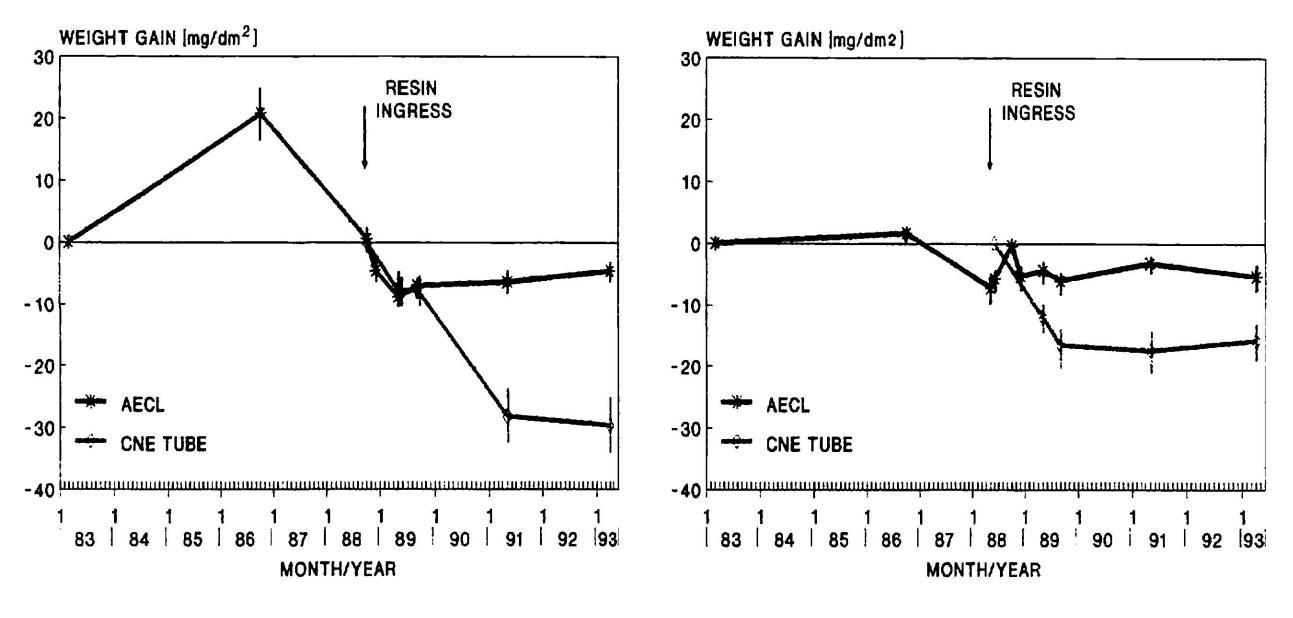
Figure 3: Weight-gain of corrosion test samples in autoclave Y2

Figure 4: Weight-gain of corrosion test samples in autoclave Y3

Figures 3 and 4 present the data from the test samples in both cold legs. Contrary to the pattern from the hot leg autoclaves, the AECL materials and the plant test samples exhibited a different behaviour. The weight of the AECL materials increased up to 1986 and a weight-loss was observed in May 1988 after the resin degradation. Weight-gains recorded during 1988 and 1989 indicated the lack of stability of the corrosion film but the values stabilized after the conditioning of the plant. The plant test samples introduced in 1988 systematically lost weight during the first 15 months reaching near constancy in weight afterwards.

The increasing weight-gain of the specimens in the hot leg autoclaves indicates that more oxide is accrued on the test sample than that generated by the corrosion process, pointing to the interaction with the corrosion-product saturated coolant, mass transfer and precipitation processes. On the other hand, the weight-loss of the coupons inserted in 1988 in the cold legs corresponds to the dissolution of the outer layer crystals in unsaturated coolant and to continuing corrosion release, partially offset by some thickening of the film. The different behaviour of the samples in the inlet and outlet autoclaves could be related to the differences of the overflowing solution, i.e. system effects, that affect the interaction between dissolved corrosion products and the corroding surface.

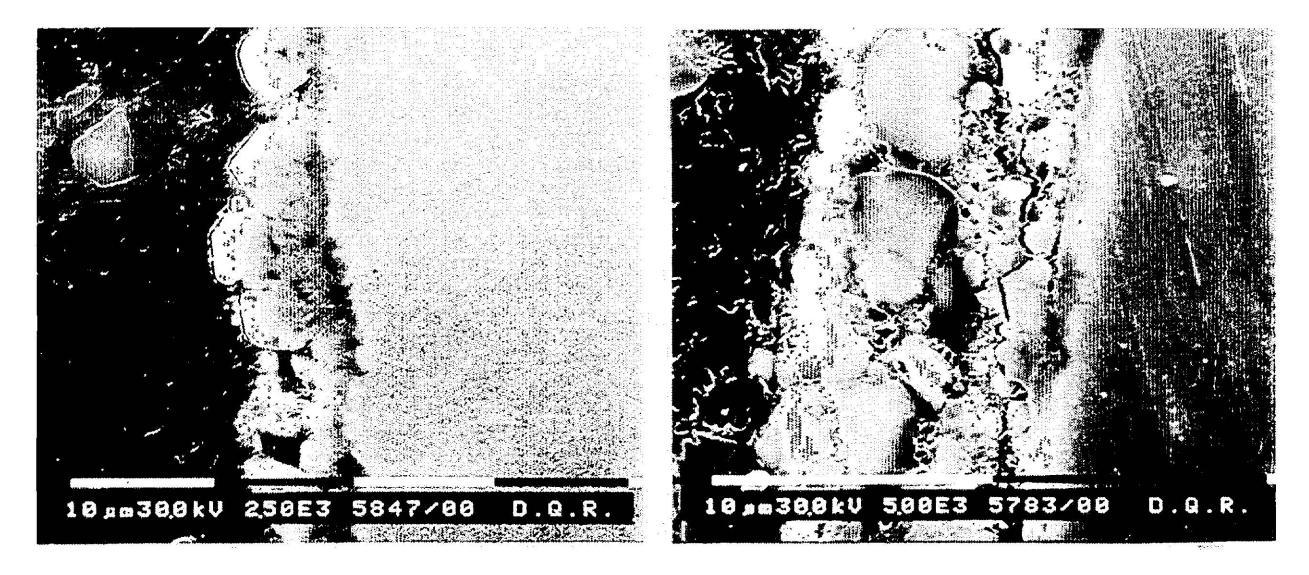
Along the length of the tube, the common feature was the irregularity of the oxide layer. As an example of the typical pattern observed by SEM in all the locations examined, Figure 6 shows a cross-section from the open area just below the second tube support plate. The majority of the film was due to the growth of crystals by precipitation from the coolant. The thin layer detected at the oxide/metal interface is due to the corrosion process of the base material, the rest of the film corresponds to the precipitation process.

At different locations, deposition of corrosion products was also found. Figure 7 shows a crosssection of a sample located in the open area above the sludge pile. Crystals of around 4 μ m were observed within an array of smaller size crystals and the thickness of the film was around 10 μ m.

Figure 6: Growth of crystals by precipitation from the primary coolant.

Figure 7: Deposition of corrosion products from the primary coolant.

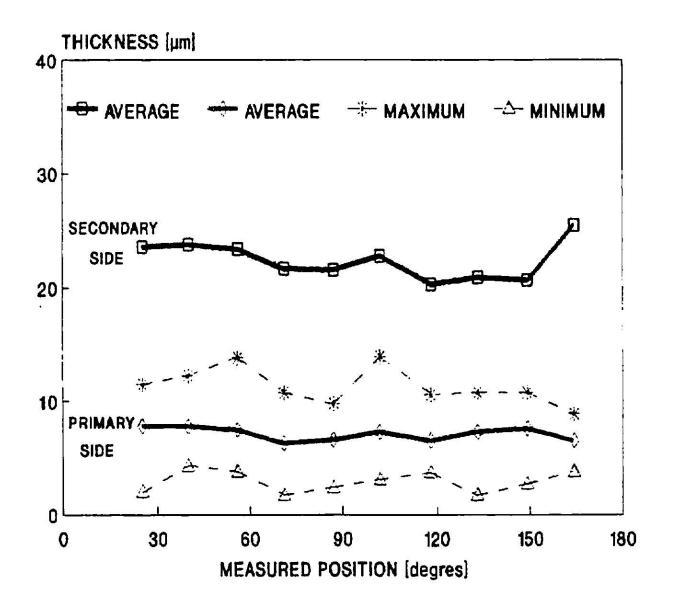
Figure 8: Primary and secondary oxide thicknesses below the second TSP

The average values of the oxide thickness measured at different locations were in the range 4 to 10 μ m. Figure 8 presents maximum, minimum and average values of the oxide thickness at the open area just below the second tube support plate, the corresponding morphology was shown in Figure 6. At this location, the average value was 7.1 μ m.

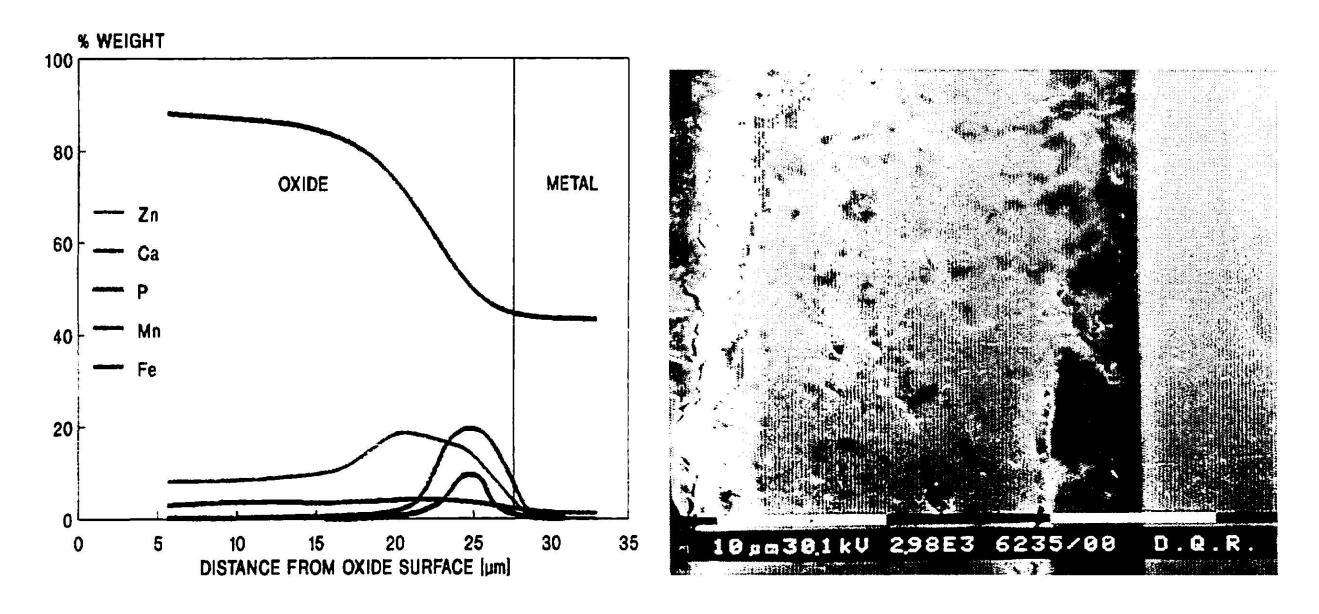
SEM/EDS analysis of cross-sections at different locations of the tube identified iron as major component of the deposits but in-depth analysis detected the presence of calcium, phosphorous, zinc, silicon and manganese. The concentration profiles of the elements in the deposits had similar characteristics at all the locations corresponding to the open area. For all cross-sections examined, zinc was detected through-out the thickness of the scale while calcium appeared in localized zones. Whenever calcium was found, it was located near the scale/alloy interface, in the inner 5-10 μ m of the film As an example, Figure 9 presents the concentration profiles of these elements in a location above the first tube support plate, the corresponding cross section is shown in Figure 10. A common observation is that an increase in the calcium concentration is always related to a marked decrease in the iron concentration. Calcium predominates in the dark areas of Figure 10 while iron predominates in the light ones. The distribution of phosphorous closely follows that of calcium while zinc, although mostly concentrated near the scale/alloy interface, is relatively shifted beyond calcium. Traces of manganese are evenly distributed across the deposits.

Figure 9: Concentration profiles across the secondary oxide scale.

Figure 10: Cross section of the secondary oxide scale.

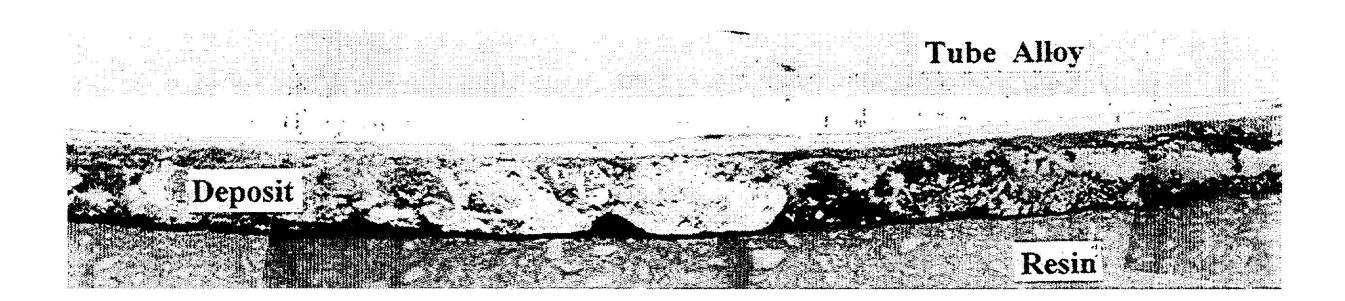
On the other hand, the concentration profiles obtained at locations immediately over the section covered by the sludge pile showed that although in the 100 μ m-thick oxide the same elements were present, the distribution of these elements through-out the thickness of the deposit changes when EDS analysis across the scale is performed at different rotating angles from the same axial position. An optical micrograph at this location shows clearly a layered structure, see Figure 11, and the concentration profiles at two different zones of this oxide scale presented in Figures 12 and 13 indicate the heterogenous composition of the deposit. The concentration of calcium and iron follow the pattern previously described for the open area scale while zinc appears to be

present mainly in the iron-rich areas. For the whole external surface of this cross-section, the oxide layer immediate to the base alloy, of about 10 µm, was enriched in iron.

Figure 11: Cross-section of the deposit immediately over the sludge pile (120X)

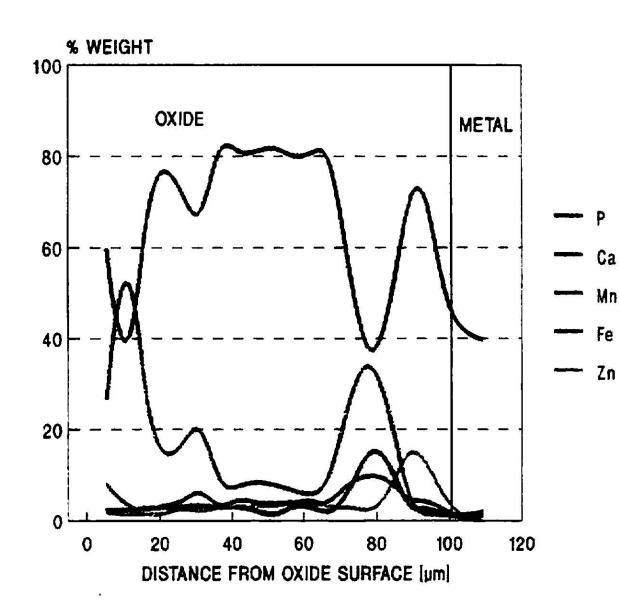
Figure 12: Concentration profiles from the scale over the sludge pile. Zone 1.

Figure 13: Concentration profiles from the scale over the sludge pile. Zone 2.
