TOP OF TUBESHEET CRACKING IN BRUCE A NGS STEAM GENERATOR TUBING – RECENT EXPERIENCE

M. A. Clark, O. Lepik, M. Mirzai,* and I. Thompson

ABSTRACT

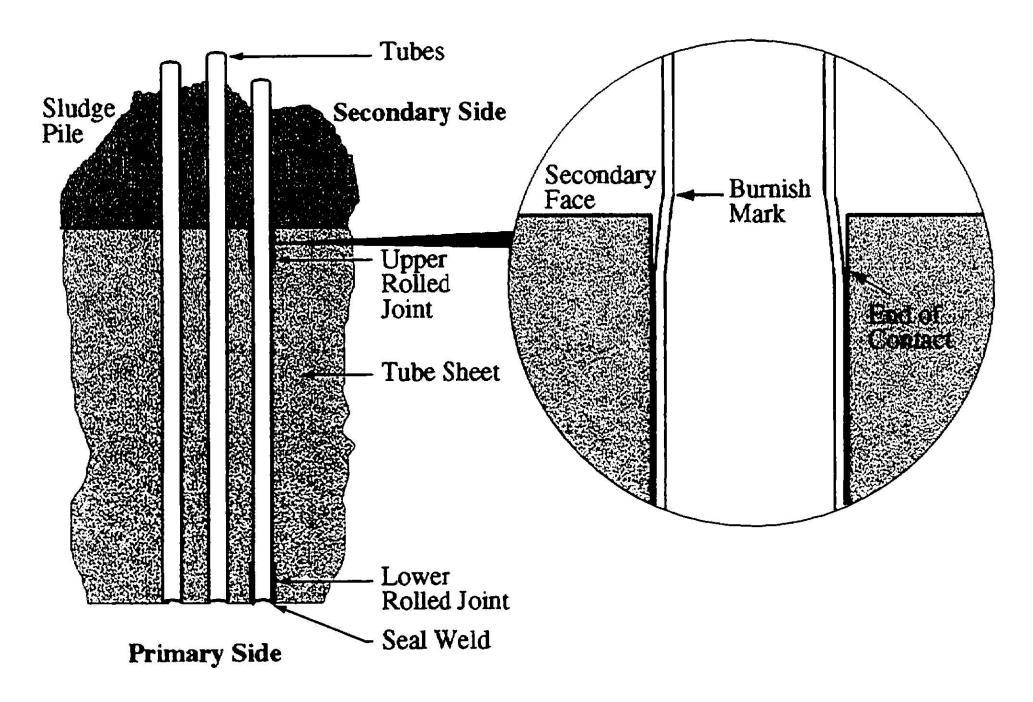
A schematic of the tubesheet area of the steam generators is shown in Figure 1. In all the tubes, the degradation was located either in or just above the upper transition region of the upper roll expansion (Figure 1). This transition region is formed by the upper tapered portion of the rollers used to form the expansion joint. The top of the roller leaves a distinct burnish mark that is readily discernible on the ID surfaces. This mark was used as a reference for the axial location of the defects. The last point of contact between the tube and the tubesheet hole was not always apparent on the outside surface.

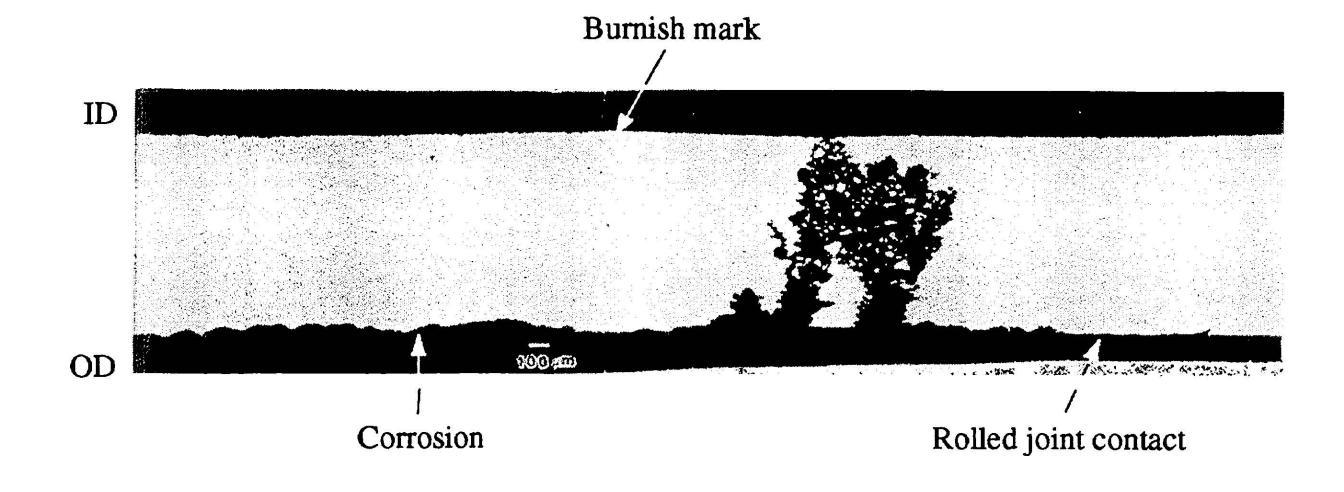
Figure 3 Features of damage in upper roll transition in tube R18C90 removed from Unit 1, SG 3

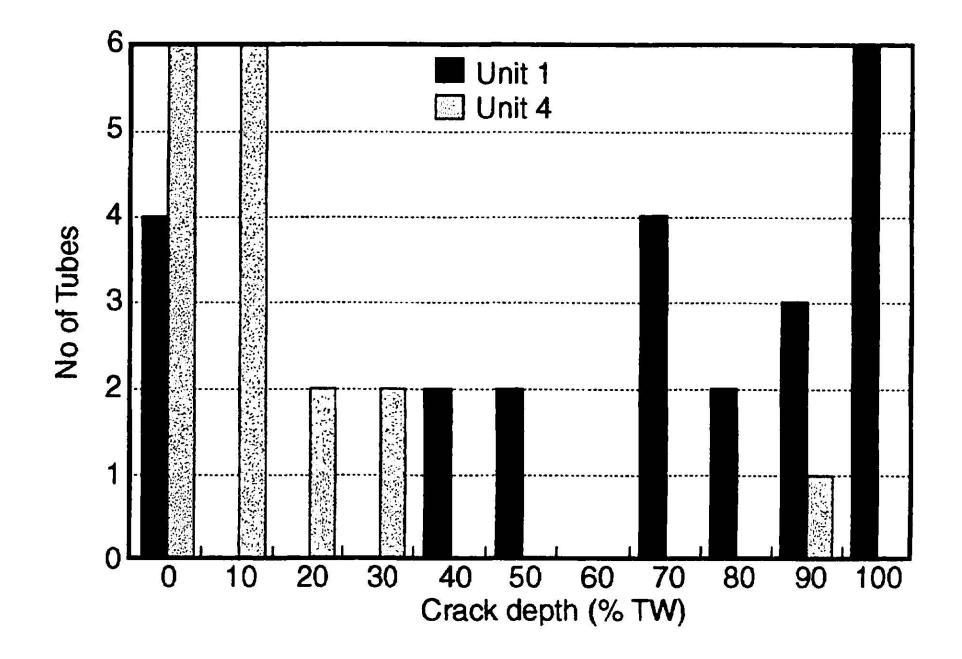
Figure 4 Distribution of maximum depths of OD initiated cracks in 40 tubes removed from Units 1 and 4

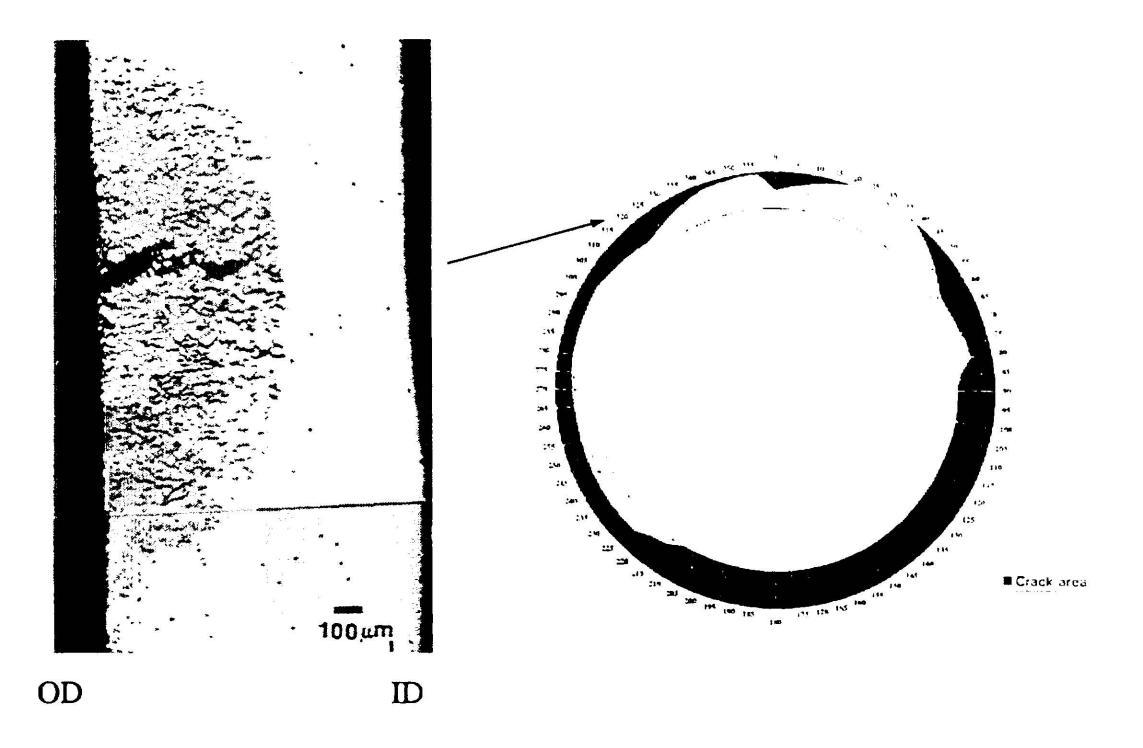
Figure 5 Features of OD corrosion in tube R30C56 removed from Unit 1, SG 5

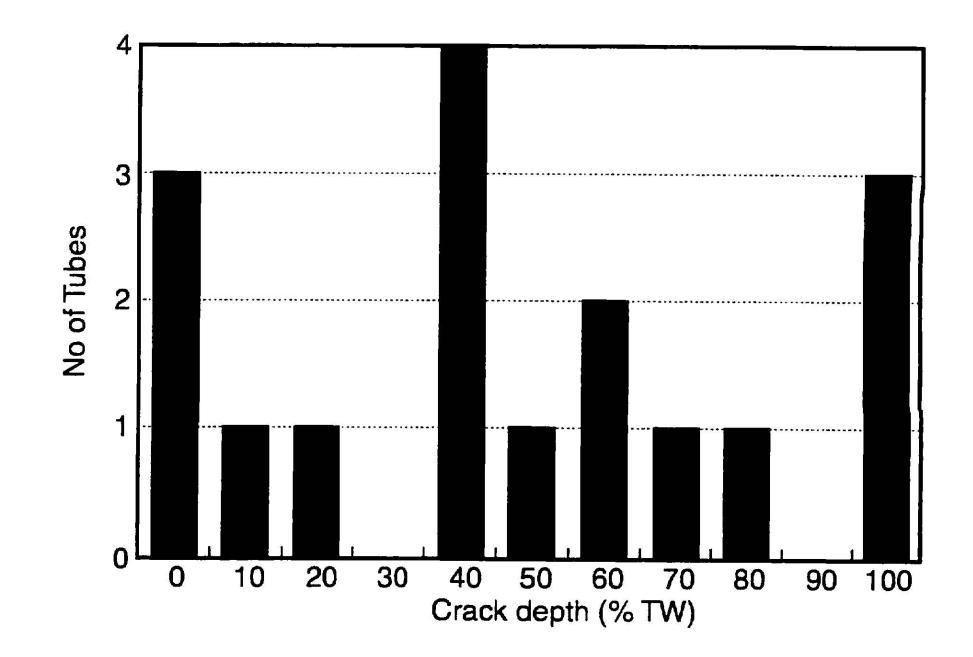
Examinations of the additional tubes showed that the ID-initiated, intergranular cracking was present in 7 of the 9 tubes from SG8 and 5 of the 6 tubes from SG4. None of these cracks were through-wall and depths ranged from 11 to 94% (Figure 7). Circumferential extents of the ID cracking could be up to 360° . The crack features and locations suggested that the ID cracks were due to primary water stress corrosion cracking (PWSCC).

Figure 7 Distribution of maximum depths of ID initiated cracks in 17 tubes removed from Unit 4

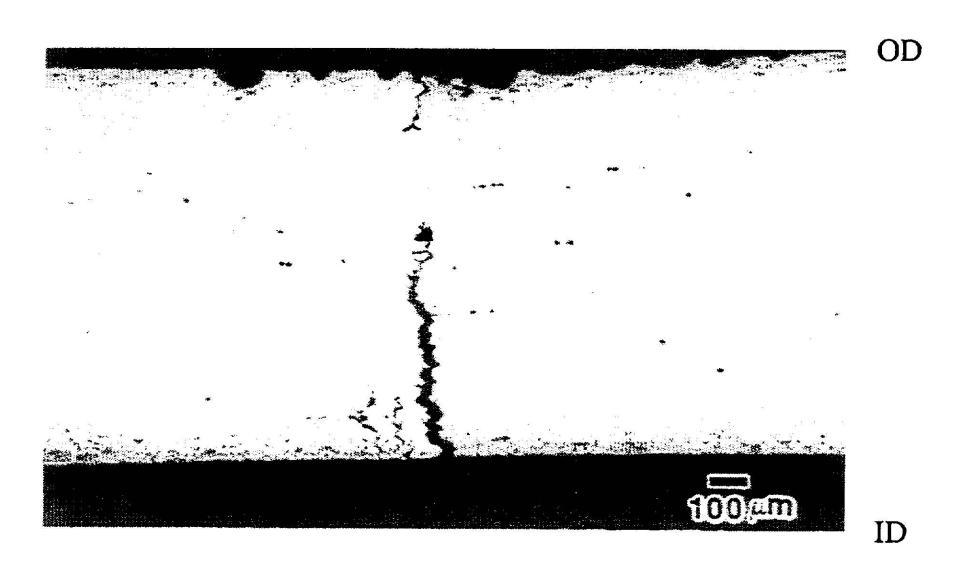
OD initiated cracking was also present in several of the tubes (7 of 15) but was generally offset axially from the primary side cracking, being slightly higher up in the roll transition region. In one case the ID and OD cracks were in the same axial position (Figure 8). The depth of the OD cracking seemed to be generally less than the ID cracking although one tube had an OD crack depth of 85%. OD damage in the form of general corrosion and pitting was also present in these tubes with wall losses up to 29% in some cases in the same area as the ID cracks. These results show that both OD and ID degradation mechanisms are affecting the tubes from the Unit 4 steam generators and can, in fact, be present in the same tube.

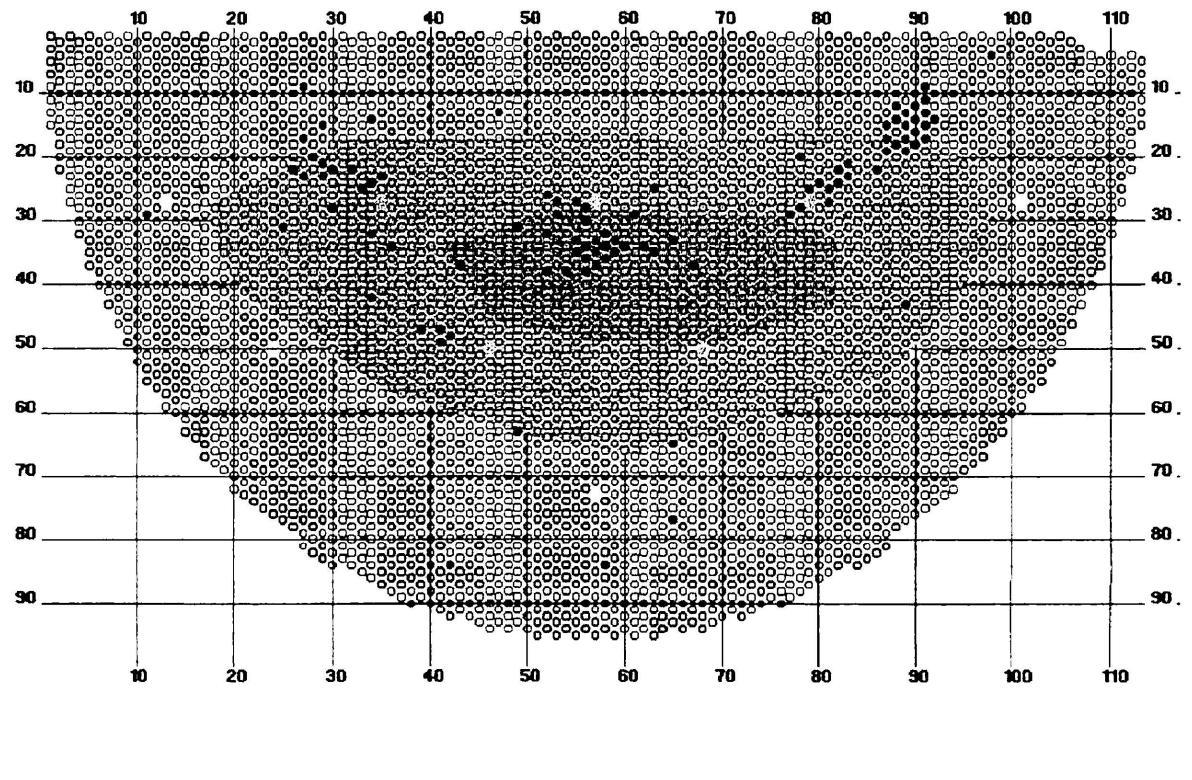
The initial observations of OD damage suggested that the secondary side environment was important in the mechanism. The locations of the damaged tubes in Unit 1 relative to the typical sludge pile are shown in Figure 9. The majority of the damaged tubes were within the sludge pile which suggests that the sludge pile environment or the interaction stresses between the sludge pile and the tubes might be important. As the sludge piles contained significant concentrations of copper, which as CuO is known to increase the propensity and depth of SCC in mill annealed Alloy 600 /3/, it is likely that this sludge constituent played a significant role in the observed OD IGA/SCC.

- Tubes with indications
- Typical sludge pile
- Figure 9 Location of all hot leg tubes containing TTS indications in Unit 1 SGs, also showing typical location of sludge pile
