DEVELOPMENT OF FATIGUE FAILURE CRITERIA
FOR DARLINGTON FUEL BUNDLE ENDPLATES

E.T.C. Ho, G.K. Shek, M.L. Vanderglas & M. Leger
Ontario Hydro Research Division
800 Kipling Ave, Toronto, Ontario

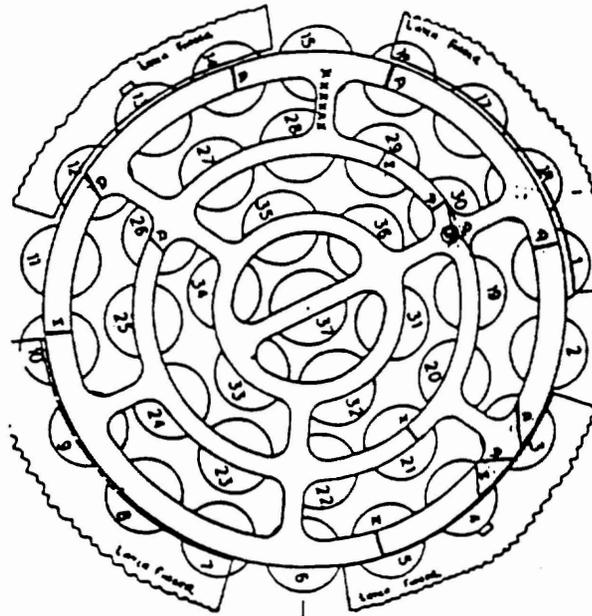
Figure 1. Schematic Diagram of Cracks Observed during Video Examination of Bundle 1 in Channel K12 of Darlington Unit 2.

The small specimen program to obtain fatigue life data was implemented early on in the failure investigation when the best information on the cracks was the video inspection of the downstream endplate of the outlet bundle in channel K12 (Figure 1). During initial discussion regarding modes of loading which could produce such cracks, it was generally agreed that

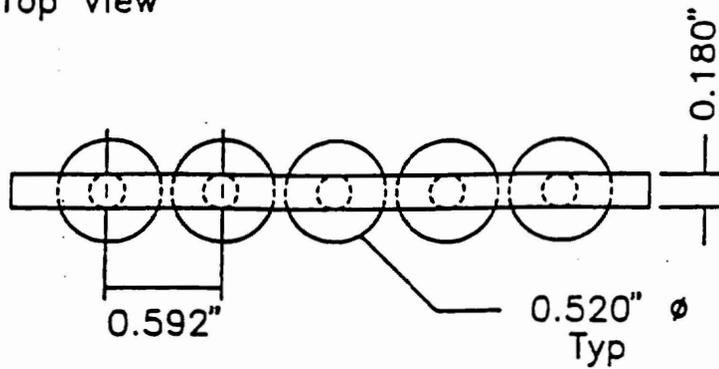
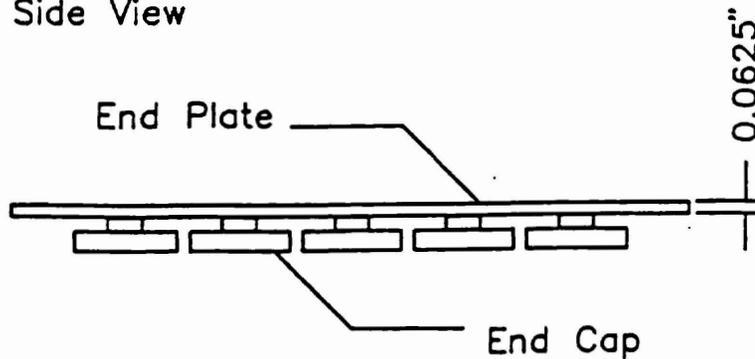
Figure 2. Schematic Diagram of the Endcap/endplate Weld Test Specimen.

The design of the endplate-to-endcap weld specimens for fatigue evaluation is shown in Figure 2. The width of the endplate strip and the spacing between endcaps were selected to correspond to those of the outer ring of a standard Ontario Hydro 37-element endplate. Endplate strips were either machined or stamped with the long dimension parallel to the "transverse" or "longitudinal" directions of the as-received parent endplate strip material. The longitudinal direction corresponds to the rolling direction of the strip. Five endcaps were welded to the endplate strip using standard production welding procedure. The test matrix encompassed differences in manufacturers (General Electric Canada and Zircatec Precision Industries Incorporated), orientations of the strips, loading frequency (0.1-20 Hz), temperature (room temperature and 310°C), and R-ratio (ratio of minimum load to maximum load for the cycle).

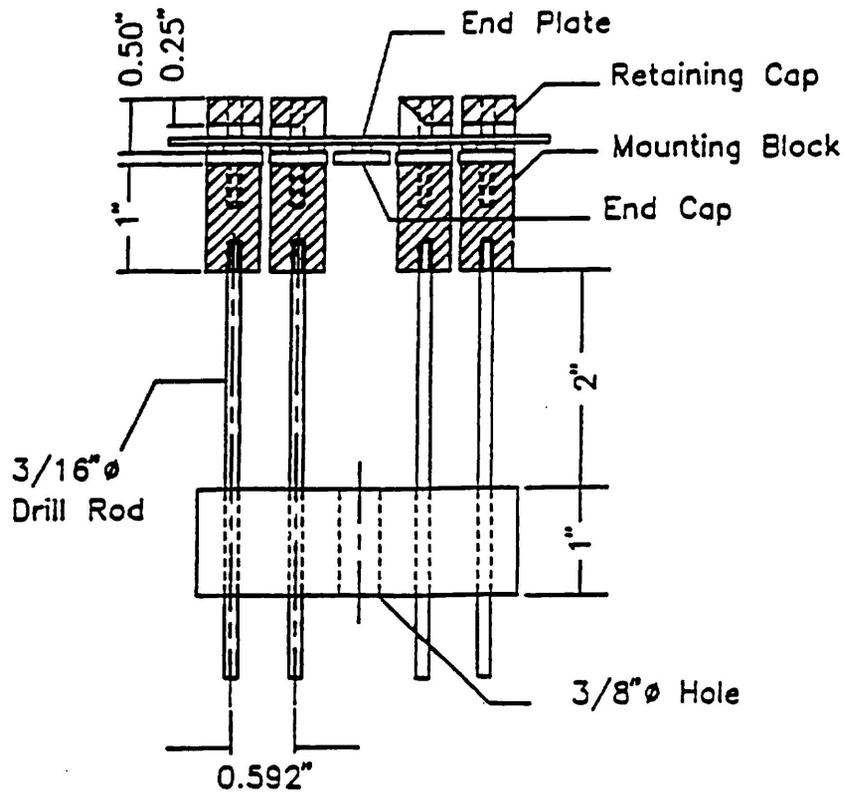
Figure 3. Schematic Diagram of the Loading Fixture developed for the Fatigue Testing of the Endcap/endplate Weld Specimens.

The design of the loading fixture is presented in Figure 3. Loads were applied to produce an axial displacement of the centre endcap with respect to the other four endcaps which were axially fixed. Under this loading condition, the two welds adjacent to the centre weld and the endplate strip at the centre endcap will be under bending stress. The two endcaps at the end of the specimen were not stressed. The main function of the 4.8 mm (3/16") diameter drill rods was to provide axial stiffness and lateral flexibility to simulate the behaviour of the outer ring fuel pencils when they are subjected to axial loading. Prior to carrying out cyclic tests, some tensile tests were performed at both room temperature and 310°C to obtain load vs ram displacement data.

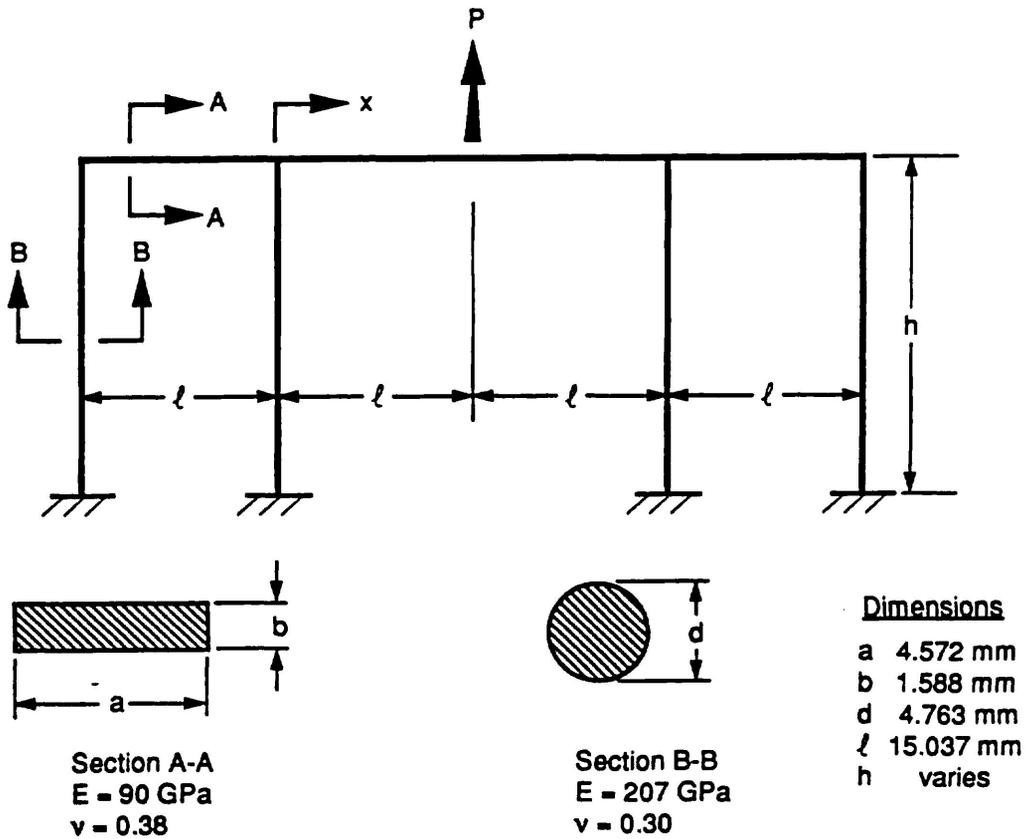
Figure 4. Finite Element Beam Model of Fatigue Specimen.

Analysis is required to interpret the data obtained from the small specimen program for application to the reactor situation. A simple stress analysis of the sample in the loading jig was carried out using ABAQUS with "B23" cubic beam elements. Figure 4 illustrates schematically the models used for the analysis. The stresses reflect the net moment near the joint. No attempt was made to determine the detailed stresses at the weld but rather the nominal stresses in the endplate at the edge of the weld were calculated at a distance of 2.29 mm from the weld centre. This distance was chosen to be consistent with the manufacturer's stress analysis of the bundle.

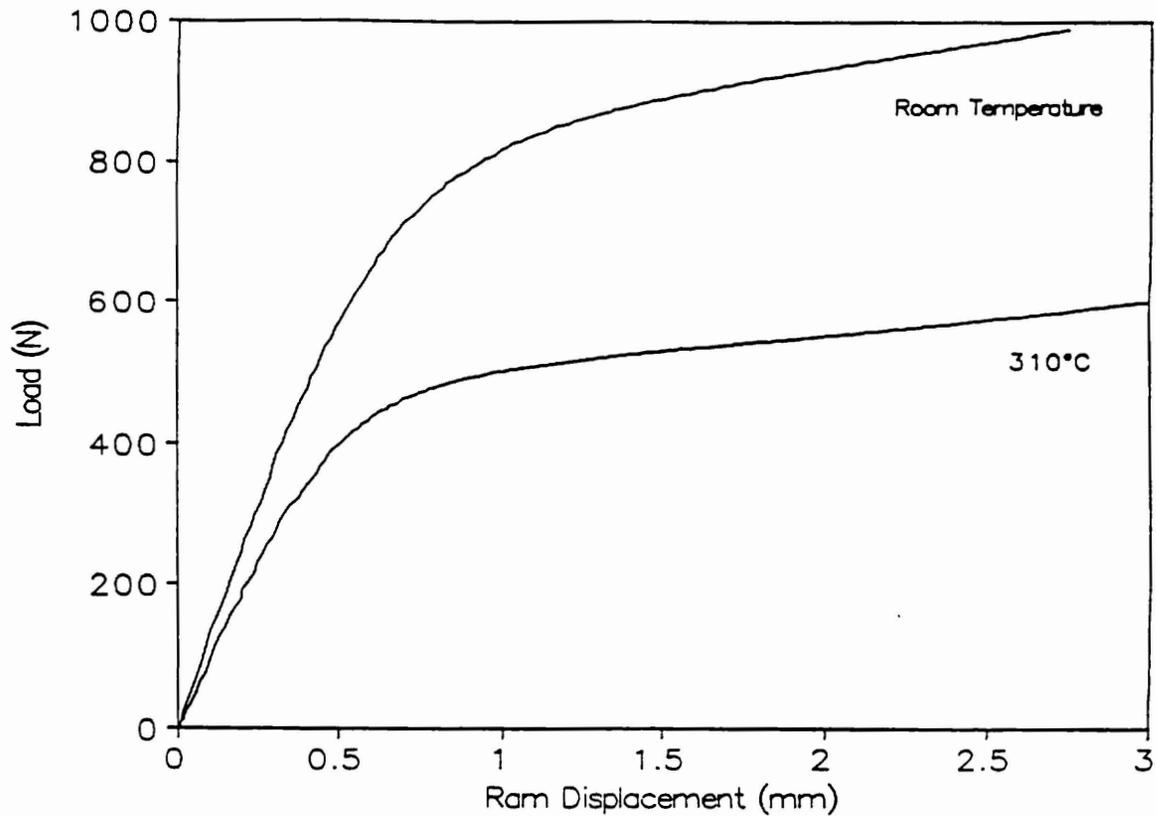
Figure 5. Experimental Load vs Ram Displacement Data for Tensile Tests carried out at Room Temperature and 310°C using GEC Transverse Endcap/endplate Weld Specimens.

3.2.1 Tensile Tests. The tensile load vs ram displacement data presented in Figure 5 have the general shape of a load vs elongation curve obtainable from a standard uniaxial tensile test. This shows that the specimen deformed initially in a elastic manner. With increasing applied load, the deformation of

the specimen became plastic and concentrated in the endplate in the immediate vicinity of the welds associated with the three central endcaps.

Fracture Surface Roughness - The roughness of the fracture surface depended upon the loading conditions. Rougher fracture surfaces were observed when the upper load limit of the fatigue cycle exceeded the elastic limit (based on the tensile behavior shown in Figure 5). There were no observable difference in surface roughness between the ambient and elevated temperature tests when the maximum stress was below the yield stress at the respective test temperatures.

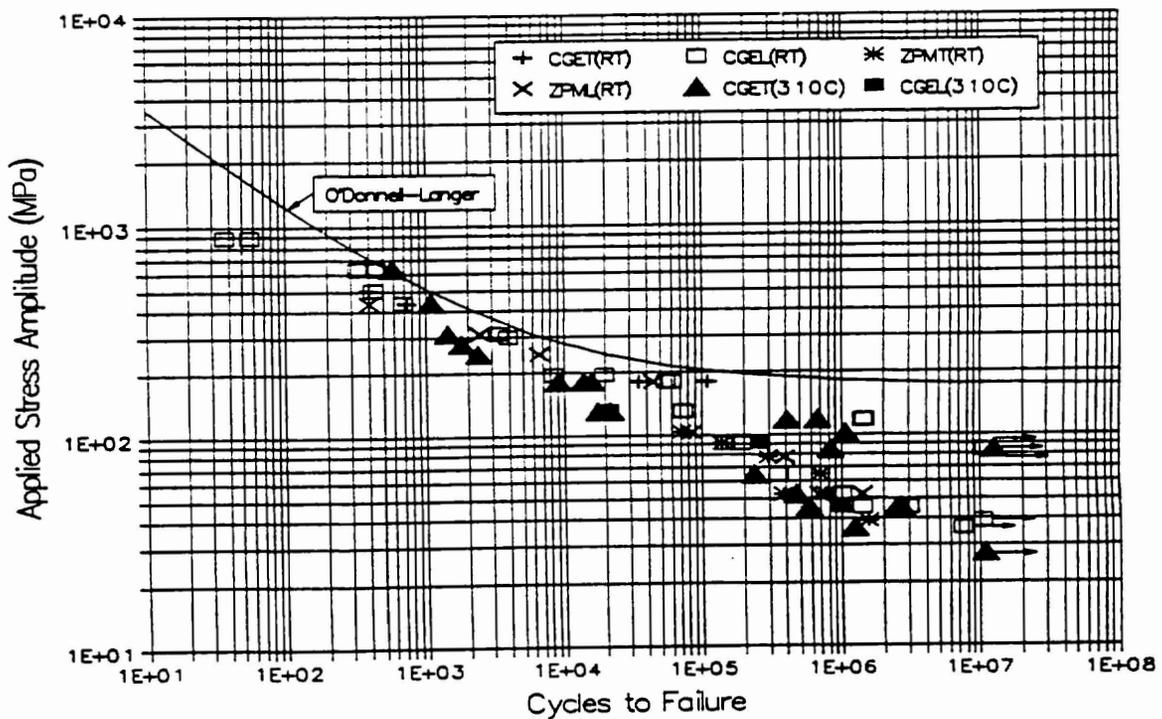
Figure 6. Effects of Applied Stress Amplitude on Fatigue Life of Endcap/endplate Weld Specimens.

3.2.2 Fatigue Life Data. Two cracks are produced in each test. These are in the welds of the two endcaps adjacent to the centre endcap. The fatigue data are presented in the form of a log-log plot of applied stress amplitude vs cycles to failure (Figure 6). The applied stress amplitude was converted from applied load amplitude using the factor of 1.3 MPa/N obtained in Section 3.1. The data leads to the following observations:

(1) The fatigue curve for endplate-to-endcap welds lies significantly below the values available in the literature for smooth specimens. The line in Figure 6 represents the curve summarizing the results of O'Donnell and Langer(1). For the high cycle region at high R-ratio, the weld can sustain a stress amplitude which is only one quarter of that for a smooth specimen. In other words, the effective stress concentration factor of the weld notch is about four.

3.2.3 Crack Initiation & Propagation . Crack propagation behaviour for some tests was monitored with ram displacement. For a few selected tests, the cracking was monitored using potential drop measurement. The ram displacement technique effectively measures the change in compliance due to both cracks whereas the potential drop method monitors change in each crack individually. Figure 8 shows results of one test in which the crack growth was monitored using both techniques. Both types of measurements show that changes are occurring during the early part of the test that signify crack growth. The presence of the weld notch appears to remove the initiation stage as the life-determining step. The relatively small scatter in the experimentally determined lifetime (compared with usual fatigue data for smooth specimens) shown in Figure 6 is attributed to the presence of the notch.

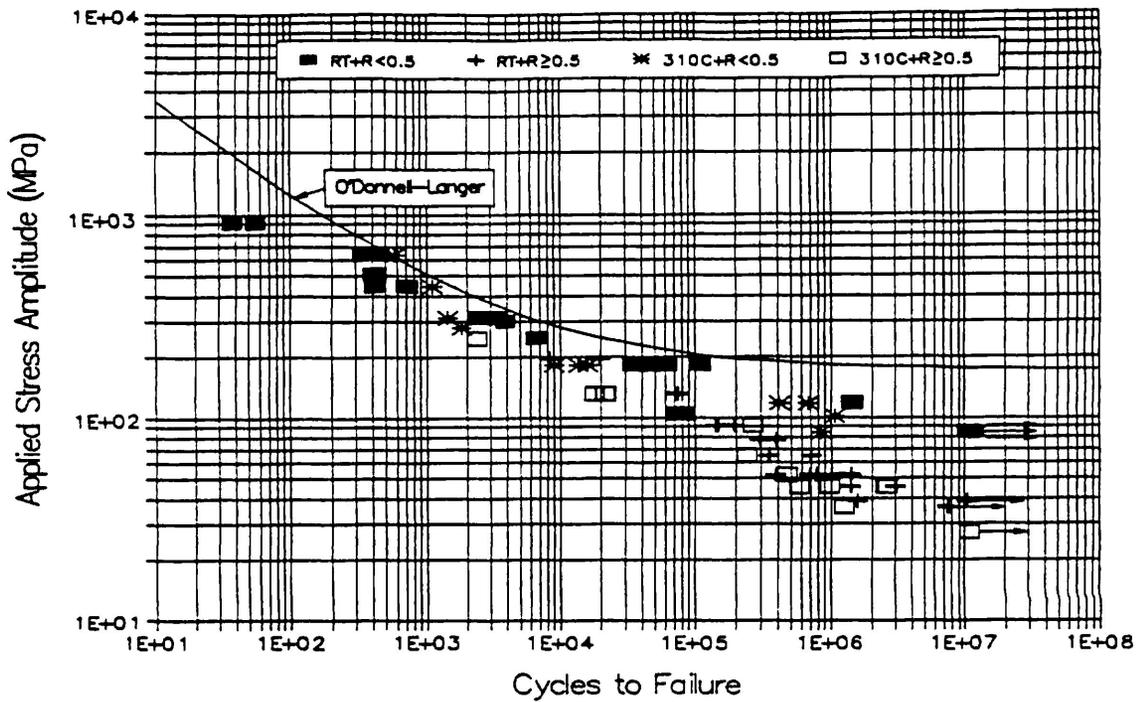
Figure 7 Same Data as Figure 6 but Showing the Effects of R-ratio on Fatigue Life.

(2) There is a significant effect of mean stress on the minimum stress amplitude which produces failures in one million cycles. Higher mean loads can reduce the fatigue limit by a factor of about two in the range of tests conducted (Figure 7). Testing is continuing to construct a Haigh diagram to determine the effects of mean stress on fatigue life. For those tests carried out at high R-ratio, a stress amplitude of 45 MPa can produce failures between 10^5 and 10^6 cycles.

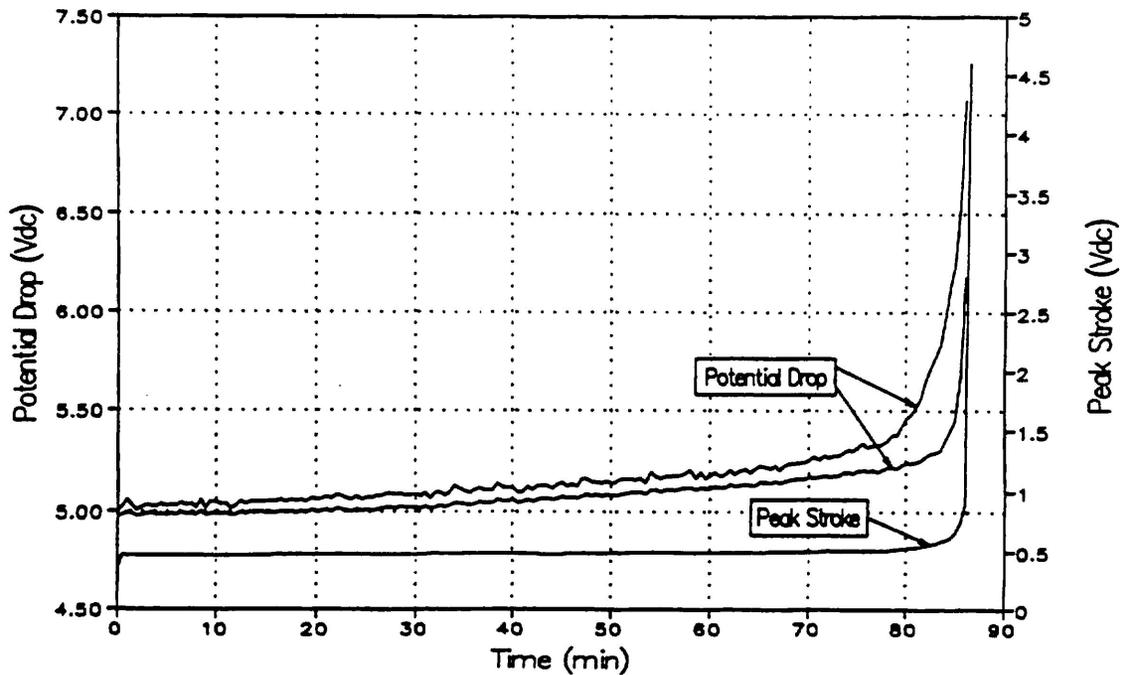
Figure 8. Increase in Ram Displacement and Potential Drop Across the Crack indicated that cracking occurred early on during Fatigue Testing.

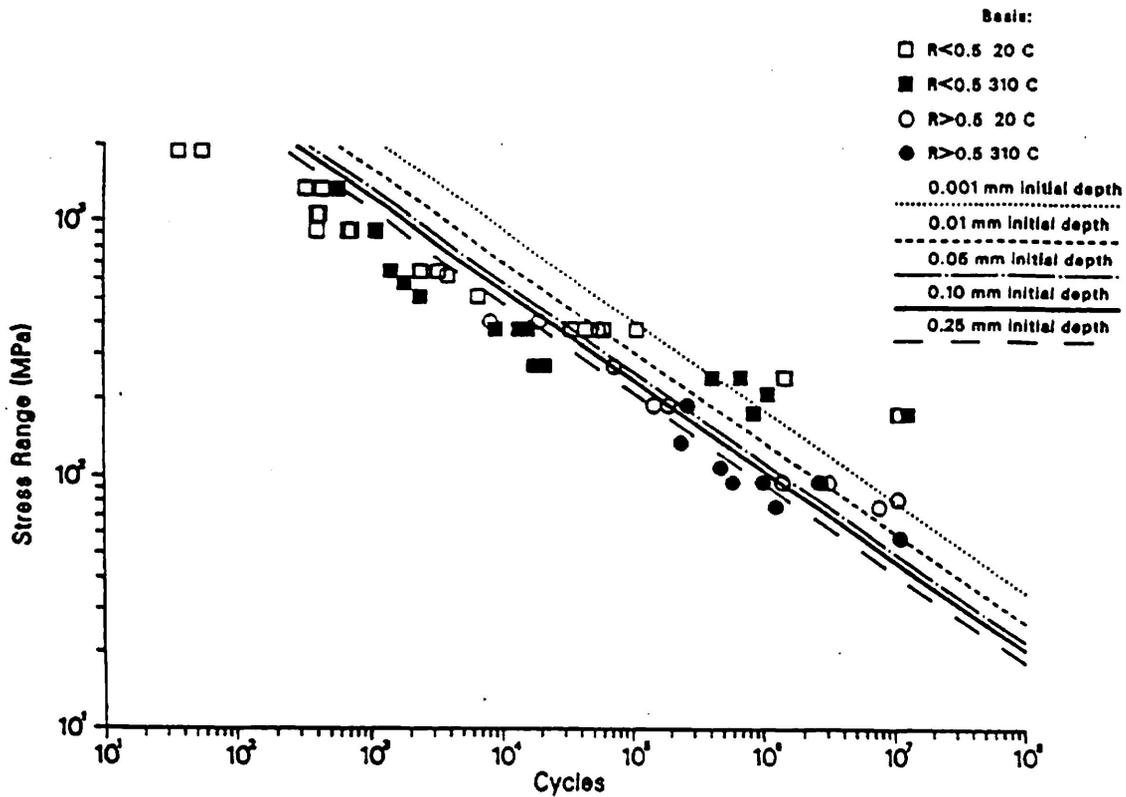
Figure 9. Comparison of Fatigue Test Results With Crack Growth Simulations (Effect of Assumed Initial Crack Depth).

The comparison between the modelled lifetimes and measurements is shown in Figure 9. The effects of different assumptions of initial crack depth are shown in the Figure. The agreement between the model and the measurements is good considering the simplifying assumptions used. Figure 10 shows the inverse comparison, viz. fatigue crack growth rates implied by the lifetime measurements compared with data from the literature. Again, there is reasonable agreement.

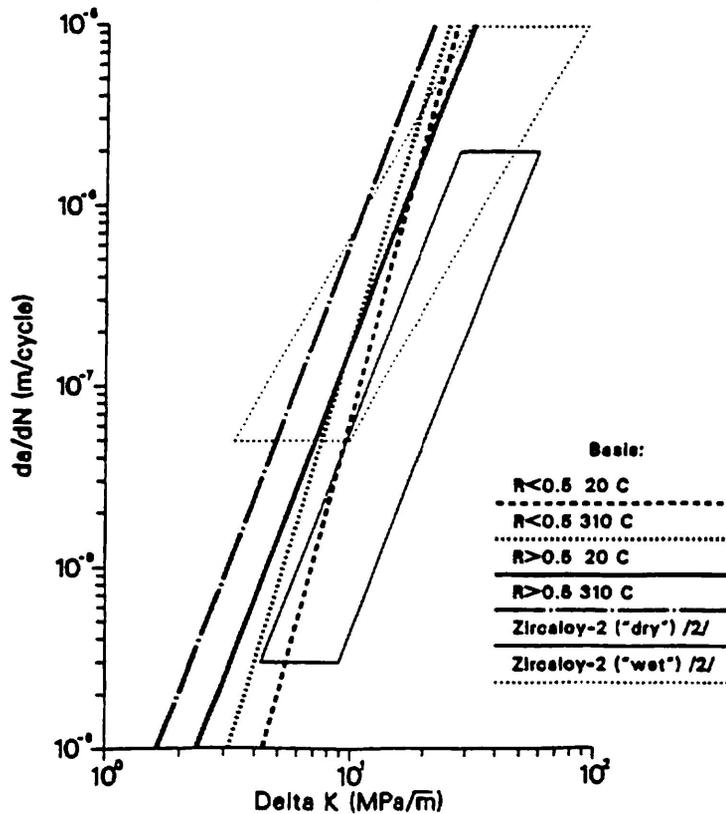
Figure 10. Comparison of Fatigue Crack Growth Data Implied by Small Specimen Program with Published Data.

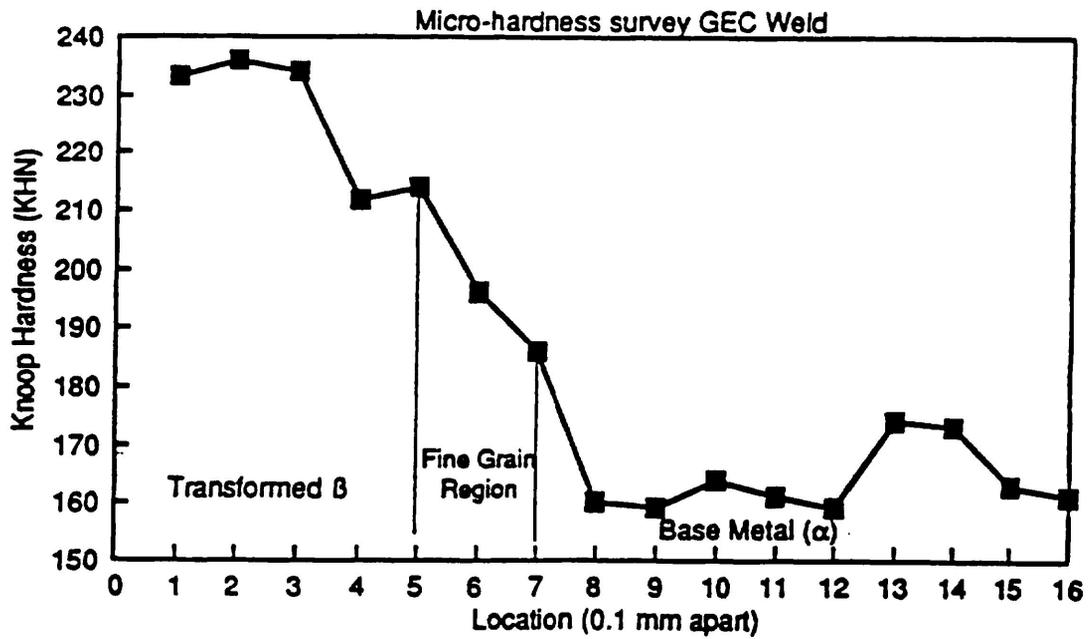
Figure 12. Micro-hardness Across the Weld Region of a GEC Endplate Weld.

Microhardness survey (Figure 12) showed that the weld was significantly harder than the base metal. However the hardest region was found in the fine grain structure at the periphery of the weld interface.
