# GRAIN-BOUNDARY OXIDATION OF USED CANDU FUEL EXPOSED TO DRY AIR AT 150°C FOR A PROLONGED PERIOD

W.H. HOCKING, R. BEHNKE, A.M. DUCLOS, A.F. GERWING AND K.M. WASYWICH

Atomic Energy of Canada Limited  
Whiteshell Laboratories  
Pinawa, Manitoba, Canada R0E 1L0

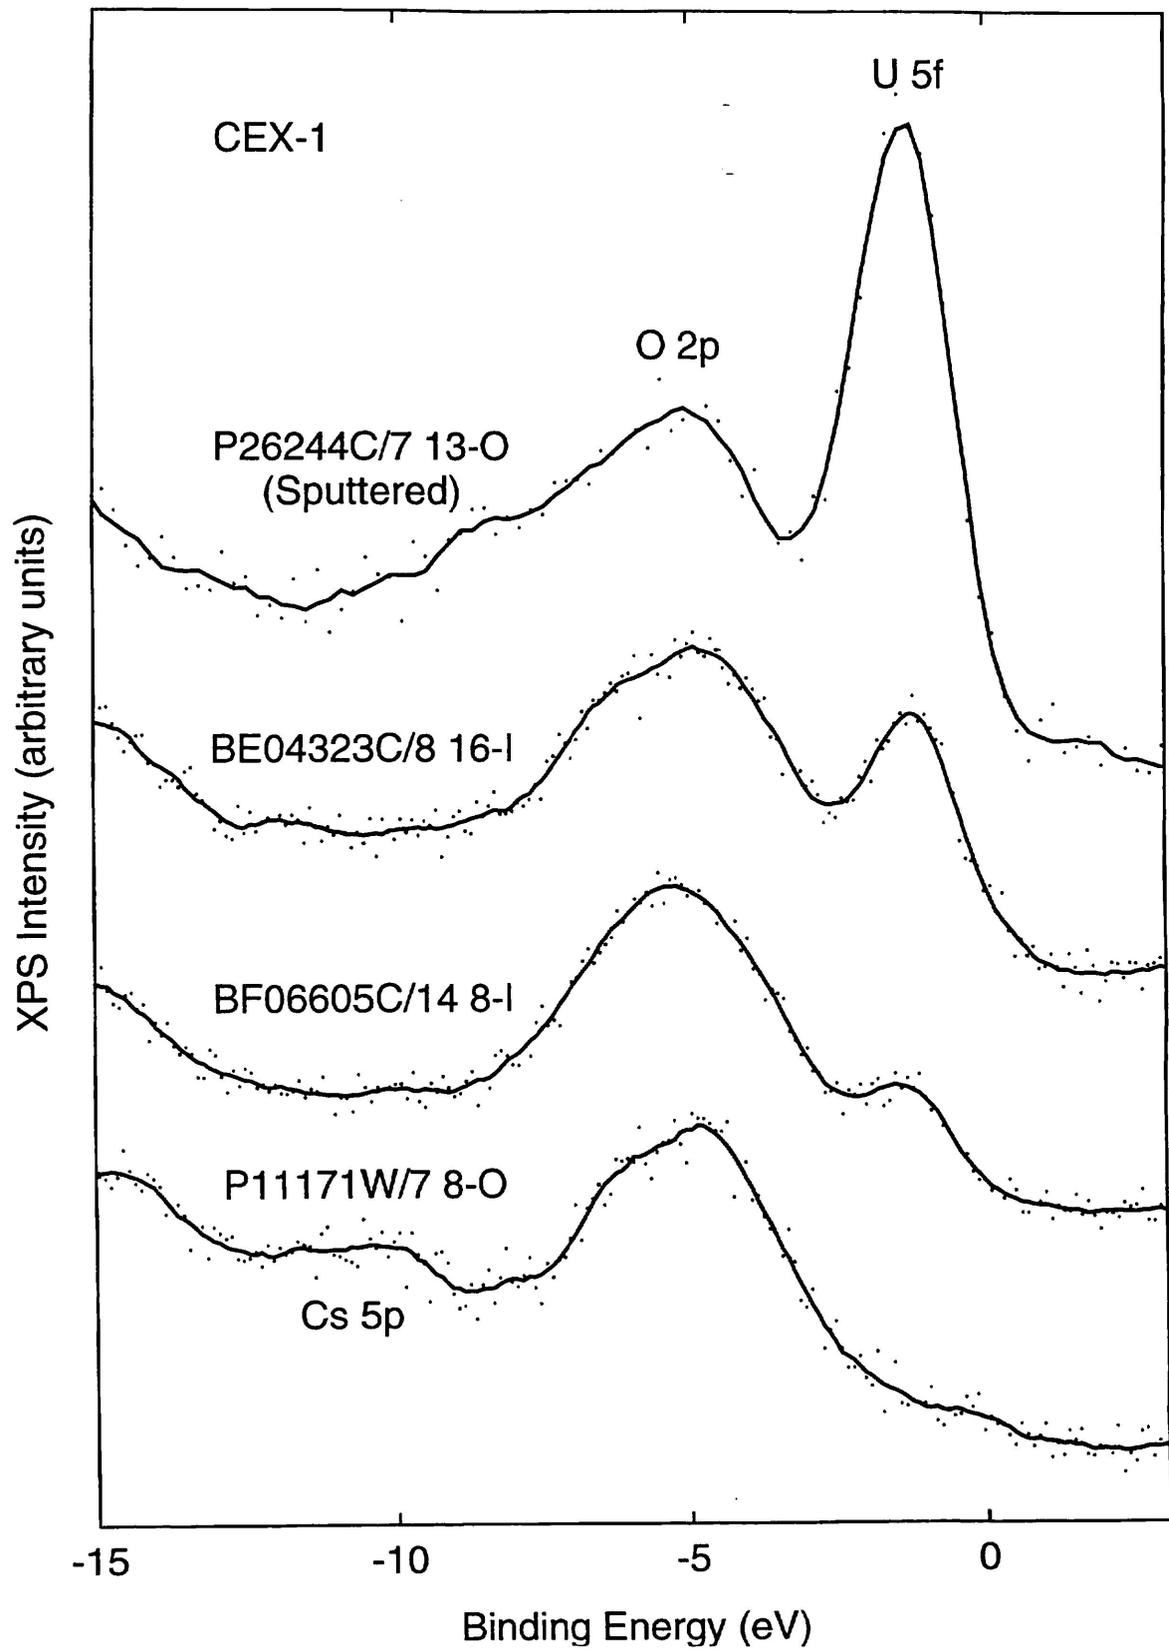
FIGURE 1. CHANGES IN THE XPS VALENCE BAND REFLECT THE URANIUM OXIDATION STATE (UO<sub>2</sub> TOP).

The degree of surface oxidation of each fuel fragment was determined from chemical-shift effects in the uranium photoelectron emission spectra. Curve-resolution of the broadened U 4f<sub>7/2</sub> peak envelope into two components yields a quantitative estimate of the proportions of uranium in the +4 and +6 valence states [3-5,9,12]. An independent check on the curve-resolved measurement is provided by the relative intensity of the U 5f peak, which progressively declines as UO<sub>2</sub> is oxidized to UO<sub>3</sub> (illustrated in Figure 1). The results for all fragments, expressed as %U<sup>6+</sup> and U<sup>6+</sup>/U<sup>4+</sup> ratio, are collected in Table 1. These data represent the extent of surface oxidation averaged over the escape depth of the photoelectrons (~2 nm) and the analysis area on the sample. An appraisal of the probable error range for the %U<sup>6+</sup> values has also been given, based on consideration of the statistical uncertainty, robustness of the fit and confidence in the surface-charging correction [3].

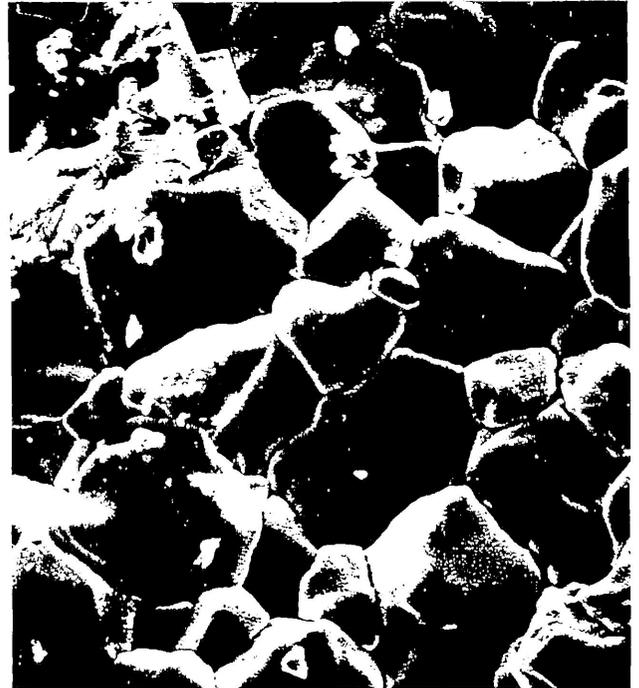
FIGURE 2. SECONDARY ELECTRON IMAGES OF BF06605C/14 FUEL FRAGMENTS 2-I (a, b) AND 17-I (c, d).

A representative selection of secondary electron images depicting the surface morphology of the CEX-1 fuel fragments has been reproduced in Figures 2-5. The range of features observed reflects the power history of the fuels as well as the subsequent storage exposure and sampling methodology. Visible indications of surface alteration were surprisingly muted considering the other evidence of grain-boundary attack; specific observations on each fragment have been summarized in Table 1. The predominant overall trait was clean intergranular fracture, accented by grain-edge rounding and separation. A small contraction of the fluorite lattice that occurs when UO<sub>2</sub> is oxidized to U<sub>4</sub>O<sub>9</sub> or U<sub>3</sub>O<sub>7</sub> would be consistent with the latter [5,13]. About a third of all fragments exhibited at least one crack; however, it is uncertain whether these are entirely a manifestation of the fuel oxidation. Visible cracking of individual fuel grains was uncommon and possibly caused by physical damage (Figure 4d) incurred during fuel handling or sample selection. Some transgranular fracturing was also seen, but more typically appeared to reflect old, in-reactor cracks rather than fresh grain cleavage (Figures 2c, 2d and 4a).

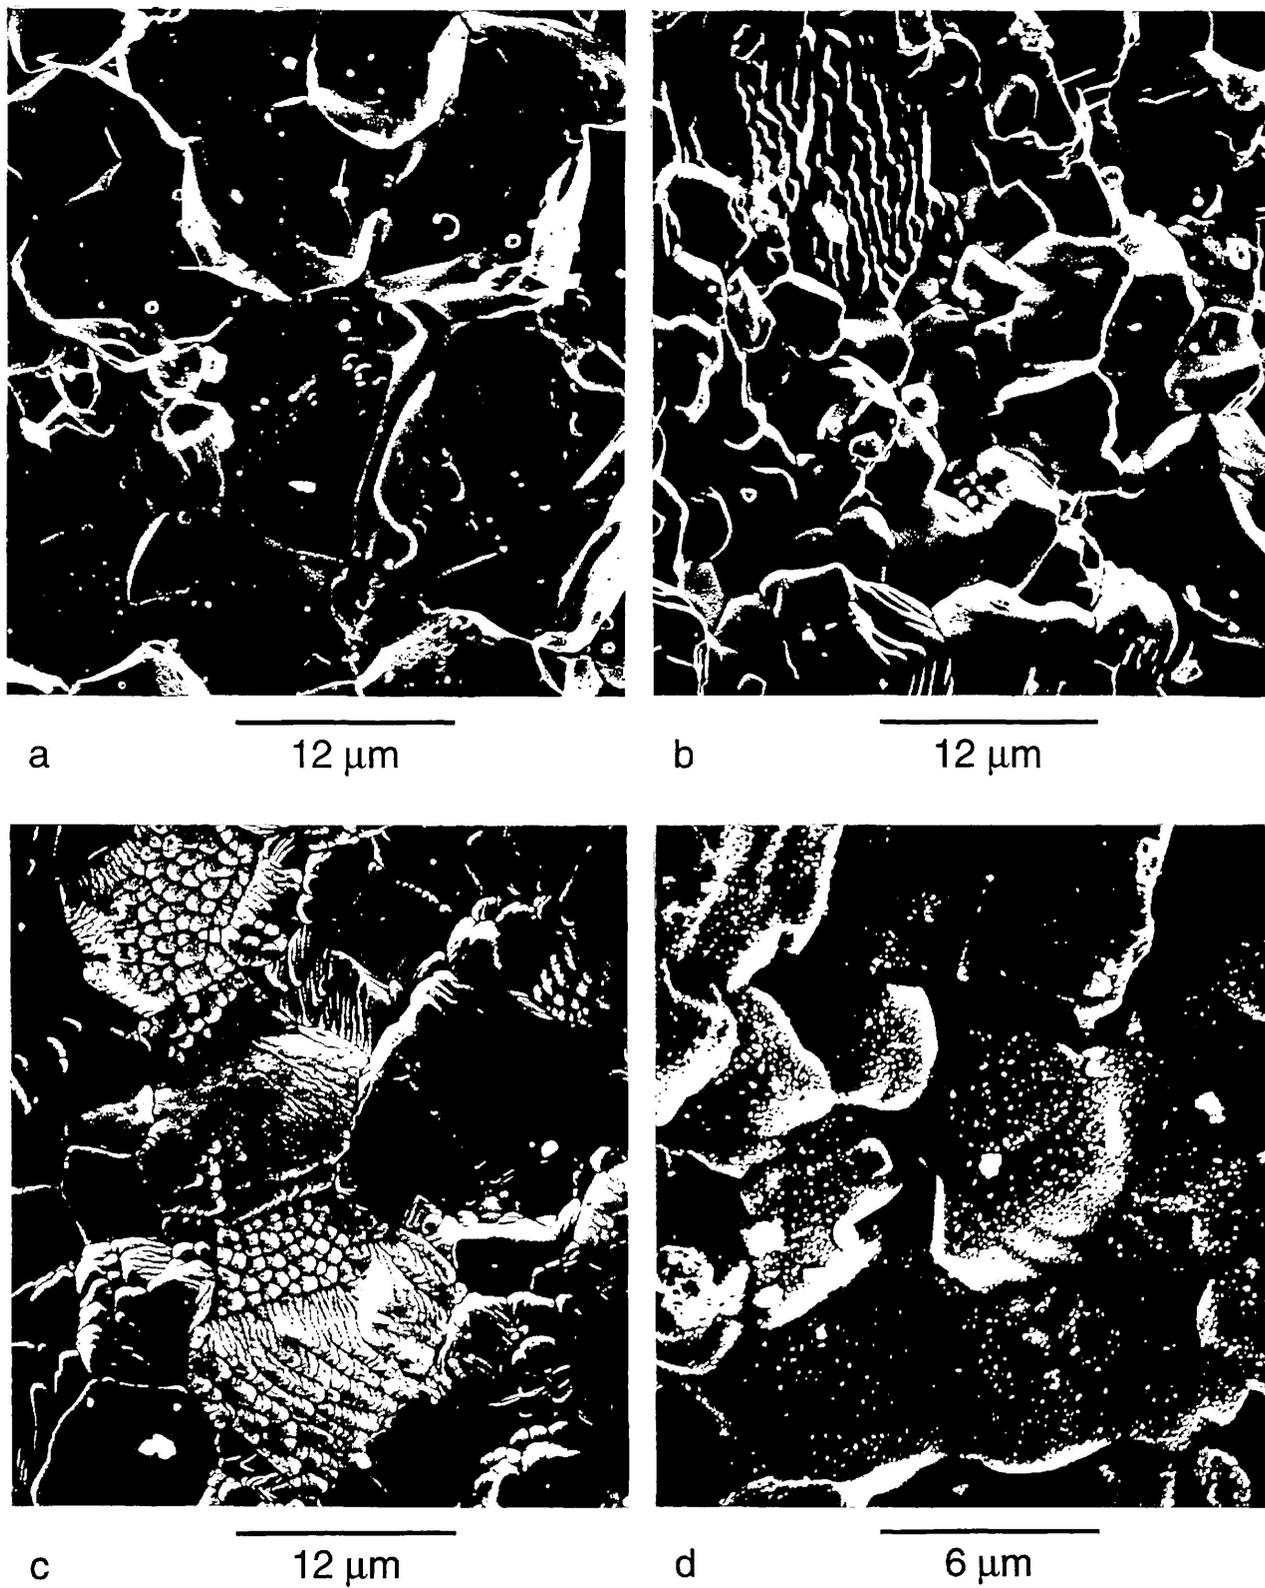
FIGURE 3. SECONDARY ELECTRON IMAGES OF P26244C/7 FUEL FRAGMENTS 8-I (a), 8-O (b), 13-I (c) AND 17-I (d).

The effects of reactor irradiation were still readily apparent on most of the fragment surfaces. Fission-gas bubbles and tunnels, decorated with  $\epsilon$ -phase (noble metal) particles [14], were identified on several fragments taken from near the centreline of the high-power fuels (Figures 3a, 4c and 4d). Extensive surface texture, which is characteristic of CANDU fuels [8,9], was observed on many other grain faces (Figures 3b, 3c, 4b and 5a). Secondary crystallization was probably found on a number of fragments as well, but in widely varying proportions and with different levels of certainty (Table 1). Sparse coverage by very fine-grained material, which may develop a cloud-like appearance, has been tentatively attributed to  $U_3O_8$  nucleation and growth (Figures 2c, 2d, 3d, 4a and 4b). Heavier deposits of less distinctive particulate may at least partly represent debris created by physical damage (Figures 5b, 5c and 5d).

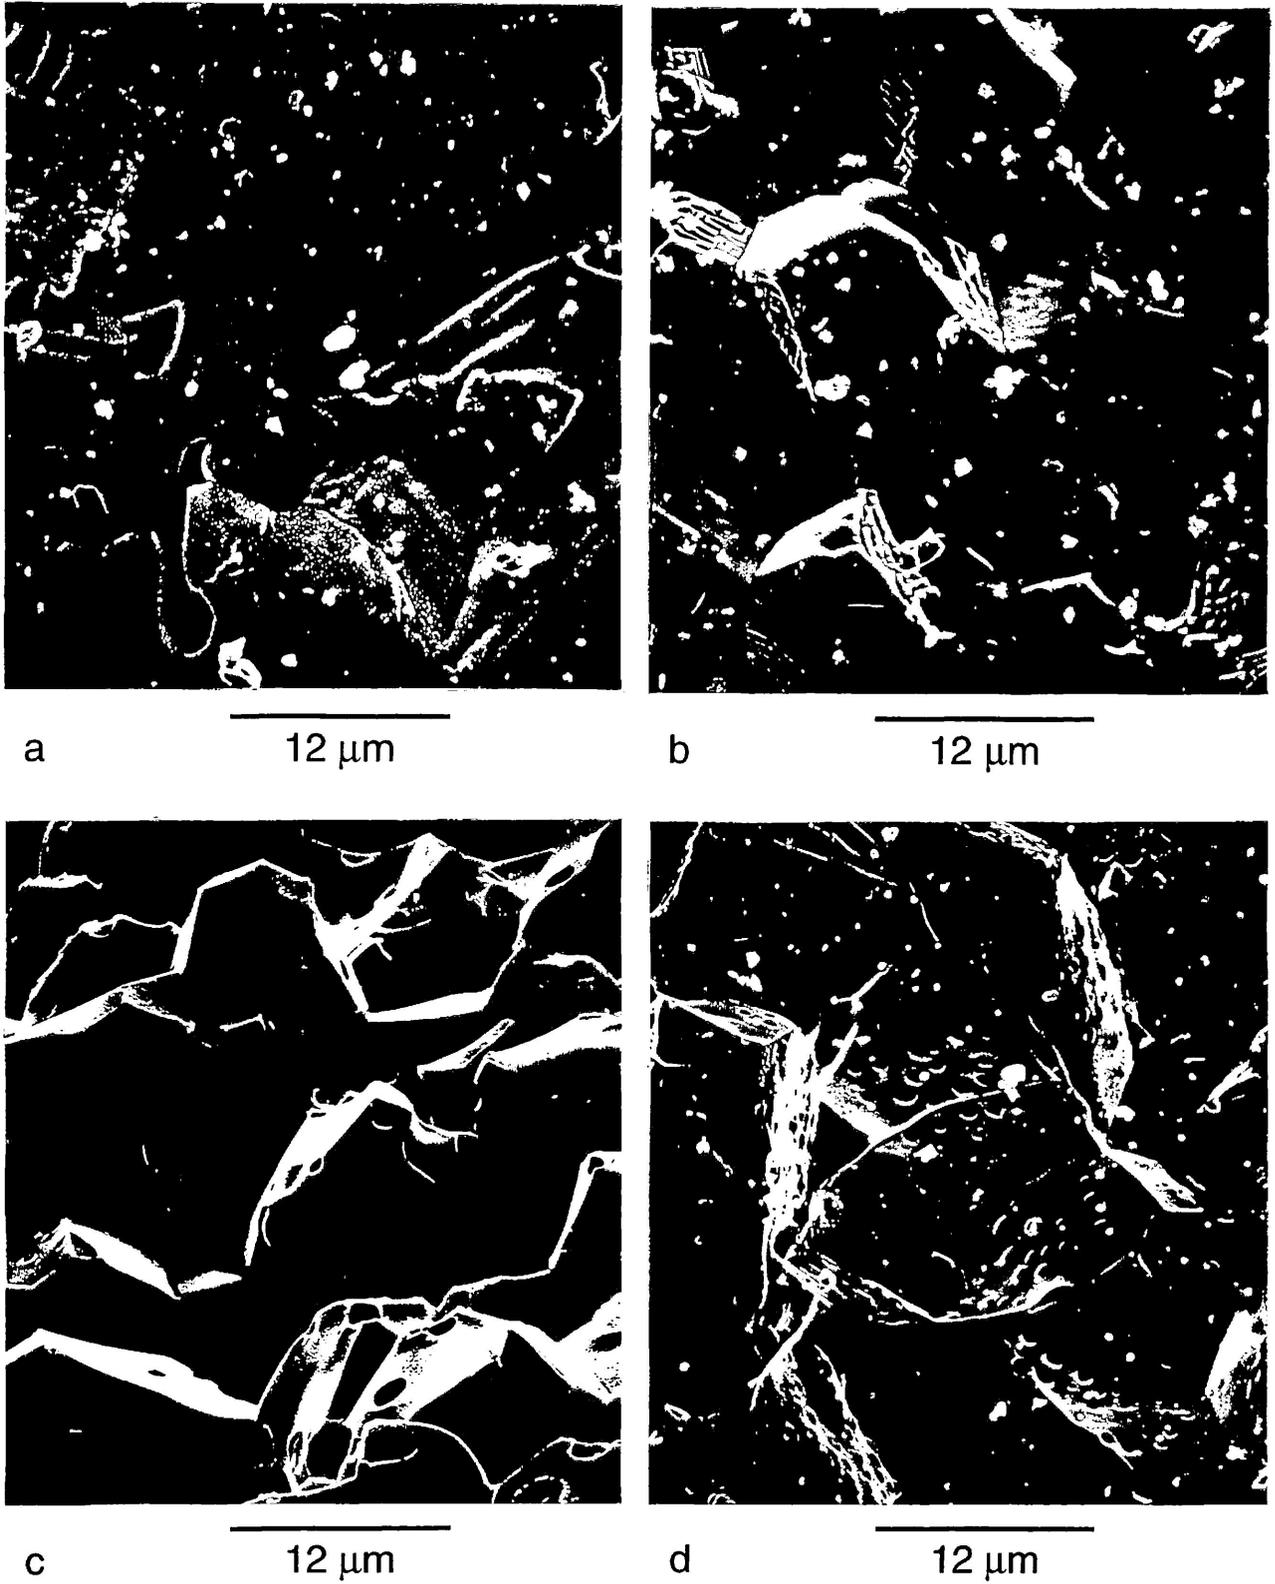
FIGURE 4. SECONDARY ELECTRON IMAGES OF P11171W/7 FUEL FRAGMENTS 2-O (a), 13-O (b), 8-I (c) AND 17-I (d).

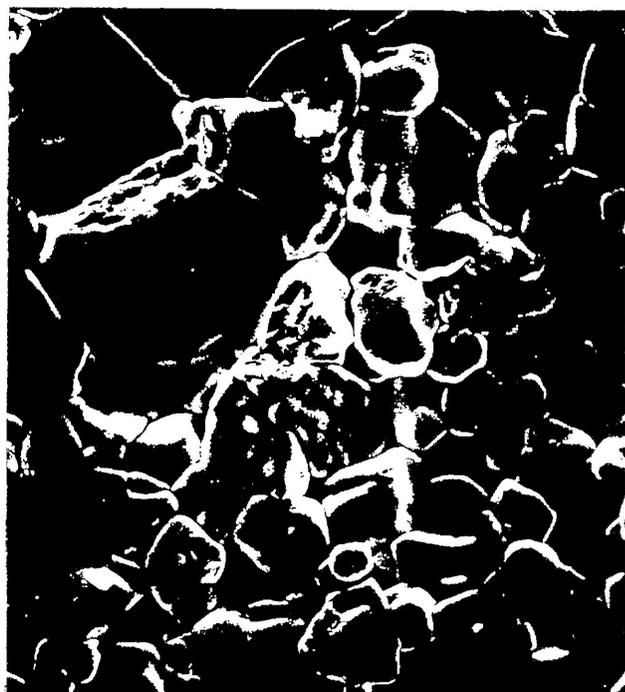
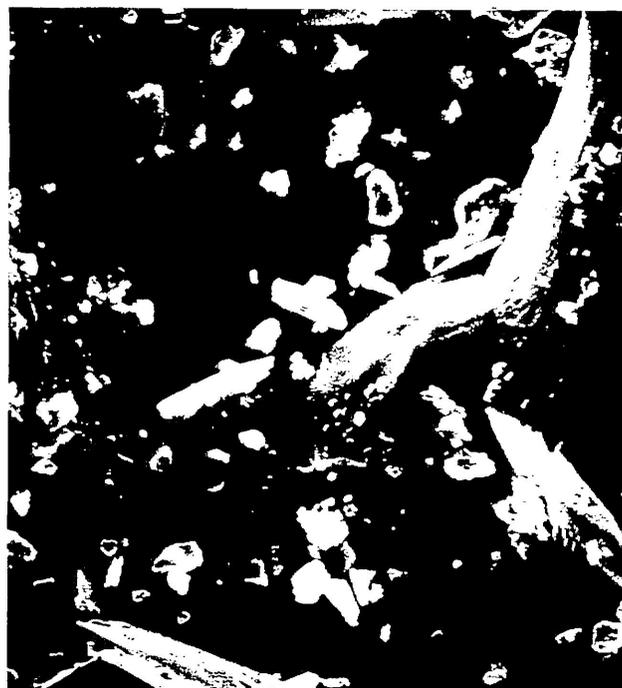
FIGURE 5. SECONDARY ELECTRON IMAGES OF BE04323C/8 FUEL FRAGMENTS 2-I (a), 13-I (b) AND 8-I (c,d).

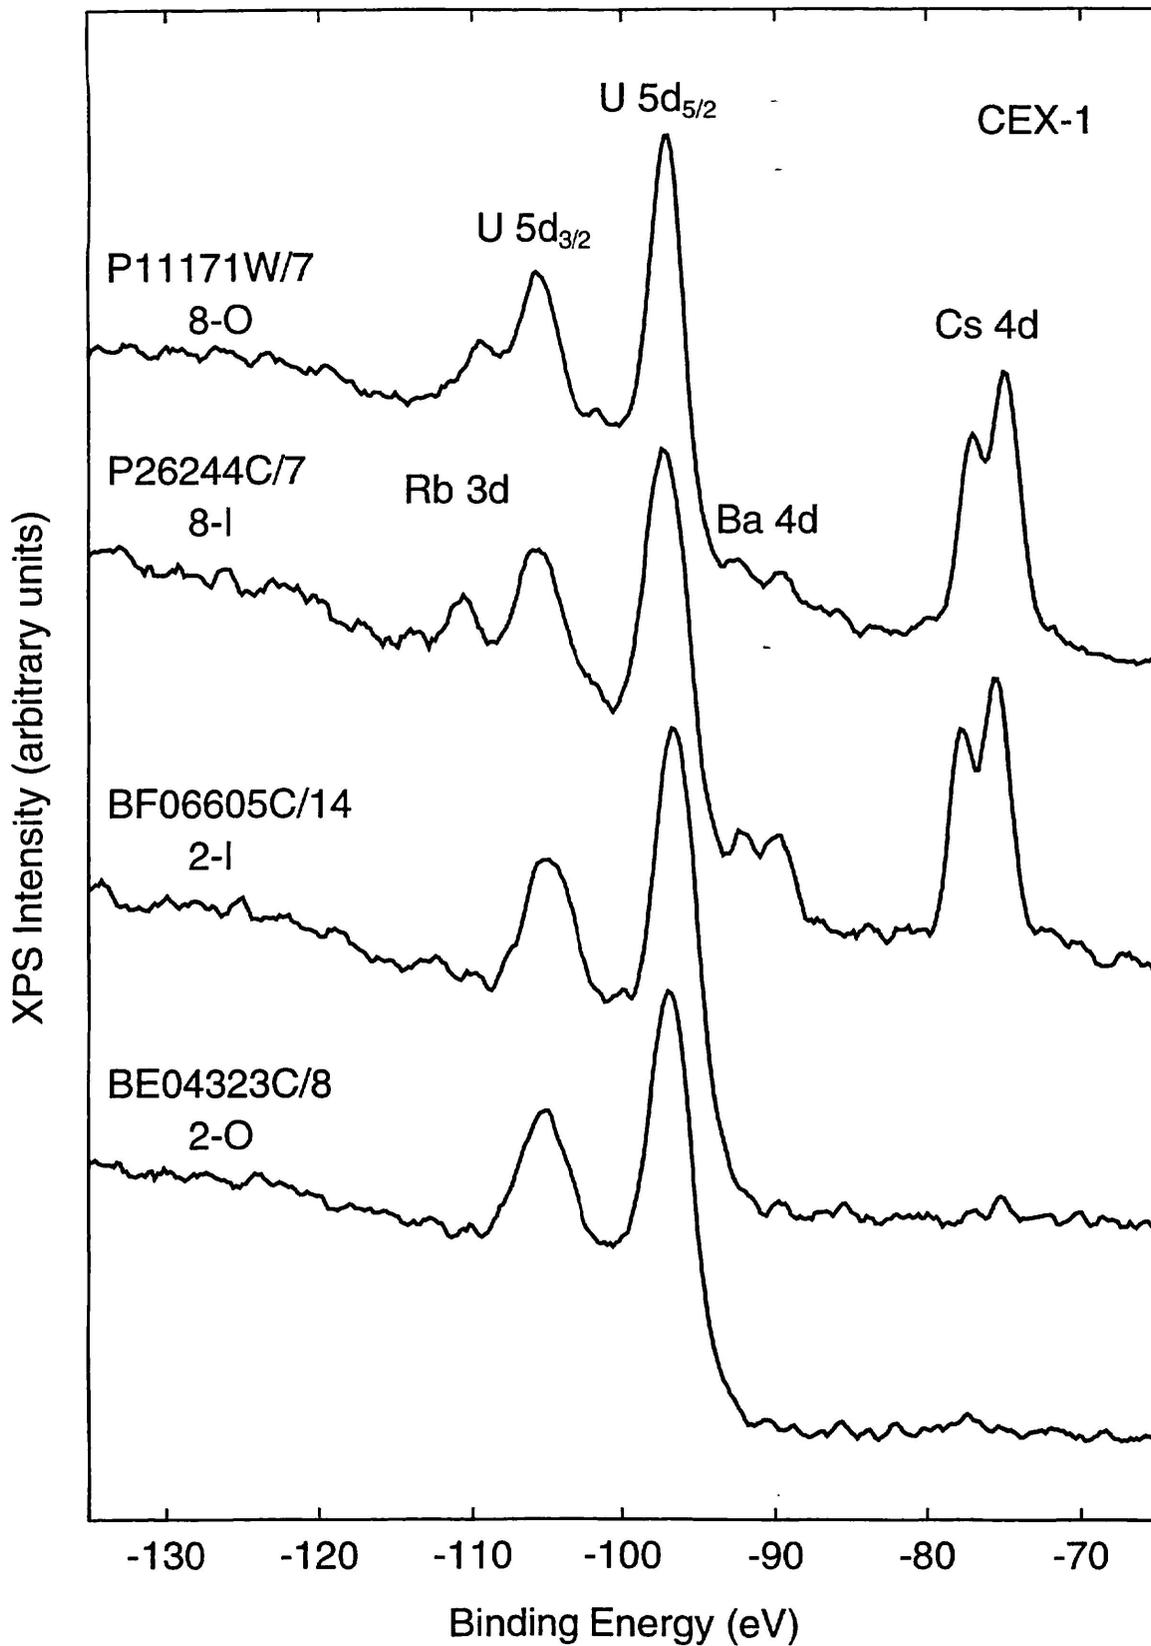
FIGURE 6. TYPICAL XPS SPECTRA ILLUSTRATING FISSION-PRODUCT SEGREGATION ON CEX-1 FUEL FRAGMENTS.

Representative low-binding-energy portions of XPS spectra recorded from typical fragments of the four CEX-1 fuels analyzed in the present study are compared in Figure 6. These show a marked dependence of fission-product segregation on fuel power history. The two high-power fuels both exhibit distinct Rb 3d and Ba 4d peaks as well as strong Cs 4d spin-orbit doublets; conversely, only weak Cs 4d emission has been detected from the two low-power fuels (more convincingly from BF06605C/14 than from BE04323C/8 in Figure 6, but the opposite for some other fragments from these two fuels). At the relatively low burnups achieved, CANLUB appears to have had little impact on fission-product segregation. Pre-storage fission-gas release (FGR) measurements and diametral  $\gamma$ -ray scans for cesium on other outer elements from the same bundles are sensibly correlated with the XPS results. The two high-power fuels had 4.5-7.2% FGR and up to 60% depletion of  $^{137}\text{Cs}$  from a central 5 mm core, whereas the two low-power fuels had <0.16% FGR and no radial  $^{137}\text{Cs}$  migration. A sequence of low-binding-energy XPS spectra collected from another fragment of P26244C/7 fuel, at increasing intervals of argon-ion sputtering, has been reproduced in Figure 7. The pattern of fission-product removal seen here is similar to that observed for fragments taken from intact elements and indicates monolayer-level surface coverage with probably some inhomogeneity [8].

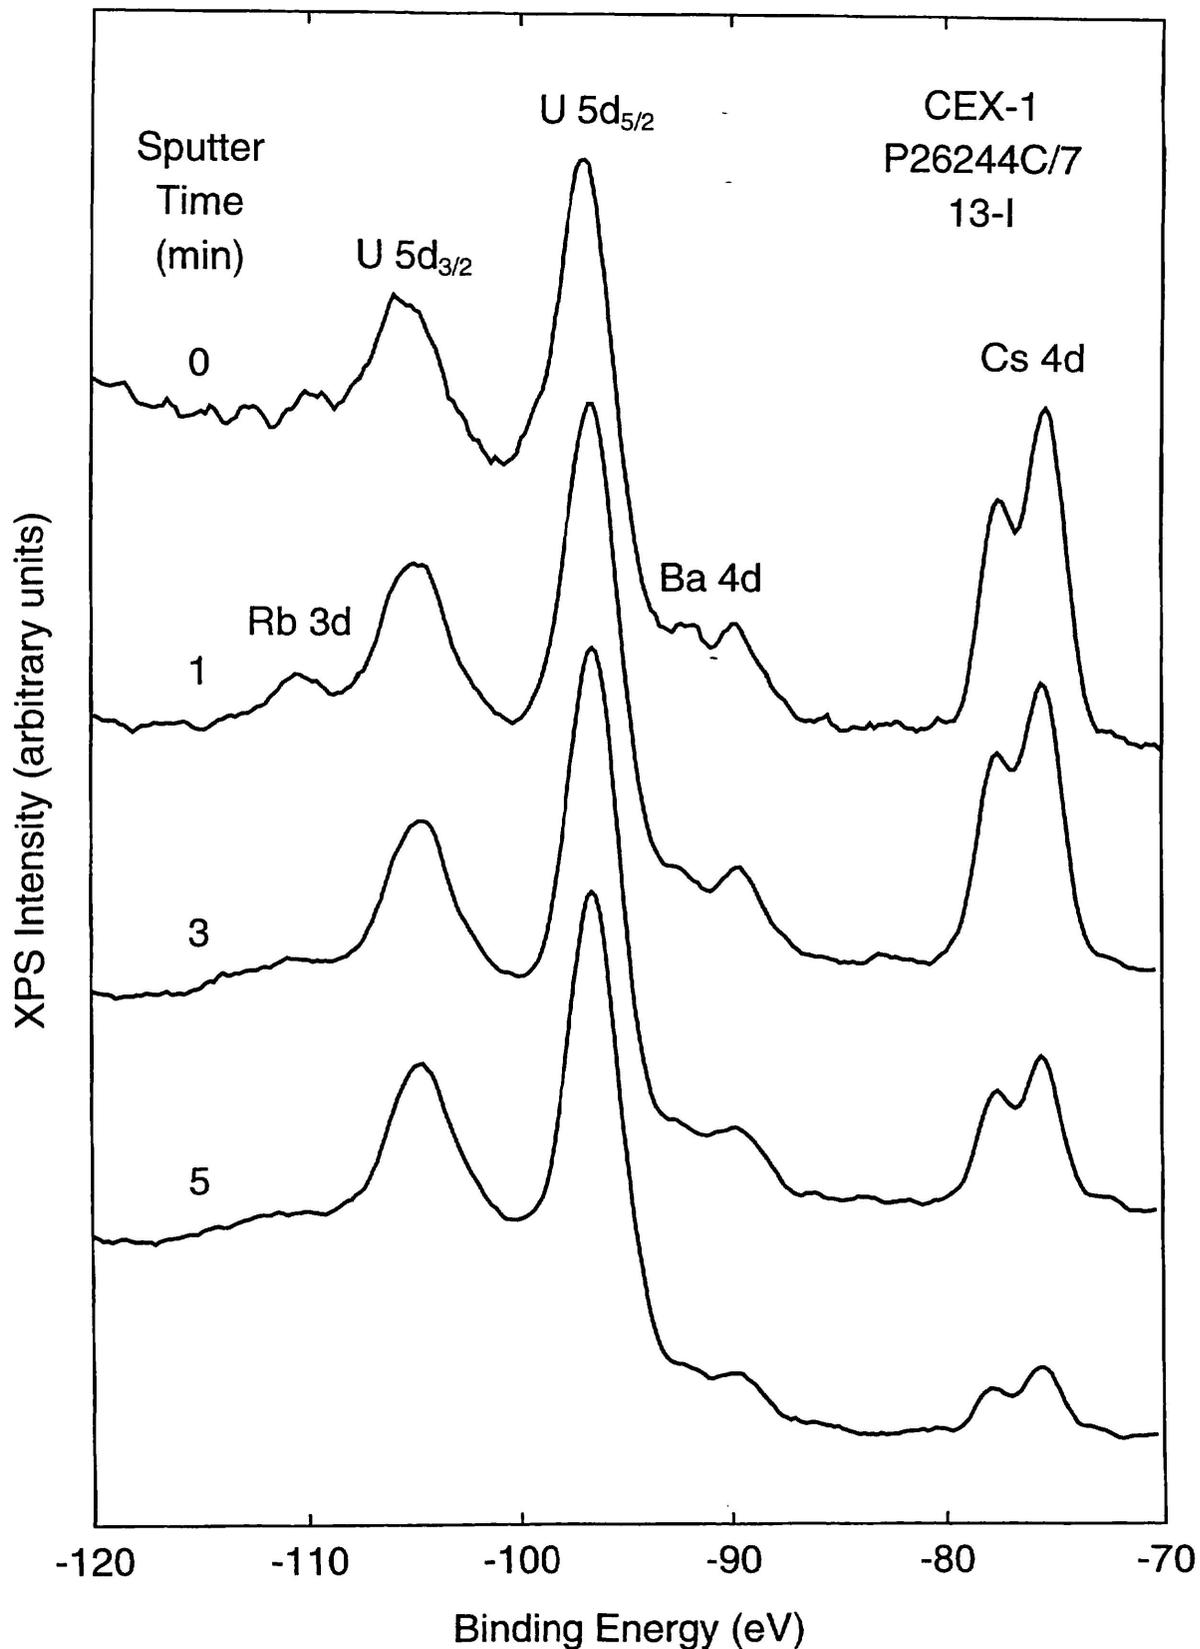
FIGURE 7. SEQUENCE OF XPS SPECTRA AS A FUNCTION OF ARGON-ION SPUTTERING FOR ONE FUEL FRAGMENT.

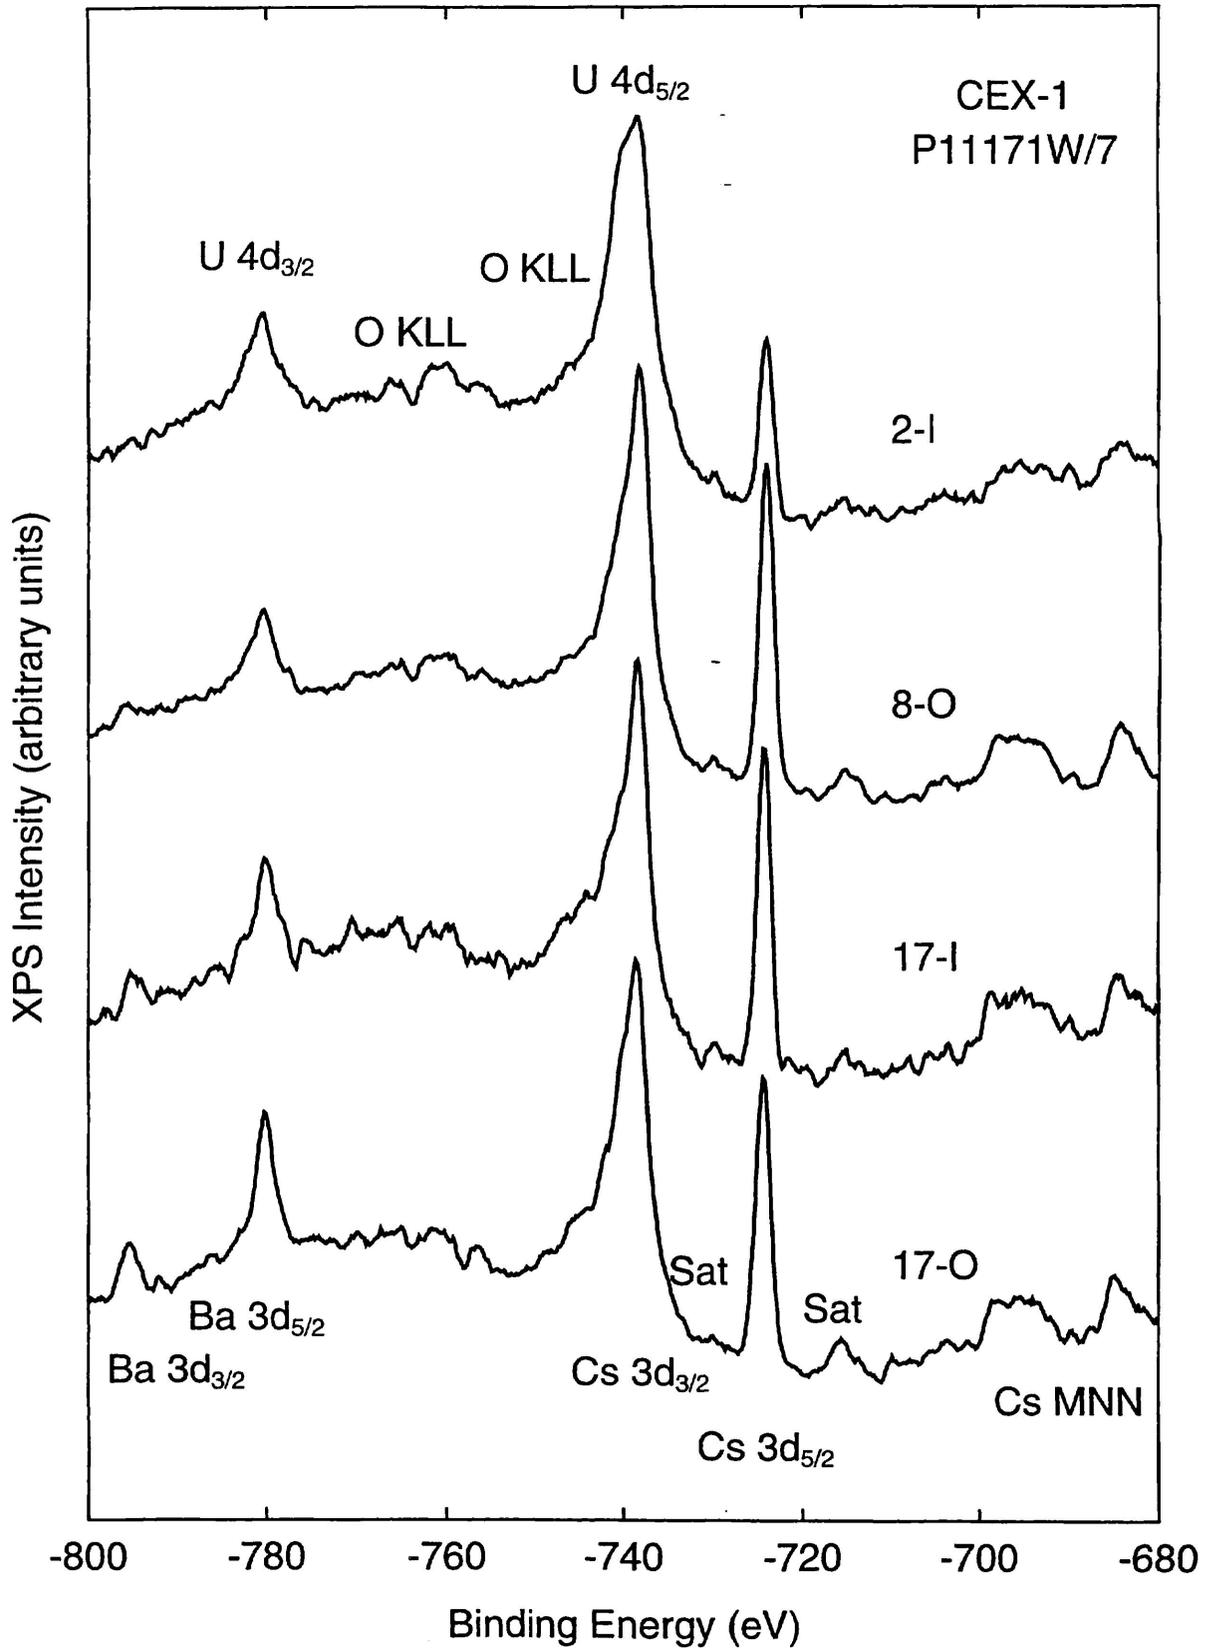
FIGURE 8. SERIES OF XPS SPECTRA SHOWING VARIABILITY IN CESIUM AND BARIUM SEGREGATION.

Variability in the extent of fission-product segregation within the high-power fuels is illustrated in Figure 8; typically, the relative abundance of cesium differs less from one fragment to another than that of barium. A similar behaviour has been observed for intact fuels and can be pronounced also for tellurium, as shown by the representative selection of Te 3d spectra in Figure 9 that were collected from the high-power CEX-1 fuels. Because of the evident lack of correlation with location in the element, as seen in Figures 8 and 9, redistribution of fission products during the recent (and prior) CEX-1 storage would appear not to have been significant.

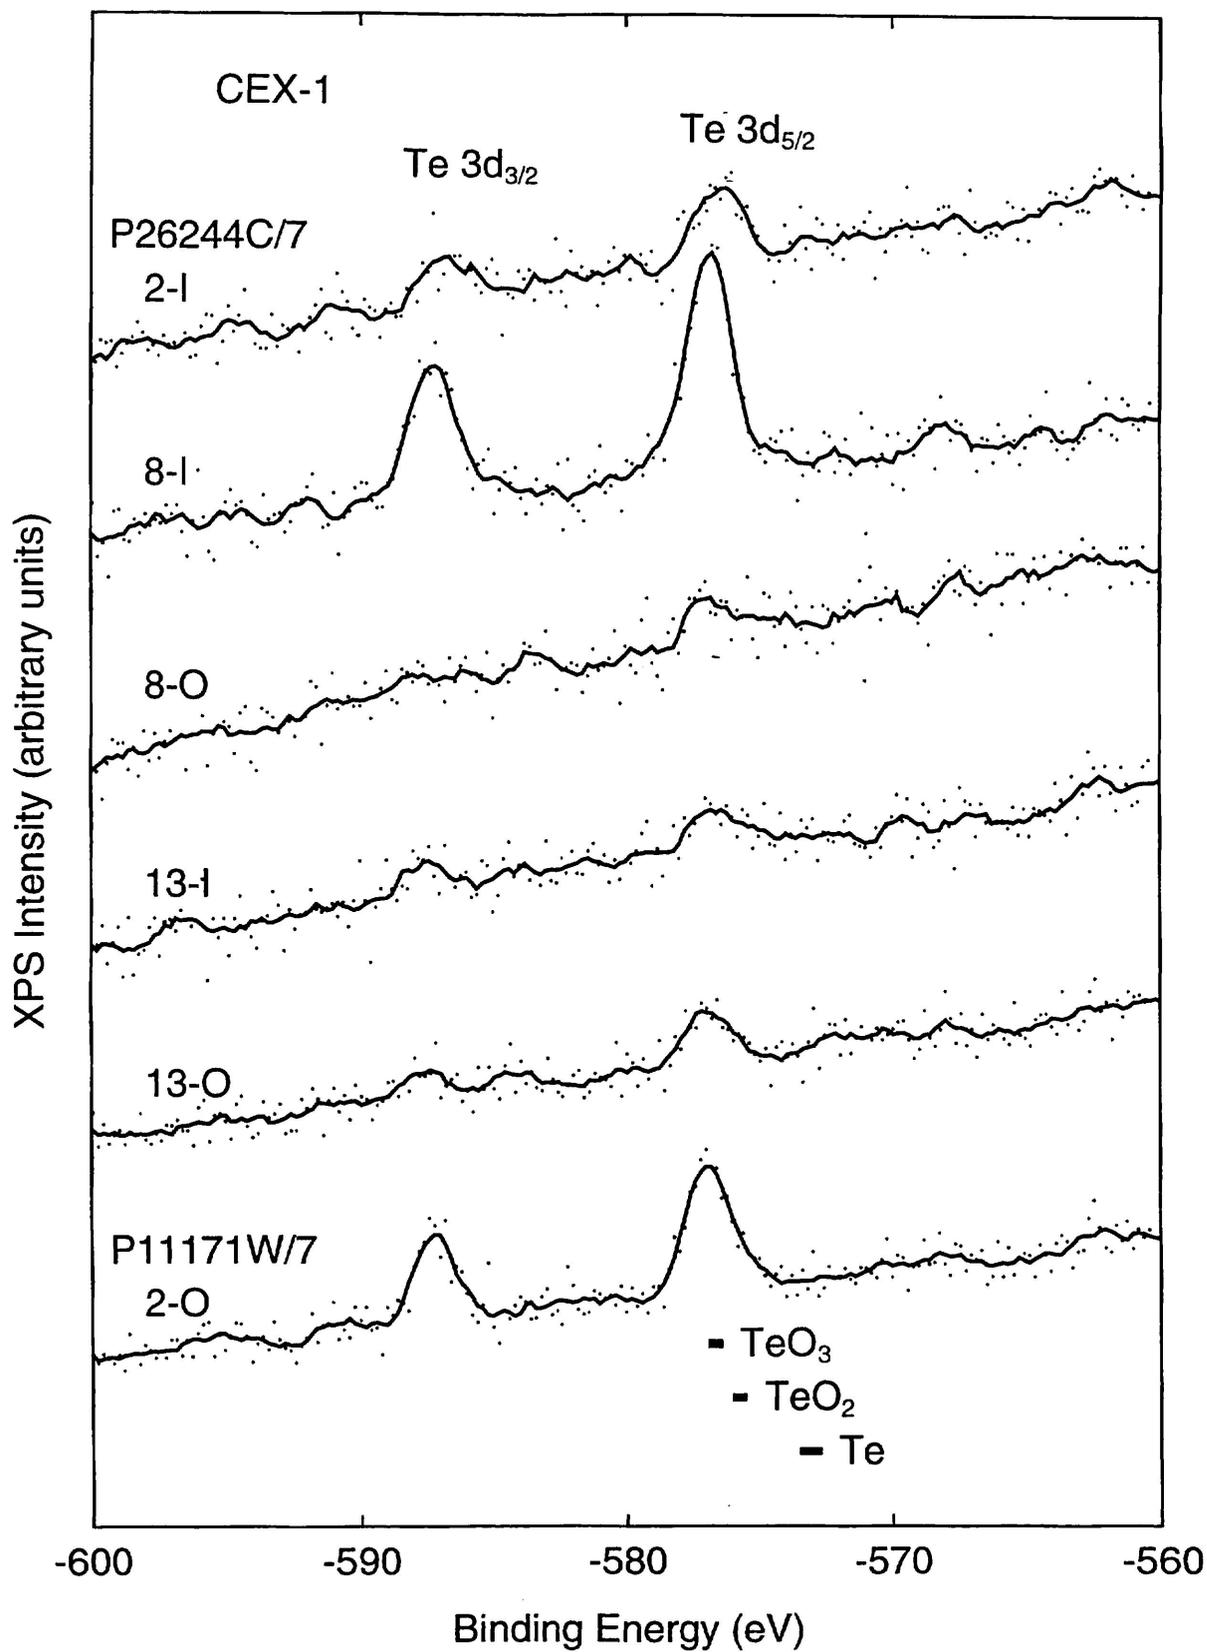
FIGURE 9. SERIES OF XPS SPECTRA SHOWING VARIABILITY IN TELLURIUM SEGREGATION.

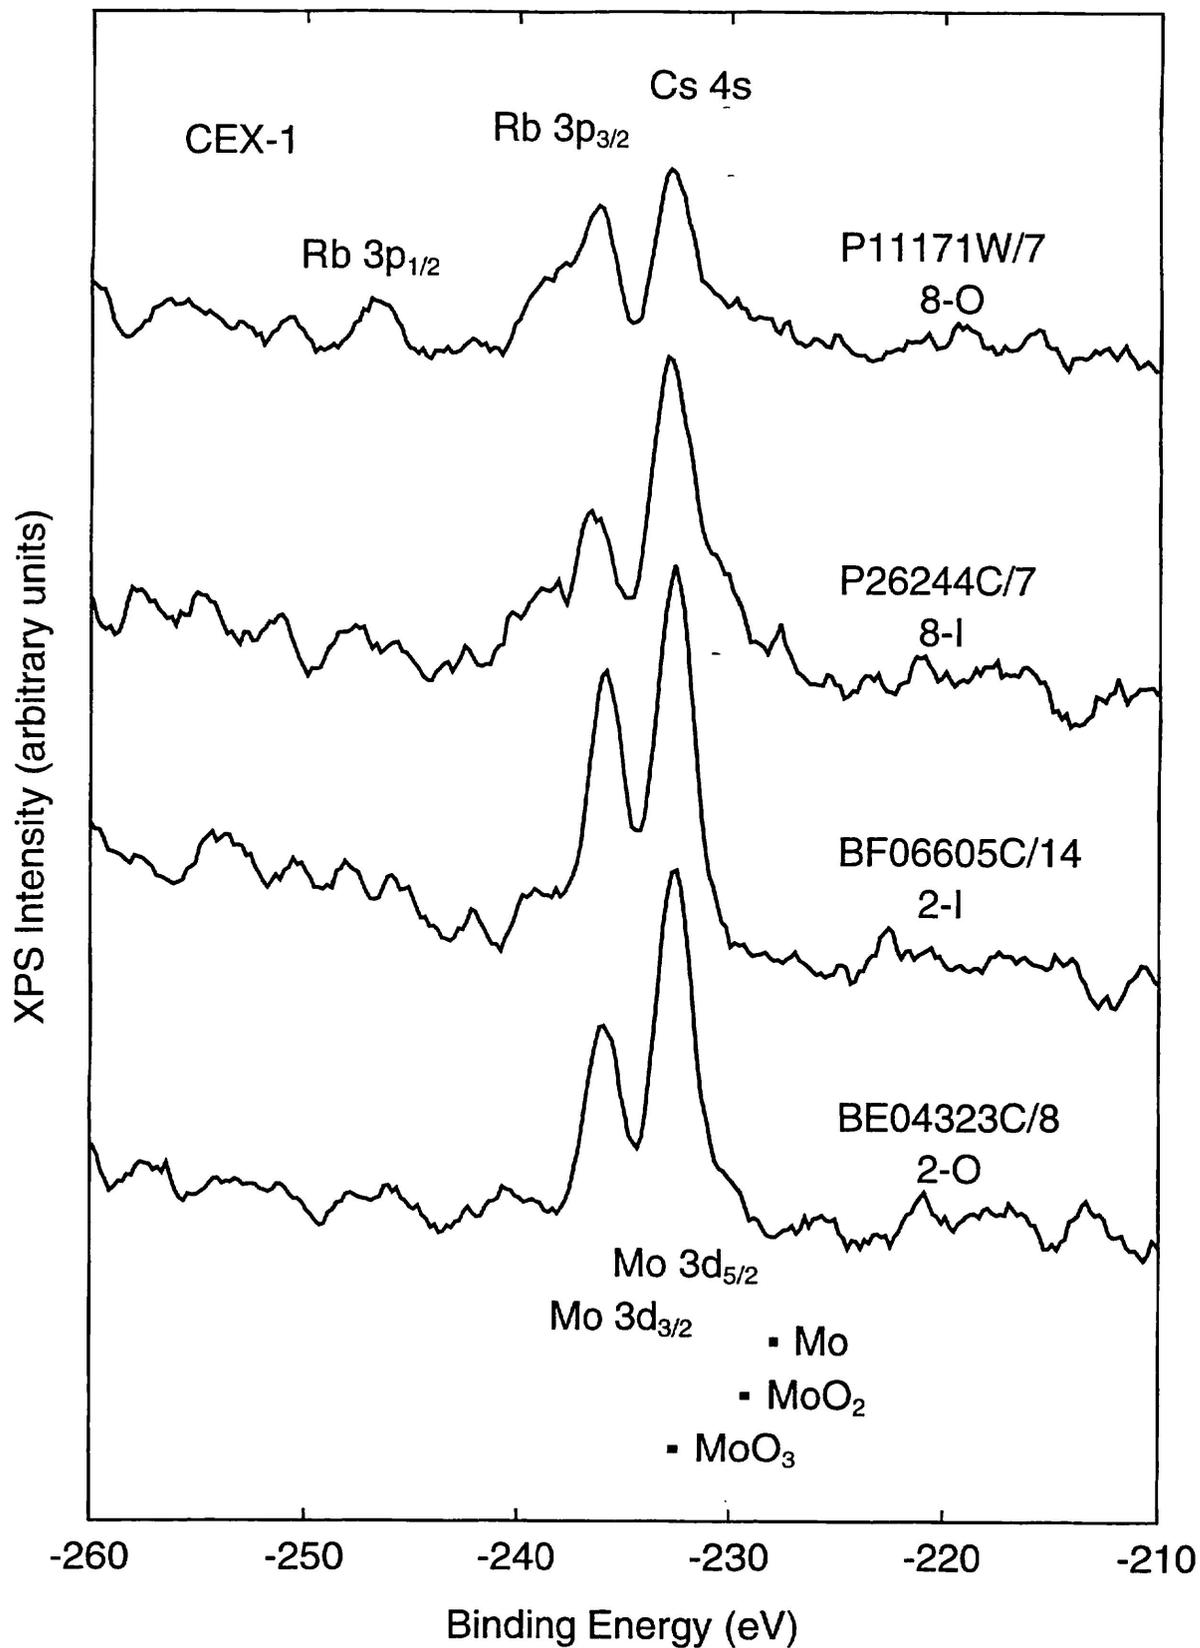
FIGURE 10. TYPICAL XPS SPECTRA ILLUSTRATING PECULIAR MOLYBDENUM SEGREGATION.

Representative XPS spectra covering the 210-260 eV binding-energy range, recorded from the four CEX-1 fuels, are compared in Figure 10. Rubidium and cesium both have secondary photoelectron peaks in this region, which provide much of the emission intensity seen for the fragments from the two high-power fuels. Conversely, the two low-power fuels consistently showed distinctive Mo 3d doublets, at binding energies that are characteristic of molybdenum in the +6 valence state, although  $\text{MoO}_3$  cannot be easily distinguished from a molybdate [15]. Further oxidation of molybdenum presumably occurred during the storage exposure, but whether it was initially in a tetravalent or metallic state remains uncertain. Oxidized molybdenum has commonly been found at similar levels on fragments of low/intermediate-power fuels from the CEX-2 experiment as well [9]. The higher power/burnup CANDU fuels that show the greatest segregation of other fission products have not yielded much evidence of molybdenum by XPS regardless of exposure [8,9]. Although there are several potential explanations for such odd behaviour in terms of molybdenum speciation [9], further XPS data on-intact fuels with a wider range of power histories will be needed for a proper assessment.
