# **PLUSS-A WELDLESS LEAKTIGHT SLEEVE FOR ALLOY 600/690 STEAM GENERATOR TUBES**

**Franz Pötz, Werner Bohmann**

ABB Reaktor GmbH, Germany

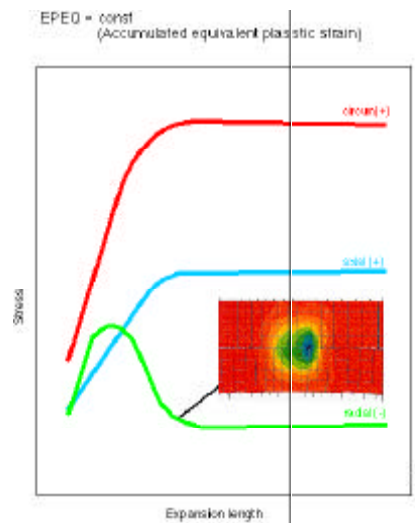
**Figure 3: Theoretical Investigation on Optimum Expansion Length**

Further potential of optimisation was in the area of the expansion length (see Figure 3). Elastoplastic finite element analysis proved evidence that a certain optimized expansion length leads to maximum radial stresses and decreasing axial and circumferential stresses. The radial stresses are directly responsible for the sealing function. The results achieved during the qualification testing confirmed this calculation.

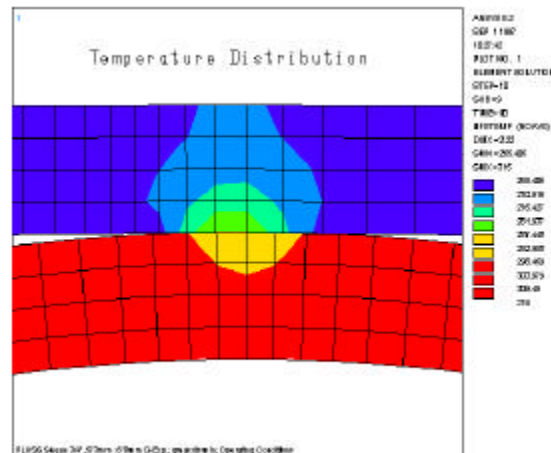
**Figure 5: Temperature Distribution on PLUSS Sleeved SG Tube**

Another advantage can be seen in the next Figures 4 and 5. The sleeving process leads to a material temperature decrease of approximately 30°C on the primary tube surface in the PLUSS sleeved range. This is very important with regard to the crack initiation and propagation, as shown in EPRI research papers, see Figure 6.

The mentioned temperature decrease of 30°C reduces the crack initiation and the crack propagation roughly by a factor of 10. In other words, a defective tube that will be PLUSS sleeved according to the valid criteria, will need for example 10 years before failing under operating conditions instead of 1 year in not sleeved condition.

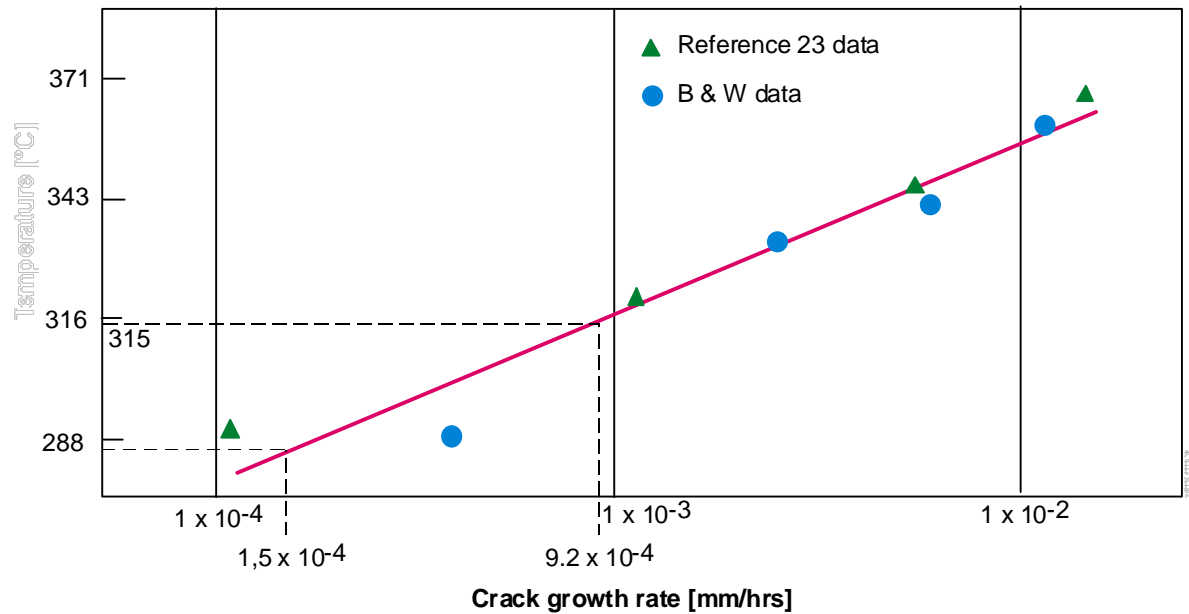
Figure 6: EPRI Corrosion Test Results

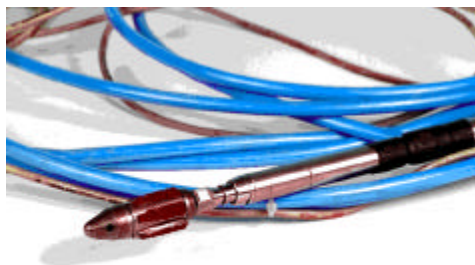
**Figure 7: Tube Cleaning and Air Flushing Tool**

- manipulation
- tool delivery
- tube cleaning and air flushing (Figure 7)
- volume controlled hydraulic expansion (Figure 8)
- torque controlled hard rolling
- non-destructive examination by ECT.

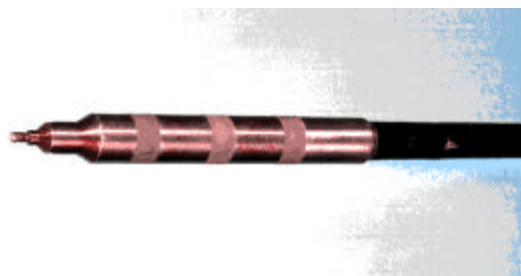
**Figure 8: Sleeve Expansion Tool**
