# **INTERNAL OXIDATION AS A MECHANISM FOR STEAM GENERATOR TUBE DEGRADATION**

T.S. Gendron<sup>1</sup>, P.M. Scott<sup>2</sup>, S.M. Bruemmer<sup>3</sup>, and L.E. Thomas<sup>4</sup>

## **ABSTRACT**

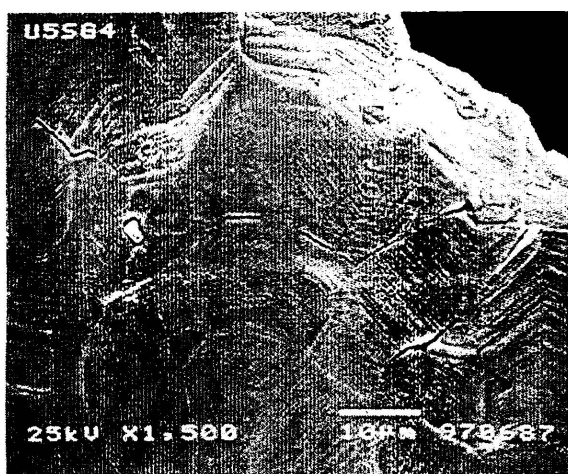
Figure 4a: SEM micrograph plan view of an alloy 600 foil showing grain boundary separation near the fracture surface.

At least seven laboratories have independently examined this mechanistic hypothesis. At two laboratories,<sup>7-13</sup> thin foils of alloy 600 were exposed to PWR primary water at 360°C or to hydrogenated steam at 380° or 400°C and subsequently fractured at room temperature. Precautions were taken to remove absorbed hydrogen to avoid any contribution from hydrogen embrittlement. Grain boundary embrittlement was observed to shallow depths of up to a few microns. Figures 4a and b show grain boundary embrittlement to a depth of ~1µm in stress-relieved alloy 600 steam generator tubing after an 8-hour exposure to 400°C steam/hydrogen<sup>13</sup>.

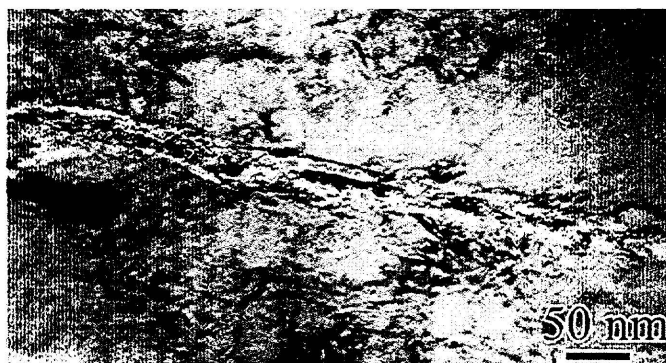
Figure 7: Brightfield Image of IG Penetration Region off the Primary SCC Crack as Illustrated in Figure 5.

In addition to evidence of local oxidation ahead of an IGSCC crack tip, many grain boundaries showed obvious IG oxide penetration as documented in Figure 7. These degraded boundaries were not associated with an active SCC crack, but originated from the primary SCC crack wall (see schematic in Figure 5). The width (10-30 nm) and depth (up to several  $\mu\text{m}$ ) of the oxidized regions were significantly greater for the IG penetrations than for IGSCC crack tips. Energy dispersive X-ray spectroscopy and electron energy loss spectroscopy (EELS) measurements showed that this IG penetration zone contained localized regions of Cr-rich oxides and porous Ni metal. EELS analysis of the penetrations showed no detectable boron or enrichment of carbon, indicating that these regions were isolated from the aqueous crack environment.
