DEVELOPMENT OF SPECIAL TOOLS FOR THE CLEANING OF REACTOR'S INTERIOR IN HANARO

HANARO Applications Reserach, Korea Atomic Energy Research Institute

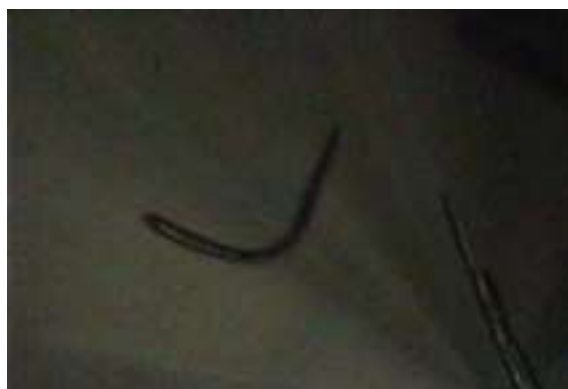
Split Pin: $\approx 6.3\text{mm}$, 75mm long, bent

Figure 7. Debris removed from Reactor using Revolving Dustpan

rubbing by another hard material. The finding was that the components of the connecting pin of the check valve assembly installed on the PCS line were worn by flow induced vibration, and the split pins were broken. Then, the link pin and its locking components escaped from the check valve and were finally gathered in the plenum by PCS flow. The lost items from the check valve were a link pin ($\phi 20\text{mm}$, 95 mm long, $\approx 28\text{mm}$ in head size), two plain washers (I.D. 21mm, O.D. 34mm, 3 mm thick), and split pins ($\approx 6.3\text{mm}$, 80mm long). It was judged that the debris in the plenum, like the plain washers, had caused the wear of the fuel central rod tips during reactor operation. Also, a few broken parts from fuel spacer plates were some of expected debris to be found inside plenum.

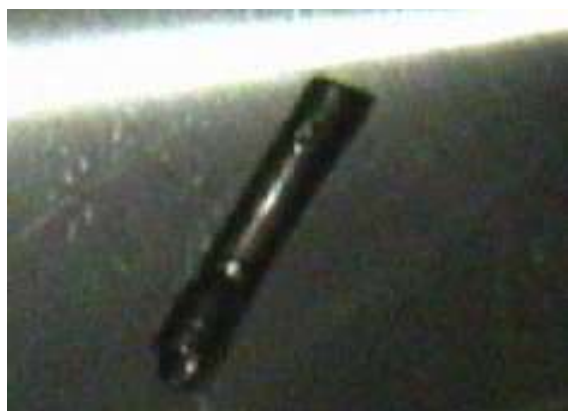
Split Pin: $\approx 6.3\text{mm}$, 35mm long, broken part

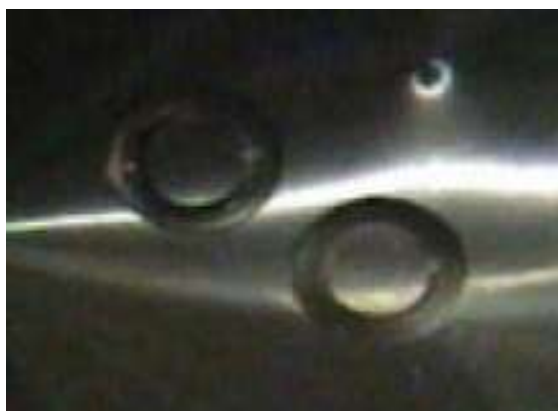
Plain Washer: ID 21mm, OD 34mm, 3mm thick
