# DEGRADATION OF CANDU FIRE PROTECTION SYSTEMS: PAST, PRESENT AND FUTURE

Peter Angell

Atomic Energy of Canada Ltd., Chalk River, Ontario, K0J 1P0

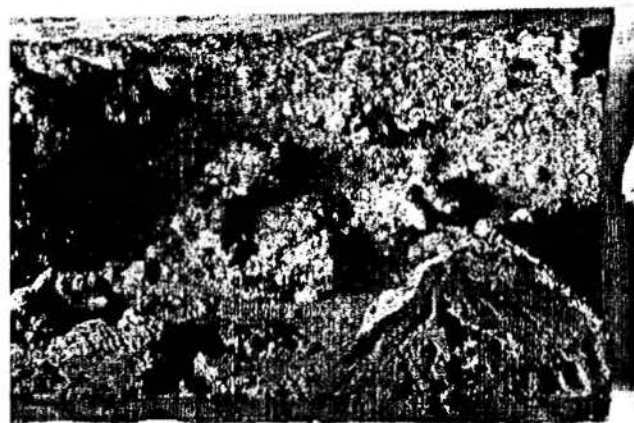
that are differentiated by their mode of formation, which leads to distinctive differences in their morphology. "Classical MIC type" tuberculation occurs when iron oxide is deposited by the microbial oxidation of soluble iron (II) within the bulk water to form insoluble iron deposits (III) on the surface of the pipe. As the new material is generated on the outside of the tubercle, this results in the centre being hard and the extremities being softer. Another characteristic feature, resulting from the mode of formation, is that MIC tubercles are often layered when viewed in cross-section (Figure 1).

Figure 1. Cross section through a MIC tubercle, from FPS piping, showing layered morphology

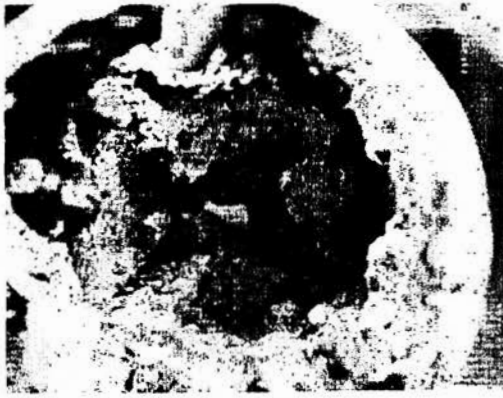
Figure 2. 3-inch riser from a FPS showing extensive build up of corrosion product (tuberculation)

In no circumstance should the piping be designed in such a manner that water constantly flows past a dead-leg (section of pipe in which water does not normally flow). Figure 2 shows the results of a plant where the ring main was exposed to constant flow. Extensive build up of corrosion products (tuberculation) was found to have occurred in the headers and risers that were essentially dead-legs connected to the ring main. In this case a 3-inch riser is almost totally blocked. It was determined that oxygen and nutrients were constantly diffusing from the colder ring main into the stagnant dead-leg. As this cold water reached the warmer riser, a small convection cycle was established that allowed mixing in the section of the riser below the header with optimal conditions for tubercle formation. It is felt that in this case the elimination of flow in the ring header should significantly reduce the level of corrosion and tuberculation seen in the headers and risers.
