USE OF SOFT-METAL ENGINEERED SURFACES TO MINIMIZE GALLING OF CARBON STEEL BOLTING MATERIALS IN GASKETED JOINTS AT ELEVATED TEMPERATURES.

NOVA Machine Products Inc – Curtiss-Wright Flow Control Corporation Nuclear
18001 Sheldon Road
Middleburg Heights, OH
44130

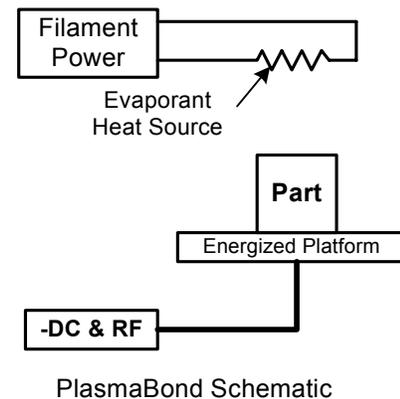
Figure 1

A negative electrical charge is used to create the plasma, and to attract the metal ions. The most intense zone of potential gradient extends for 2 or 3 cm from the item. This strong potential gradient results in a “dark space” where ion concentrations are low because they are rapidly drawn to the charged object. Evaporant ions are accelerated toward the substrate and impact with kinetic energy on the order of 100eV. The recombined neutrals and the vapor are believed to impact the surface with kinetic energy in the approximate range of 0.01 to 10 eV. On average, the

The metal vapor deposits predominately in a line-of-sight path from the evaporant source, but the metal ions that enter the dark space are able to coat the item 3-dimensionally. The ions are also able to penetrate into relatively narrow cavities in the substrate. This occurs as a result of (1) evaporant ions experiencing scattering collisions in the plasma and (2) the applied charge.

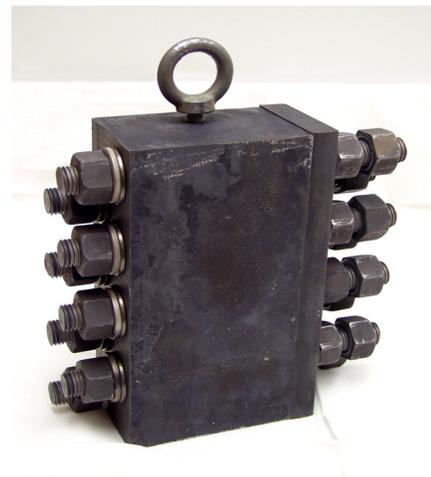
Figure 2

Heated Test Block

Test blocks that mimicked gasketed joints were designed and built, while test procedures that reflect field techniques for assembling gasketed joints by torquing were developed. Belleville washers were used to simulate the 0.5 to 0.8 mm (20 and 30 mils) “crush” in the sealing element in a gasketed joint. Compliance (deformation in response to an applied load) for the load cell used to measure fastener assembly performance was measured and also determined to be reasonably similar to a sealing element.

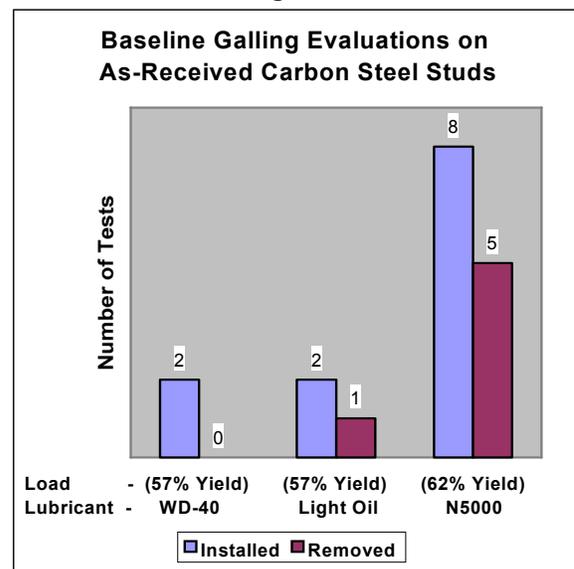
Figure 3 presents results from twelve (12) untreated carbon steel fasteners that were cleaned, degreased then assembled using various assembly lubricants. Loads were moderate (57 to 62% of the yield), temperature was 325°C (616°F) and exposure was 3-days.

Eight of these untreated studs were assembled using LotTite N5000. Loaded to 62% yield, and exposed to 325°C (616°F) for 3 days. LocTite N5000 is commonly used in the nuclear industry and is widely considered an effective lubricant. Three of the eight studs galled during disassembly even though the loads and temperatures seem quite typical. The 38% failure rate suggests that N5000 provides less than adequate galling protection during disassembly. These results confirmed that the equipment, assembly procedures, and operating conditions produce significant galling risk.

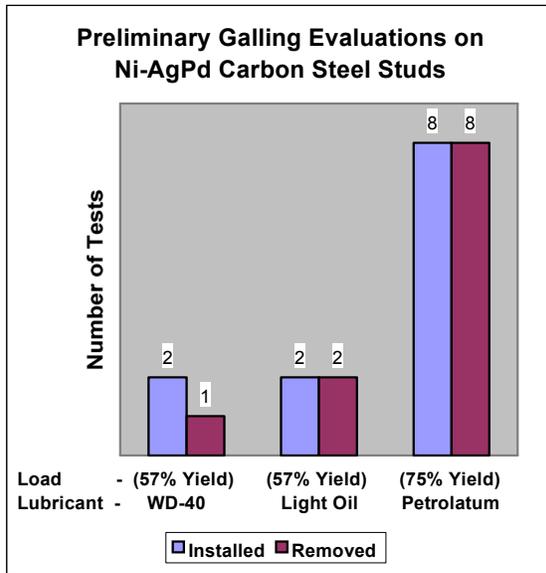
Figure 4 shows results of the preliminary tests on twelve (12) studs with Ni-AgPd PlasmaBond surfaces. Overall thickness of Ni-AgPd layer was about 500nm on the inclined thread surface. The tests showed that “light” assembly lubricants (WD-40 and mineral oil) were unsatisfactory because fastener preloads could not be maintained in the desired range. These “light” assembly lubricants were not included in the main test. Petrolatum’s performance as assembly lubricant was shown to be at least equal to that of N-5000 on fasteners with Ni-AgPd engineered surfaces. These studs were loaded to 75% of yield and this is considered to be a very high stress under TXU design philosophy. Petrolatum’s

The objective of the main test (Figure 3 and 4) was to determine practical operational limits for PlasmaBond-treated fasteners installed using torque. This test involved 32 fasteners and as before, they had Ni-AgPd PlasmaBond surfaces that were about 500nm thick on the inclined thread surface. The fasteners were exposed to 325°C (616°F) for times that ranged between 70 and 2040 hours. The test was stopped after the eighth cycle because 2 of the 30 (more than 5%) fasteners installed at the beginning of the cycle galled during disassembly.

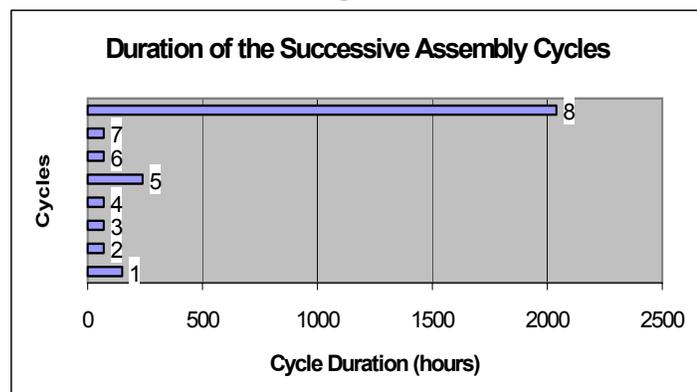
Figure 5 shows the duration of each of the eight assembly cycles. As before, the fasteners were exposed to 325°C (616°F) but loads were raised to about 75% of the material's specified yield strength. Exposure duration for the first seven cycles was relatively short ranging between 70 and 240 hours. To assess the galling risk of long-term exposure the duration for cycle eight was increased to 2040 hours. The total "accumulated" exposure time was nearly 2800 hours.

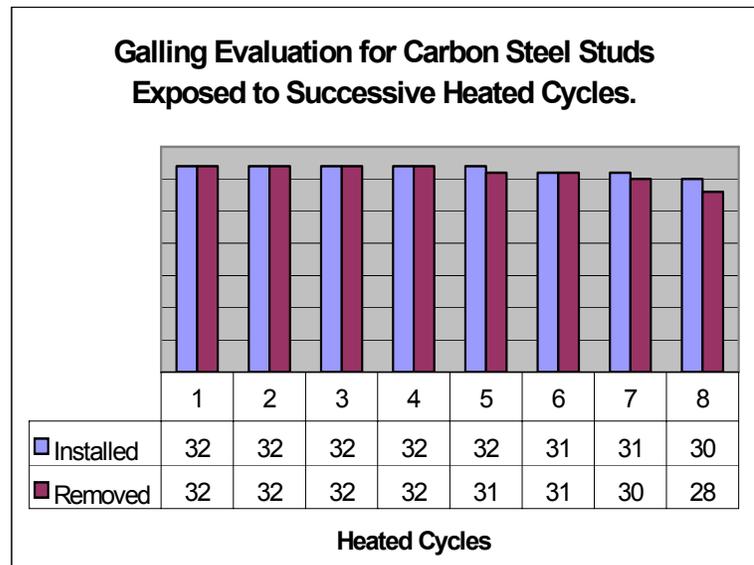
Figure 6 shows one (1) fastener galled during cycle 5, another during cycle 7 and two (2) fasteners during the eighth cycle. The two galling events in cycle 8 are believed to have occurred due to the combined effect of damage that had accumulated over eight assembly-operating-disassembly cycles and the relatively long (2040 hour) duration of cycle eight. After this series of tests the free span of the studs had stretched about 2 percent indicative of the high stress imposed on the fasteners.

As was expected, the galling risk appears to increase with successive assembly cycles. The time-dependent component of galling risk appears to accumulate more quickly at early in the cycle. This data (very approximately) suggests that about half of the time-dependent galling risk in a 100,000-hour operating cycle, might accumulate during the first 1000 hours.
