## SUMP STRAINER PERFORMANCE EXPERIMENTS FOR VVER-440

### Abstract

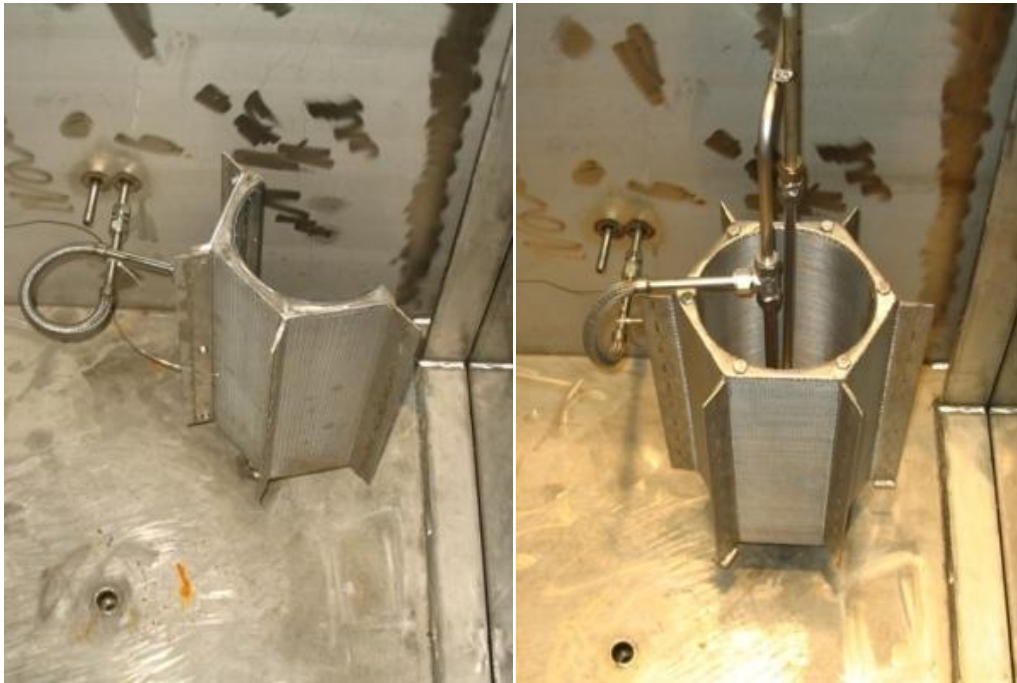
Figure 2 A scaled down (left) and a full scale sump strainer model (right).

In the first phase tests were carried out to find out the amount of mineral wool fibers passing through the sump strainer and a pressure loss caused by insulation material accumulating on the surface of the strainer both with the original and the enhanced strainer construction. The most of the experiments were carried out by using a scaled down sump strainer, which screen

area ( $0.08 \text{ m}^2$ ) corresponded one FA in the VVER-440 reactor, Figure 2. During the test series settling time and concentration of mineral wool and water flow rate through the strainer were varied. Meanwhile, boric acid ( $\text{H}_3\text{BO}_3$ ) concentration ( $13 \text{ g/kg}_{\text{water}}$ ) and water temperature ( $50 \text{ }^\circ\text{C}$ ) remained constant through the test series. After experiments with a scaled down sump strainer two “licensing” experiments were carried out by using a full-scale sump strainer (screen area  $0.44 \text{ m}^2$ ).

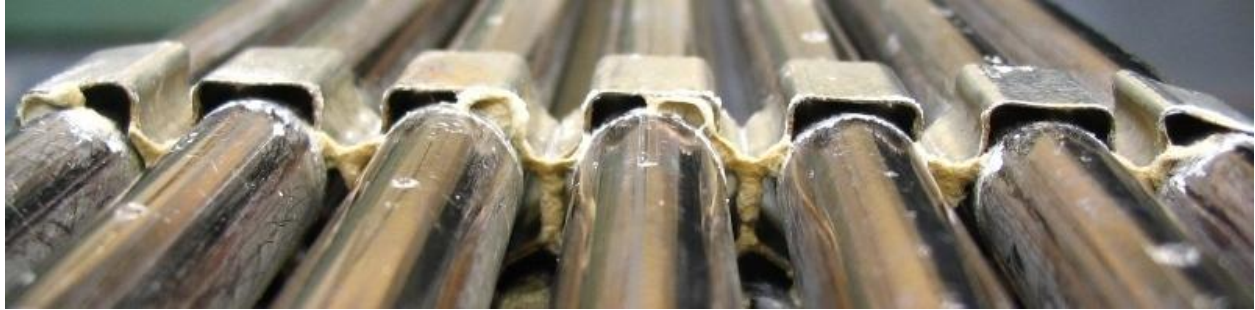
Figure 4 Mineral wool fibers attached at the spacer grid of the VVER-440 FA model in the experiment carried out with a full-scale sump strainer model.

Mineral wool fibers that penetrated through the filter surface were carried to the FA and the fibres attached to all spacer grids, Figure 4. With a full scale strainer (screen area corresponded conservatively 5.5 FA in the VVER-440 reactor) fibers caused less than 15 kPa pressure loss over the FA with the maximum flow rate of 5.5 kg/s through the FA, Figure 5.
