## **OPERATING AN ONSITE USED FUEL TRANSPORTATION PROGRAM**

**G. Pringle and S. Siu**

Ontario Power Generation, Nuclear Waste Management Division, Pickering Waste Management Facility, Pickering, Ontario, Canada

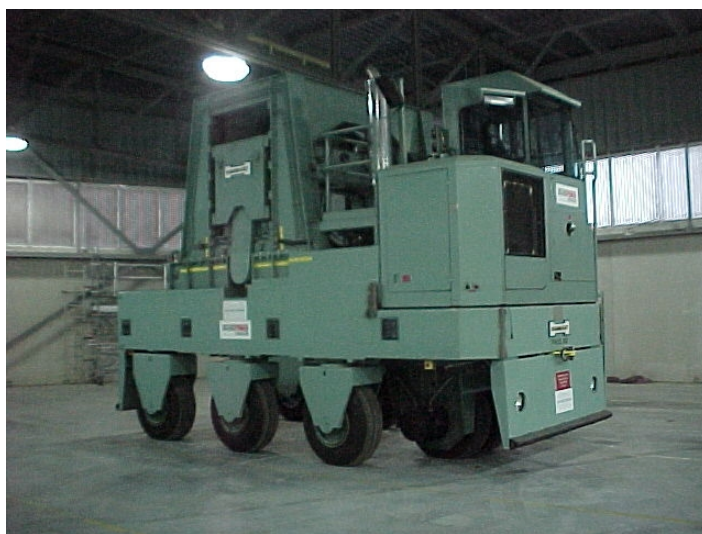
Figure 1 Hammant Transporter

The first lift-and-place DSC vehicle built for transporting DSCs at the prototype Used Fuel storage facility in OPG, the Pickering Waste Management Facility (PWMF), was named the Hammant (see Figure 1) after the manufacturer of the vehicle. Designed in 1990, commissioned and placed in service in 1995, it was a custom U frame design with 8 wheels and weighed approximately 40 tonnes (~22'L 11'W 16'H). Four of the six rear wheels were steerable and the driving and braking functions limited to the two front wheels. All 8 wheels were solid, foam filled tires to prevent deflation. The open end of the U frame received the DSC. The Hammant was powered by a 2

stroke, 300 HP diesel engine with maximum speed of 4 km/h. Steering was controlled by a hydraulic motor via a programmable logic controller. The hydraulic system consisted of two closed loops for the drive/brake systems and one open loop to control the lift and place system. A 49.8 Hz radio control unit provided remote operation capability. The lift and place system consisted of 2 lift trunnions, 2 lift arms, 2 lift cylinders and 2 locking cylinders. The safety system consisted of 5 perimeter emergency stops, button, front and back bumper limit switches.

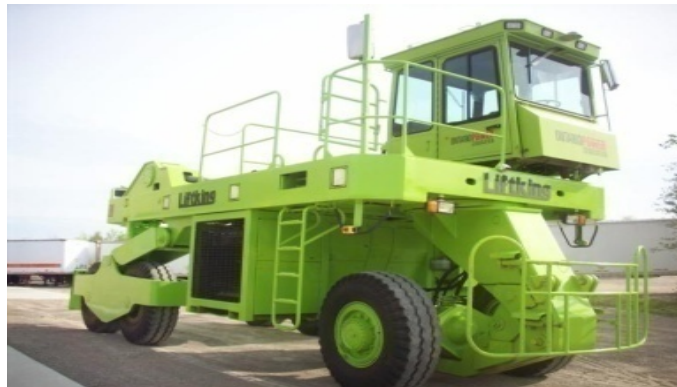
Figure 2 Liftking

The following improvements were included in the Liftking transporters (see Figure 2) in response to previous operational experience. A four stroke diesel engine was specified to reduce emissions; and the control system was upgraded from analog to a digital control system. Walking beams were incorporated in the rear frame to improve axle load distribution via wheel contact with the ground. New features in the Liftking included use of a vehicle lift system to lift and place DSCs. The raised cabin, and a rear-facing drive mode during lift and place operations, improved sightlines sufficiently that the remote control option was rarely used in operation. In addition, steering capability was concentrated in the front wheels only in order to reduce complexity and alignment problems while a seat occupancy switch was added as an additional safety feature.

The first two Liftking transporters experienced teething problems with the lifting cylinders, hydraulic motor, starting system, braking system and control systems. Subsequently, two additional Liftking transporters were built with some minor enhancements including a winter package with a heater for the coolant and battery and an improved lift joint utilizing spherical joints that were more forgiving and less failure prone than the original 'straight through' rigid design (see Figure 2).

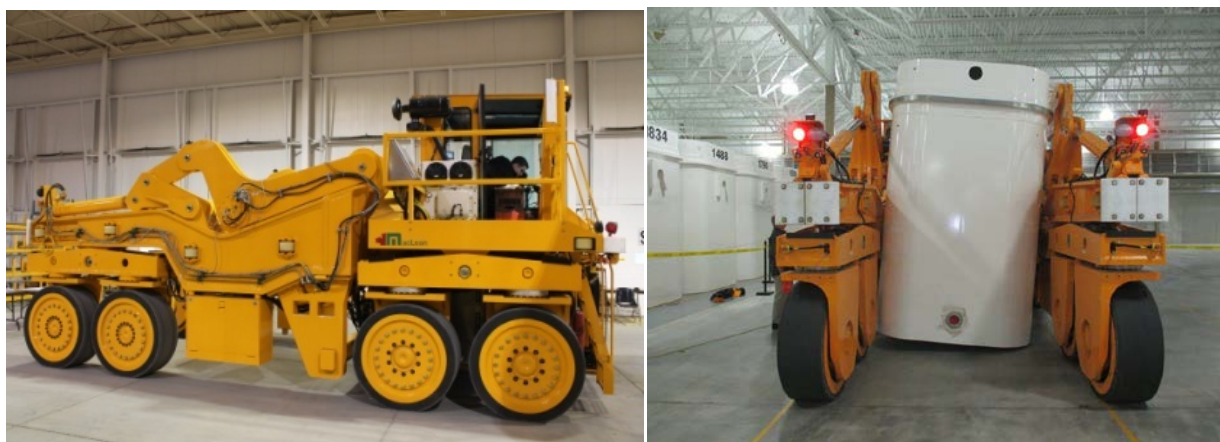
Figure 3 (a) Gen4 Transporter and (b) uneven lifting incident

In 2011 OPG commissioned a new design of DSC transporters to provide redundancy during and after the Liftking refurbishment. The design was completed in 2012 and the first transporter was fabricated in 2013. The new transporter was named “GEN4” signifying the fourth generation DSC transporter. A second GEN4 transporter was built in 2015. Changes made in the GEN4 included eliminating the front and rear lift joints by reintroducing a hydraulic arm lift system, using a CANBUS control system with open sourced components to avoid future obsolescence issues and employing 8 wheel vehicle with 2 front and 6 back wheels of which all but 2 rear wheels are capable of steering.

Also, during commissioning, the on-board DSC made contact with another DSC during placement operations. An error in the step logic of the remote control was missed during commissioning because a hand wave was used to simulate the interruption of the laser beam sensor and simulate proximity to the stationary DSC. The resulting ‘remaking’ of the beam prevented an expected delay and did not allow the operator to react.

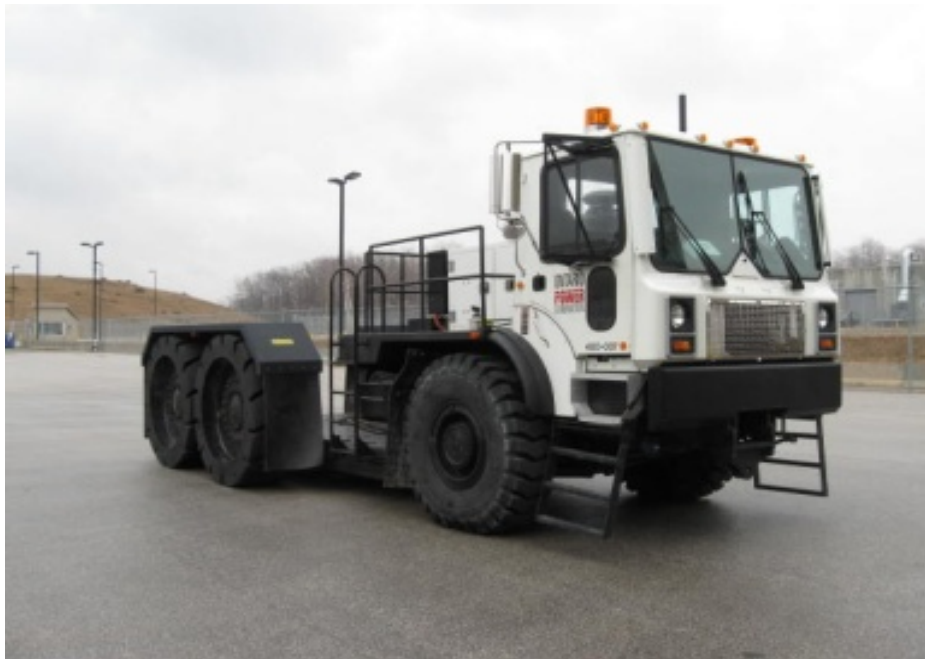
Figure 4 TOR transfer vehicle

A DSC transfer vehicle capable of 20 km per hour was deployed at the Western Waste Site in 2005 for transporting DSC’s longer distances (4 km) than at the other two sites. The TOR (see Figure 4) is a truck-based vehicle to reduce unique design features and is not capable of DSC lift and place operations. Instead it relies on cranes in the IFB and the processing facility to load the DSC onto a flat bed. Most failures with the other transporters relate to the complex lift and place system requirements. The simpler TOR consequently has fewer functional failures than the other transporters. A Liftking is used at this site for lift and place operations in the storage buildings. The TOR also utilizes solid rubber tires and has had a number of teething problems involving tires debonding- almost off of the wheels. Current running hours average approximately 13-15 per month, totalling approximately 1100 lifetime running hours.

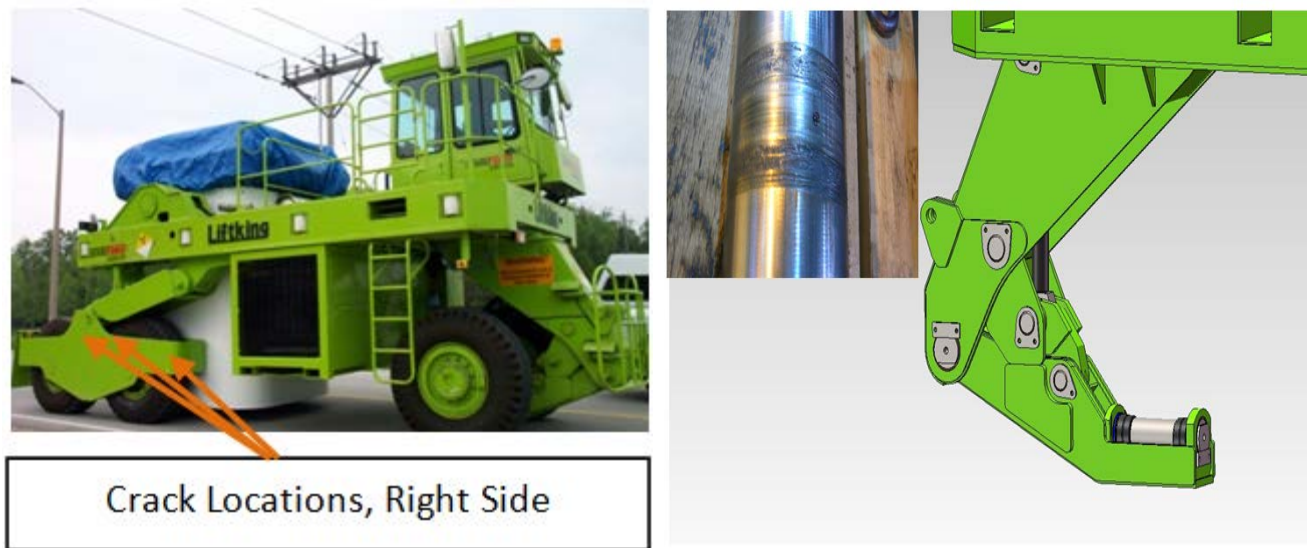
Figure 5 (a) walking beam cracked welds in cross members (b) damaged lift joint pin

Safety systems on the transporters such as the lifting system, onboard fire protection system, hydraulic systems require strict adherence to periodic maintenance. Components that require lubrications are maintained during planned preventive maintenance. These are all tracked using the preventative maintenance program and completed at Transport equipment facilities onsite. However major maintenance such as structural inspection (e.g. walking beam), major power train repair (e.g. cracked walking beam (see Figure 5) may require shipping the transporters off-site to the manufacturer or an alternate qualified shop to complete the work. Costs of annual maintenance for each transporter adds up to tens of thousands annually thus making periodic upgrades or new designs cost-effective when repetitive problems surface.

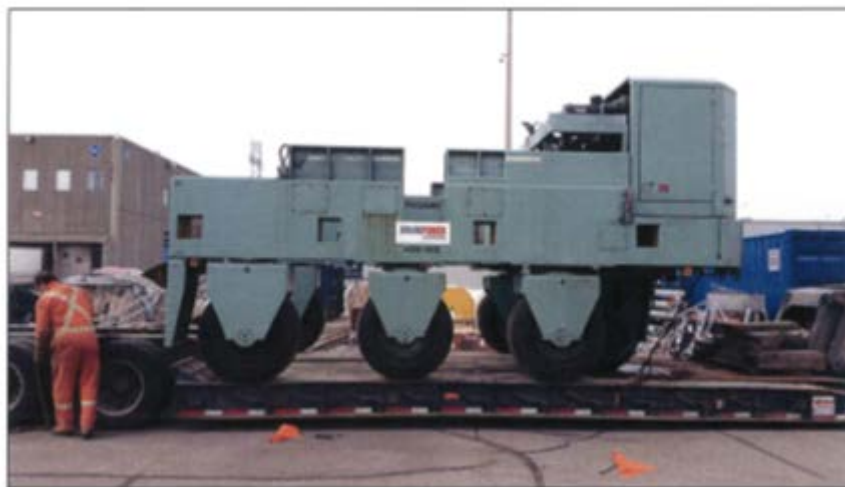
Figure 7 Body of Hammant with cab and lift structure removed ready for transport

The Hammant transporter was limited to use within the storage buildings and had numerous problems identified above and was decommissioned in 2015. All of the fluids were tested for contamination and removed for liquid disposal (no contamination found). The transporter cab and lift mechanism was removed since it was too tall for transport on a flatbed transport. It was decided that a conditional transfer permit to another licensed facility for final disassembly and decontamination would be less effort and cost than a full tear down and an unconditional transfer to an unlicensed facility. Prior to cab removal, control systems were emptied of fluids, the cab was removed by boom crane and the transporter driven onto the flatbed. After receipt at the disposal facility (Kinectrics) the machine was disassembled, decontaminated and the bulk of the materials free-released for recycling. Both a boom crane and the Hammant were successfully disposed of in this fashion and the only contamination found was on the basket of the boom crane. Total cost was less than \$200,000 of which one third arose from partial disassembly at site.

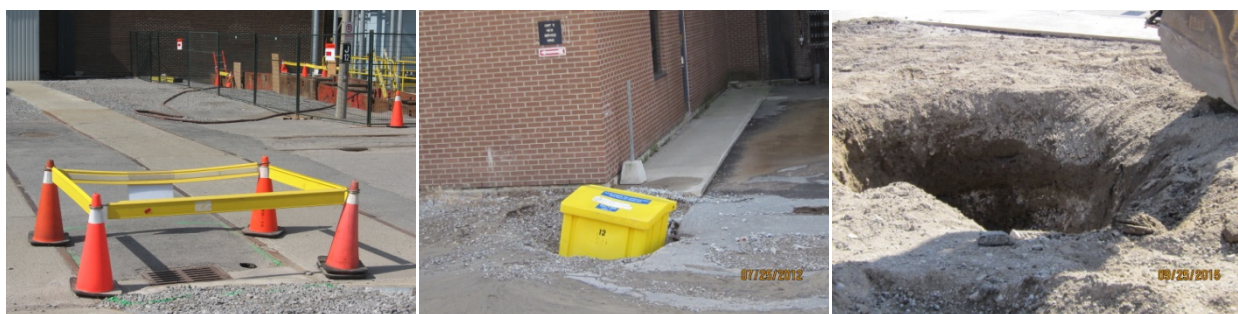
Figure 8 (a) catch basin sinkholes (b) buried service failure (c) yard drainage sinkhole uncovered

In 2015 a rusting and deteriorating yard drainage line, and lake level surges in the forebay tempering water tunnel into which it drained, result in a significant sinkhole (3m deep and 2.5 metres across) that was only evident because of a 20 cm hole in the covering asphalt. This sinkhole was not observed by the 2014 study of nearby roadway. It occurred directly in front of the approved entry to the processing and storage facility, enroute to the Pickering B fuel bay and halted production for 2 months. Subsequent review of the safety analysis confirmed that current design basis bounded the case of a transporter dropping with the pavement into a sinkhole of this size.

A review of ground inspection techniques has been concluded by the Engineering group and a more sensitive GPR array is being purchased to complete continuous scans of the route triannually. This technology will decrease the risk of slow-growing sinkholes. Fast-growing sinkholes from pipe rupture occur very rapidly and the probability of affecting a transfer has been estimated to be very low. Towing procedures are available and have been proven for vehicle recovery; however procedures will be updated for specific circumstances as needed. The road closures have also highlighted the need to get approval for an alternate transport route and entry point for the processing facility. Hazard and roadbed analysis for an alternate entry point to the processing facility, has been completed, approval obtained and is currently in service. It was successfully used
