## CANADIAN NUCLEAR SAFETY COMMISSION'S REGULATORY OVERSIGHT OF THE LORADO SITE CLEANUP PROJECT

This paper provides an overview of the Canadian Nuclear Safety Commission's (CNSC) regulatory oversight of the Lorado uranium mill site remediation project. Lorado is a historic site resulting from the former operation of a uranium mine in Northern Saskatchewan during the late 1950s. The most significant waste feature at Lorado was an unconfined tailings area which extended into a lake. Lorado is being remediated under the Government of Saskatchewan's commitment to the cleanup of abandoned uranium mine sites in northern Saskatchewan. This project is regulated under a 10-year CNSC licence issued to the Saskatchewan Research Council and entails the remediation of tailings that cover a land surface area of 14 hectares and treatment of lake water to improve water quality around the site. CNSC compliance verification activities include technical evaluations and inspections to ensure the project meets regulatory requirements and is in conformity with general safety objectives. Key aspects regarding CNSC's regulatory oversight of Lorado are highlighted including the remedial process, engineere

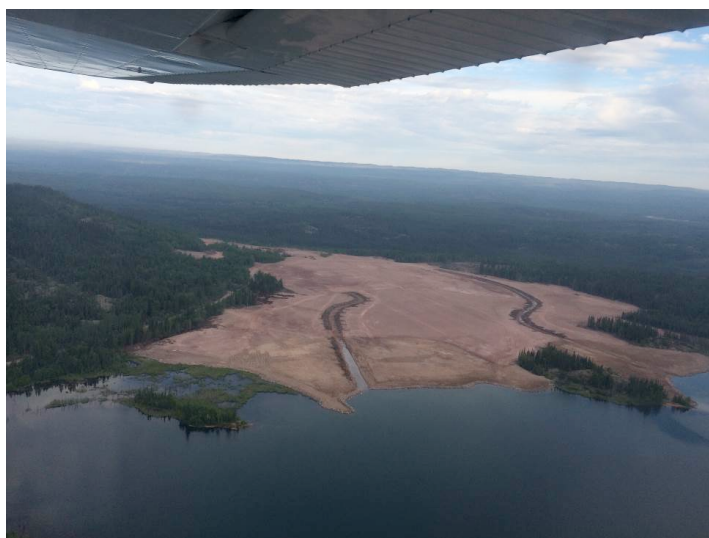
At the end of operations at Lorado, uranium mine tailings covered an area of about 14 hectares, including tailings submerged in the adjacent Nero Lake (Photo 1). Over time, the state of the abandoned mill worsened due to natural deterioration and vandalism. Furthermore, acid generation from the pyritic mine tailings decreased the pH in Nero Lake to 3.5 and concentrations of metals and radionuclides were elevated. The mill structure was dismantled in 1990 and efforts were focused on characterizing the tailings, improving knowledge of contaminant transport and environmental impacts and developing general remediation strategies. The need for a barrier between the tailings and the environment became apparent, in order to limit windblown dust, contaminant transport of metals and radionuclides into the environment and radiation exposure. Local communities helped to raise awareness, including residents of nearby Uranium City.

Figure 1 Aerial view of Lorado mill tailings site in 2015 (Photo courtesy of SRC)

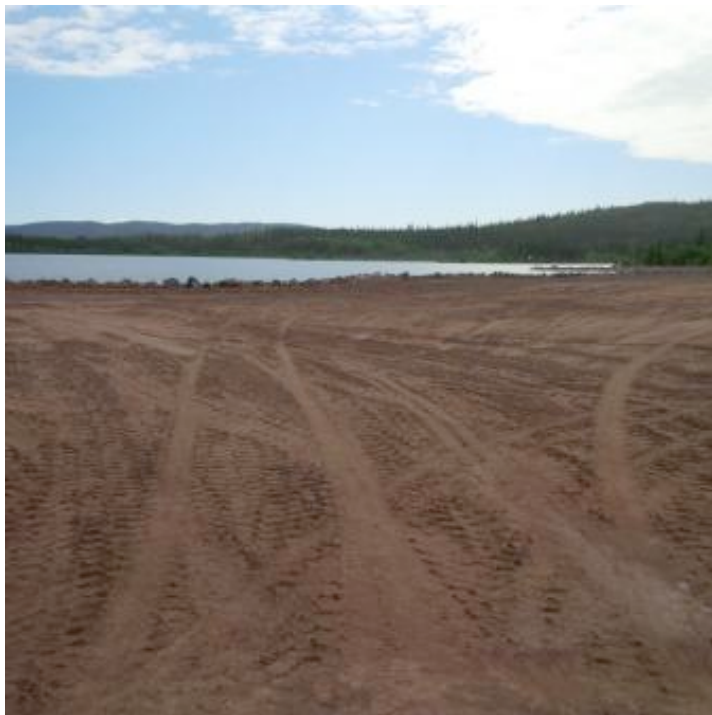
In 2015, part of the CNSC staff inspection focused on verifying the performance of the cover (Photo 2). Performance criteria were divided into three categories: technical performance criteria, containment performance criteria and environmental performance criteria (Reference 2). An example for each type of criteria at Lorado is provided below:

- Technical performance criteria specify that the cover should meet certain technical requirements including material properties such as density, thickness, and placement. The licensee had logged all data into a GPS computer software program that documents, compiles and displays all measurements along with a timeline of completion. CNSC staff were able to verify that the cover was being constructed according to specification for the

selected areas; this will support the eventual review of as-built records to verify technical specifications were met for the facility.

- Containment performance criteria specify that the cover should achieve a certain level of containment or control. The cover was designed to limit radiation to no higher than 2.5 micro Sievert per hour above background (spot reading) and no higher than 1.0 micro Sievert per hour above background as an average over 1 hectare. CNSC staff performed spot checks on the cover by measuring gamma radiation and found levels to be below the criteria in most cases levels were at or near background.

Photo 2: Cover on mine tailings at Lorado before final grading and seeding in 2015

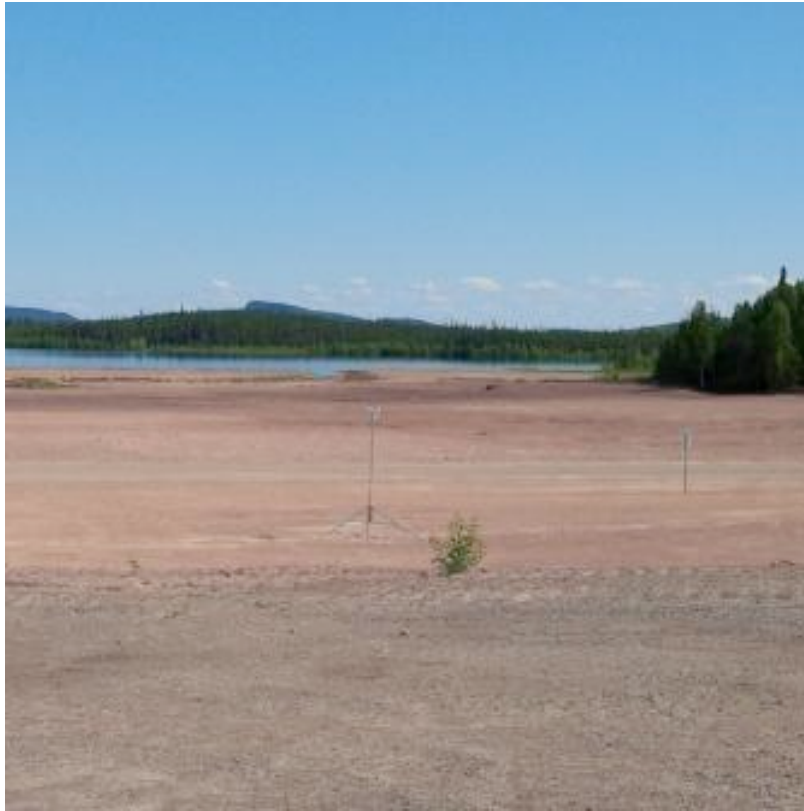
Photo 3: Dust monitoring station at Lorado (2016)
