## **REMEDIATION OF A FORMER LOW-LEVEL LANDFILL (WASTE MANAGEMENT AREA C) AT CHALK RIVER LABORATORIES**

<sup>1</sup> Canadian Nuclear Laboratories, Chalk River, Ontario, Canada

<sup>2</sup> Golder Associates Ltd, Mississauga, Ontario, Canada

### **Abstract**

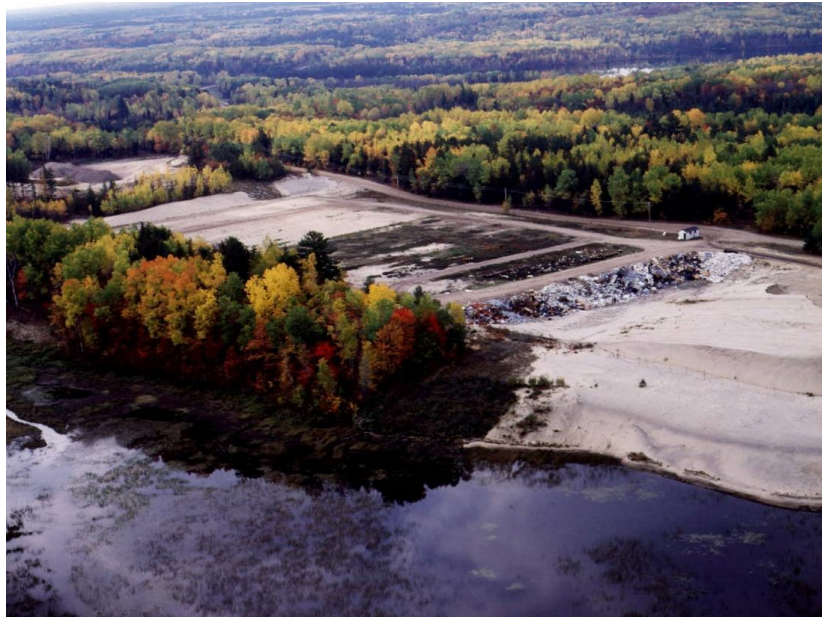
Figure 1 Aerial view of WMA C during operation in 1982

Waste Management Area C (WMA C) is a 4-hectare near-surface landfill-type facility at Chalk River Laboratories (CRL) that operated between 1963 and 2006. WMA C received a large variety of low-level radioactive wastes (generally with hazardous lifetimes <150 years in terms of half-life and activity) from CRL operations and from medical, biological and other nuclear research activities in Canada. WMA C also received non-radioactive wastes in the form of asbestos, sewage, biological waste (e.g., animal carcasses), organic compounds (e.g., chlorinated solvents) and heavy metals. The facility consists of 28 unlined sand trenches, 2 large unlined sand pits, 12 special burials and 5 chemical pits. Figure 1 shows WMA C during the filling in 1982 of the north sand pit.

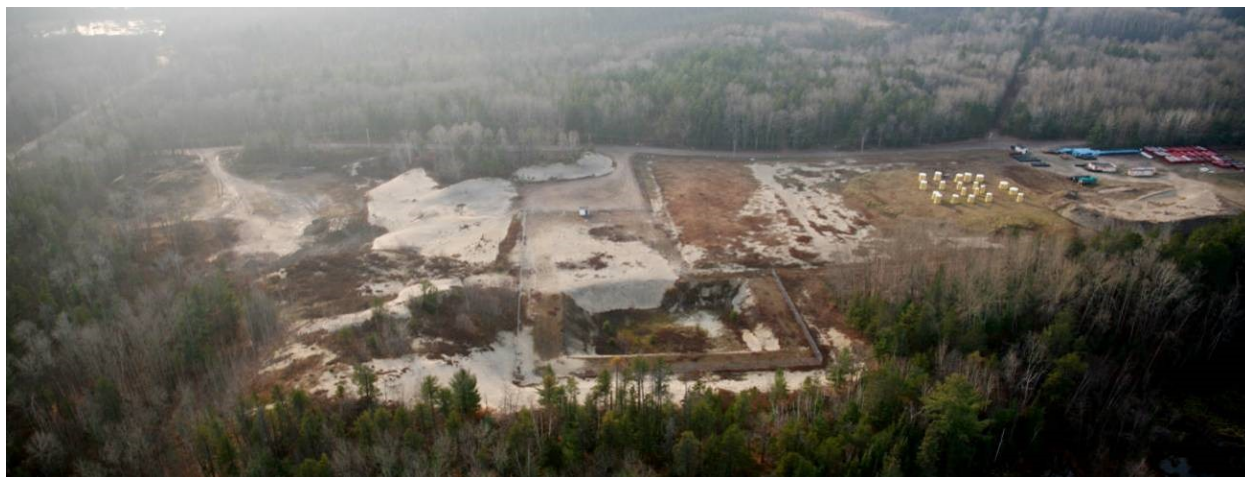
After the facility at WMA C ceased operations, temporary storage of contaminated items on the surface at WMA C (right side of Figure 5) was permitted under the facility authorization.

The first preparation for the engineered cover was the removal of surface-stored items, starting in 2009 with drums and containers (upper right in Figure 5). More than 2,000 drums needed to be dispositioned. Most drums were transferred to other CRL waste management areas for storage, with the contents of some drums repacked into compaction bins prior to transfer. An external contractor was engaged for offsite disposition of 241 empty contaminated drums and 4 contaminated sealand containers.

Figure 5 Aerial view of WMA C in 2007, after closure

Finally, 21 cut sections of the ventilation stack from the former NRX reactor (center right in Figure 5) were relocated to another waste management area. Loose contamination found falling

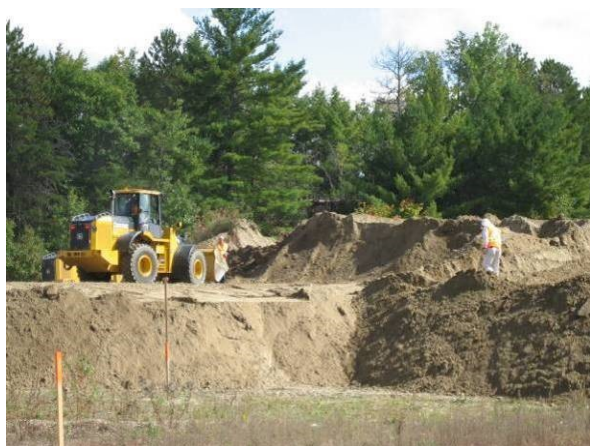
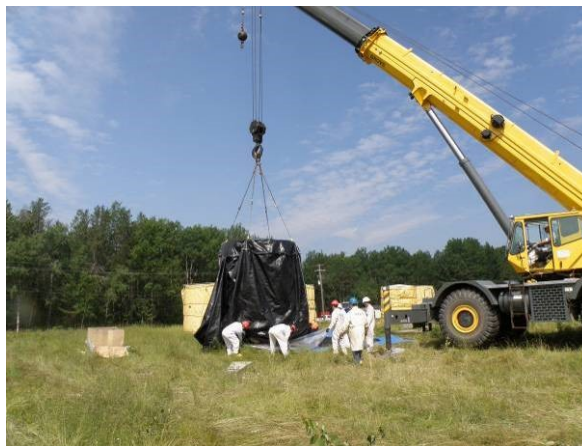
WMA C had also served to store bulk soil excavated from the Controlled Area at CRL that was either suspect or had very low levels of contamination. With approval from the Canadian Nuclear Safety Commission (CNSC), this soil could be added to WMA C as fill for cover construction. The soil pile was carefully spread in 2012 following the rough fill contours called for in the design (Figure 6).

Figure 6 Preparations: spreading of suspect soil (left), relocation of NRX stack pieces (right)

from the stack pieces during initial attempts led to the packaging of each piece in a large custom-made overpack sack. The stack pieces were repackaged and relocated (Figure 6) shortly after the contractor arrived in 2013 June to start regrading the surface for the cover.

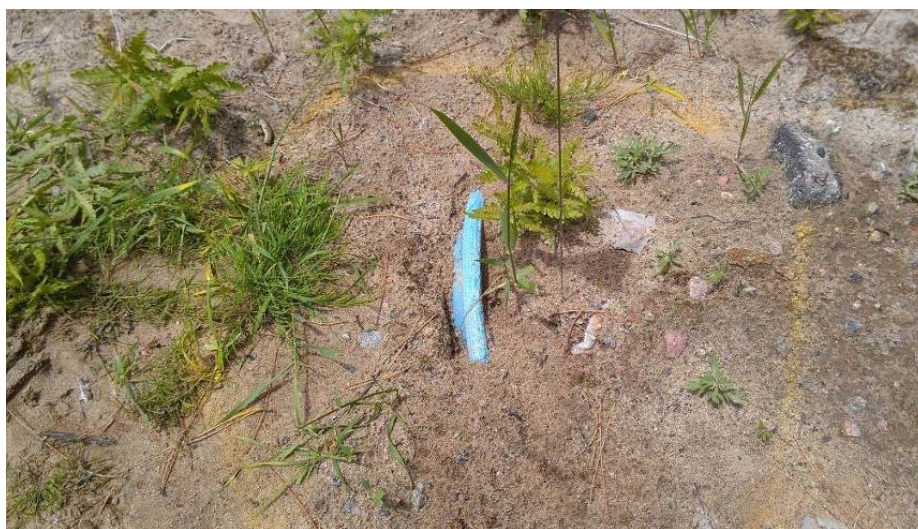
A more disruptive surprise was the discovery that the original cover soil over the buried wastes was much less than the assumed 1 m, likely due to erosion. Within one week of starting work, a bulldozer operator regrading the surface cut into a waste package; a strong chlorine smell led to evacuation of workers from the field, and a 1-day stand-down was enforced to understand the problem. Around the same time, waste items were discovered at surface at several other locations (Figure 9).

Figure 9 Plastic waste drum near surface

It became clear that excavation of drainage ditches would breach the waste almost everywhere. A requirement for the remediation from a health and safety perspective was that no waste would be breached or removed. A major re-design of the contours was therefore needed, and quickly because the contractor had already mobilized. Golder Associates revised the design to include shallow drainage swales instead of ditches, as well as increases in elevation everywhere, to minimize cutting for the rough contours and to accommodate the slopes required for adequate water run-off.

With acceptance of this change by stakeholders and another change order to the contractor, Sullivan proceeded to import yet more soil (~11,000 m<sup>3</sup>). Ultimately, hard work by the contractor meant that the cover installation was finished – despite the delays – in time for seeding and grass growth before frost. A vital lesson in this was that the assumption of “1 m soil everywhere” should have been verified well in advance of the design, and manually if necessary (as geophysical surveys did not have a high enough resolution to determine cover soil thickness).

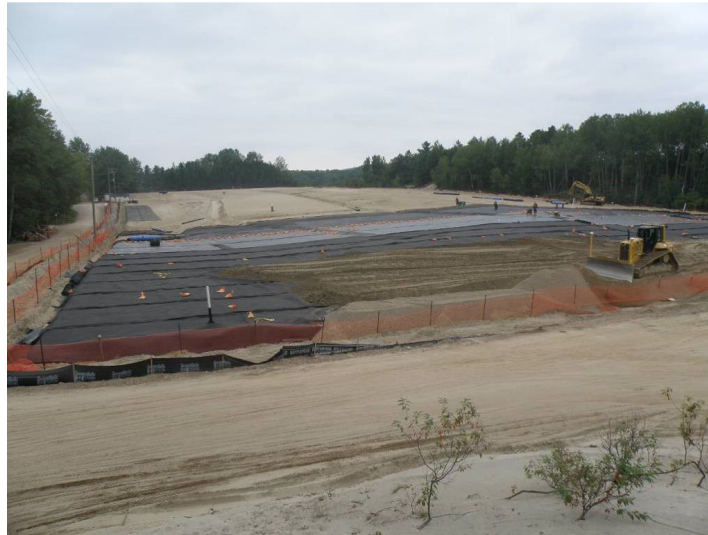
Figure 10 shows the various layers of the cover during installation in 2013, and Figure 11 shows the site one year later.

Figure 10 WMA C during cover installation (2013 August)

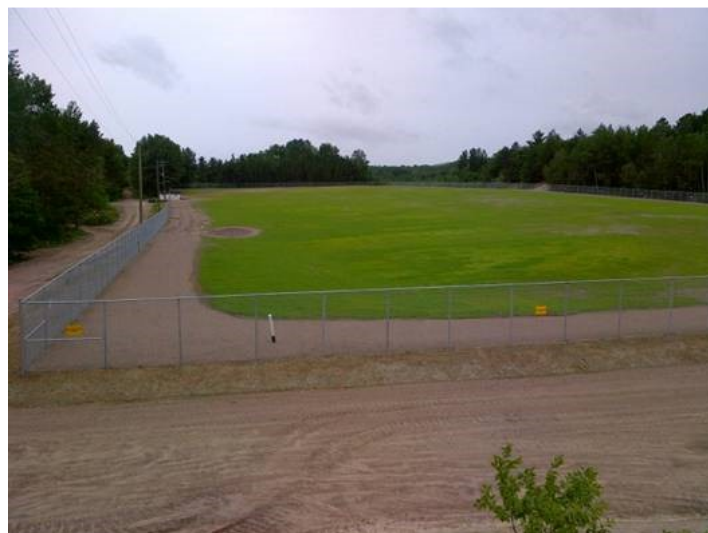
Figure 11 WMA C one year later (2014 July)

Another issue in the first spring following installation was that grass was sparse and slow in growing. The culprit was not poor seeding or winter kill, but local wildlife such as Canada geese that could fly over or crawl under the perimeter fence. The problem resolved itself with the unpalatable white clover (originally only 10% of the seed mixture) taking over the area as shown in Figure 11.

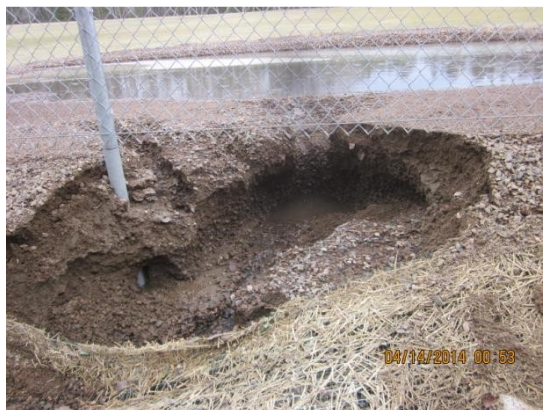
The area has taken several years to stabilize. The first issue presented itself in 2014 April, six months after cover installation. Heavy rains fell before ice in the ground and culverts had thawed, which led to flooding of the drain pits and erosion of areas with gravel and riprap (Figure 12). These areas were repaired in the summer, but with erosion continuing the following year, Golder Associates were engaged to inspect the cover and recommend more substantial repairs. The use of larger riprap and good compaction of repaired road appear to have addressed

Figure 12 Erosion during wet spring 6 months after installation

the erosion issues. The use of heating cables in the culverts to prevent blockage by ice was recommended but has not yet been implemented.

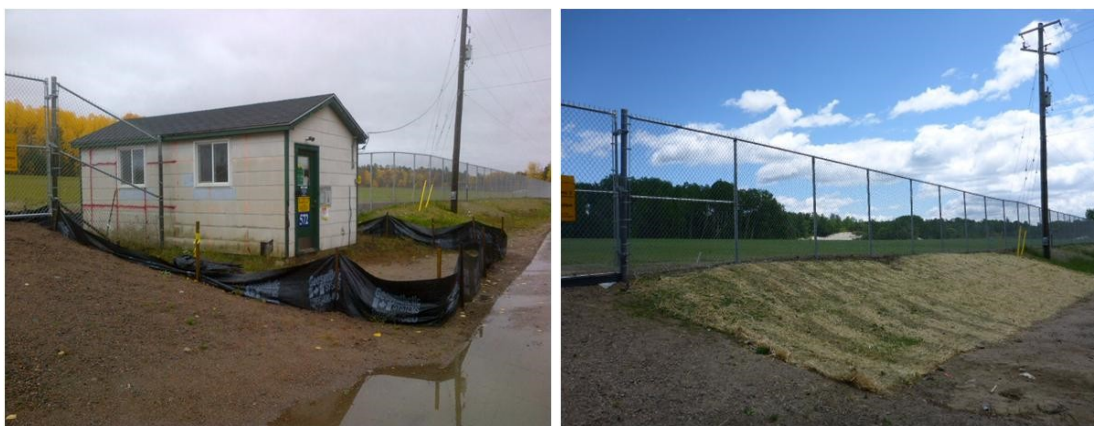
Figure 13 Gate house before and after removal

A final step in the remediation was the removal of the old gate house (Figure 13) in 2015. This shack had been used as a radiological dressing station by workers entering WMA C, but was no longer needed with the cover acting as radiological shield. The planning took more than a year due to the decommissioning process being rigorous even for low-hazard structures. Also, the gate house was methodically dismantled rather than demolished, to avoid the spread of any contamination (which turned out to be minor).
