## THE REMEDIATION OF RADIOACTIVE CONTAMINATION AT THE LONDON 2012 OLYMPIC PARK

### Abstract

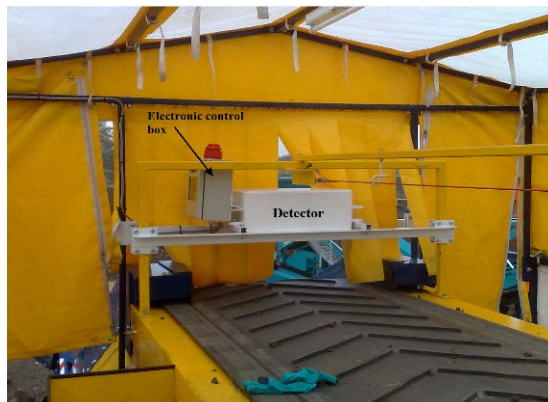
Figure 2 Monitoring Area of the Sorter Conveyor

Further detections required a more comprehensive approach to the conveyor sorter. It was redesigned with an alarmed CsI detection system, which was capable of detecting any artefacts or volumes of contaminated soil at levels above 2 times background. The system is shown below.

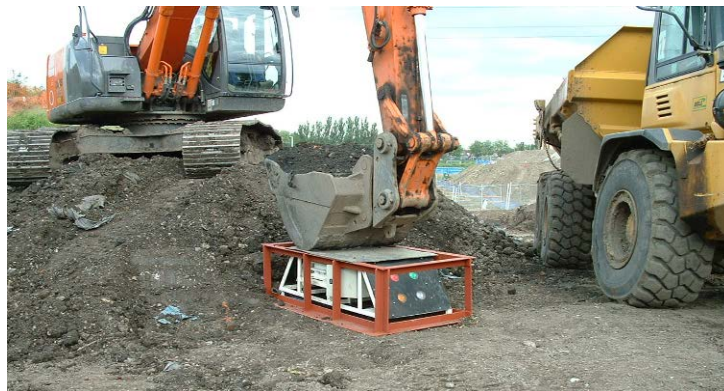
Figure 6 The Gamma Excavation Monitor System

The Gamma Excavation Monitor (GEM) system used a 3" NaI scintillation detector built into a rugged holder and frame. It was fitted with a large display panel on one end with a set of 4 lights. These were clearly visible to either the excavator driver or banksman. One light indicated that the unit was counting the bucket contents. A green light on count completion indicated that the material was "clean". An amber light indicated that the contents were Very Low Level Waste (VLLW). A red light indicated Low-Level Waste (LLW).

The system was calibrated using the Monte Carlo radiation transport code, MCNP, with standard sizes of buckets and loading levels. It was checked against the high resolution gamma spectrometric results for a bag standard. All results were logged to provide a QA record. This system was able to process up to 400 buckets per day, with a typical excavation bucket holding ~1.0-1.1 Te of spoil. It enabled the stockpiled waste to be quickly assayed and sentenced into the appropriate waste categories. The cleared spoil was loaded immediately into trucks for recycling on site, whilst the VLLW and LLW were held in distinct stockpiles for later disposal.

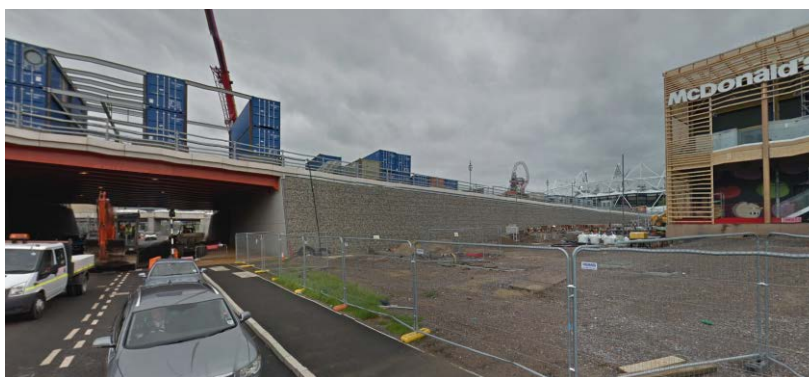
Figure 9 The completed Bridge Abutment with Disposal Cell
