## AGING MANAGEMENT APPLIED TO STORAGE OF BULK ION EXCHANGE RESIN IN EPOXY COATED CARBON STEEL CONTAINERS

<sup>1</sup>*Ontario Power Generation, 700 University Avenue, Toronto, Ontario, Canada;  
gloria.kwong@opg.com*

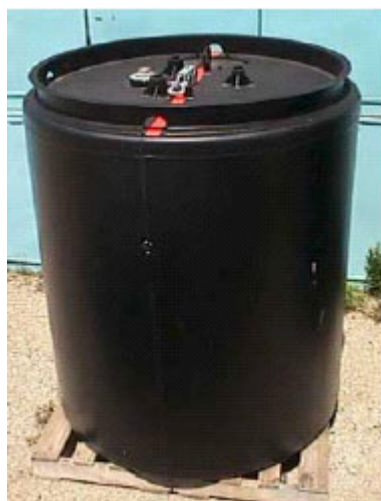
Resin liners used for in-ground storage of the spent resins are of a capacity of  $3\text{m}^3$ , with an overall height of 71" and 64" in diameter. The liners placed in service in the 1980s are made of ASTM A36 or A285 Grade C carbon steel with a 6.35mm thick side wall and 7.94mm thick top and bottom end shells during fabrication. The container surfaces were cleaned using abrasive blasting and 2 coats of epoxy were applied to give a dry film thickness of  $375\text{ }\mu\text{m}$  for the interior surface and  $250\text{ }\mu\text{m}$  for the exterior surface of the liners. An internal filter manifold was provided for resin dewatering and free water content as low as 20% (volume) was achieved via the hydrosphere filter. A typical resin liner is shown in Figure 2.

Figure 2:  $3\text{m}^3$  Resin liner

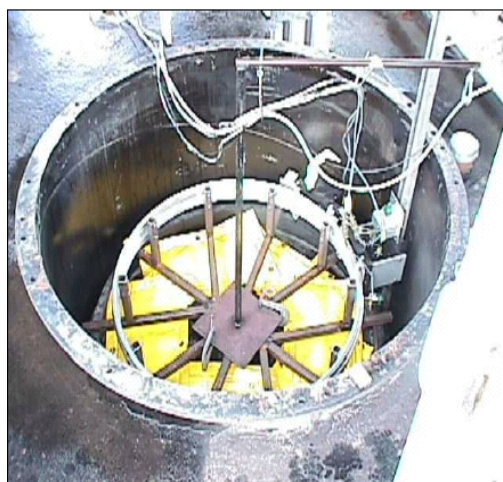
The 2002 inspection campaign used an ultrasonic scanner system consisted of an automated scanning rig, a wet (water cushion) ultrasonic transducer and the Winspect™ data analysis software [2]. The scanner system was designed with the following requirements:

- Performs C-Scan (thickness monitoring) of the resin liner surface via a remote operated control;
- Detects a minimum 10% wall loss and corrosion pits of diameter > 4 mm
- Scans in annular space of 38 mm
- System can be set up in < 15 minutes to limit worker exposure to radiation from the resin liners.

Figure 3 shows the ultrasonic wall thickness mapping system used in the inspection campaign.

Figure 3: *Ultrasonic Wall Thickness Mapping System.*
