## **NRU Main Cooling Circuit Heat Exchangers – Life After 50 Years Of Operation**

**L. McCrea, R. Gold, R.F. Dam, J.H. Nickerson**

Atomic Energy of Canada Limited, Mississauga, Ontario, Canada

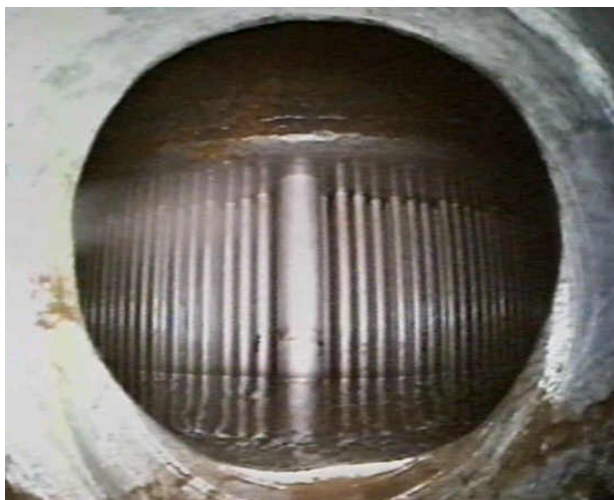
One of the highlights of the inspections conducted is a video inspection of the secondary side internals of Heat Exchanger (HX) #7, conducted in November 2004. A video camera was inserted into the shell drain at the bottom of the heat exchanger and manoeuvred around the heat exchanger from the shell drain to the cooling water inlet (just above the bottom tubesheet). Inspection showed the secondary side of the heat exchanger to be quite clean. This is an exception to industry experience, which identifies fouling as the predominant aging mechanism (44.1%) causing heat exchanger failure/degradation [4]. In this case, the tubes, tie rods and baffles were practically free of deposits and appeared to be in very good shape. There was no evidence of any appreciable deposit build-up between tubes, nor at the tube-to-baffle joints, as shown in Figures 2 - 4. The internal surfaces of the shell, drain and cooling water inlet were clear, and had a rough appearance (which is expected due to the cast construction). The impingement plate (baffle in the vicinity of the cooling water inlet) was also intact and appeared not to have suffered any measurable amount of material loss, as can be seen in Figure 5.

Figure 2: Cleanliness of Secondary Side Internals

Pitting, crevice corrosion, and Microbially Influenced Corrosion (MIC) are all known to occur in CANDU systems, especially on open loop secondary side/service water systems. Experience with various heat exchanger failures in the earlier CANDU reactors have also shown that what was perceived to be good quality cooling water could, by concentration of impurities, turn out in practice, to be quite aggressive and has forced heat exchanger replacement [5], [6]. Failure was usually the consequence of through wall corrosion, which originated under a heavy layer of fouling on the shell side of the heat exchanger tube bundle that is cooled with lake water. For the NRU heat exchangers, the fact that the tube bundle is so clean is likely one contributor to the heat exchangers retaining their pristine condition.

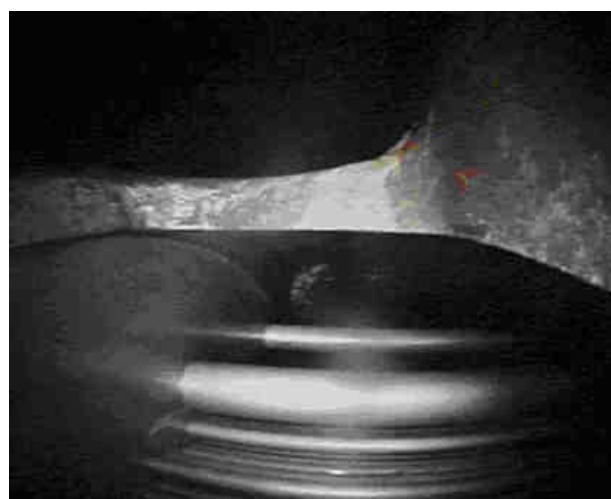
Figure 5: Process Water Impingement Plate

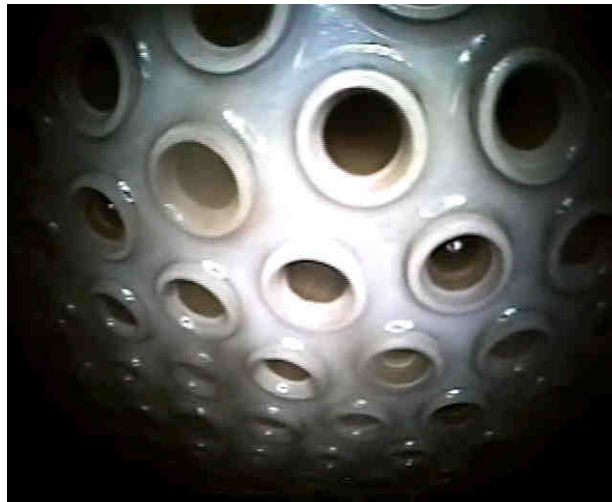
A second video inspection of the primary side bottom tubesheet in HX #5 was also conducted in November 2004 wherein a video camera was inserted into the heavy water outlet through the elbow connection to the associated pump. Inspection showed the outer tubesheet to be in good condition as shown in Figure 6.

Figure 6: Bottom Inner Tubesheet

The tubesheets are constructed of Type 304L stainless steel, which, under the low operating temperature of NRU should be virtually immune to Stress Corrosion Cracking (SCC).
