Electrochemical And Weight-Loss Study Of Carbon Steel Corrosion

V.J. Thomas and R.P. Olive
Supervisor: Dr. Derek Lister
University of New Brunswick, Canada

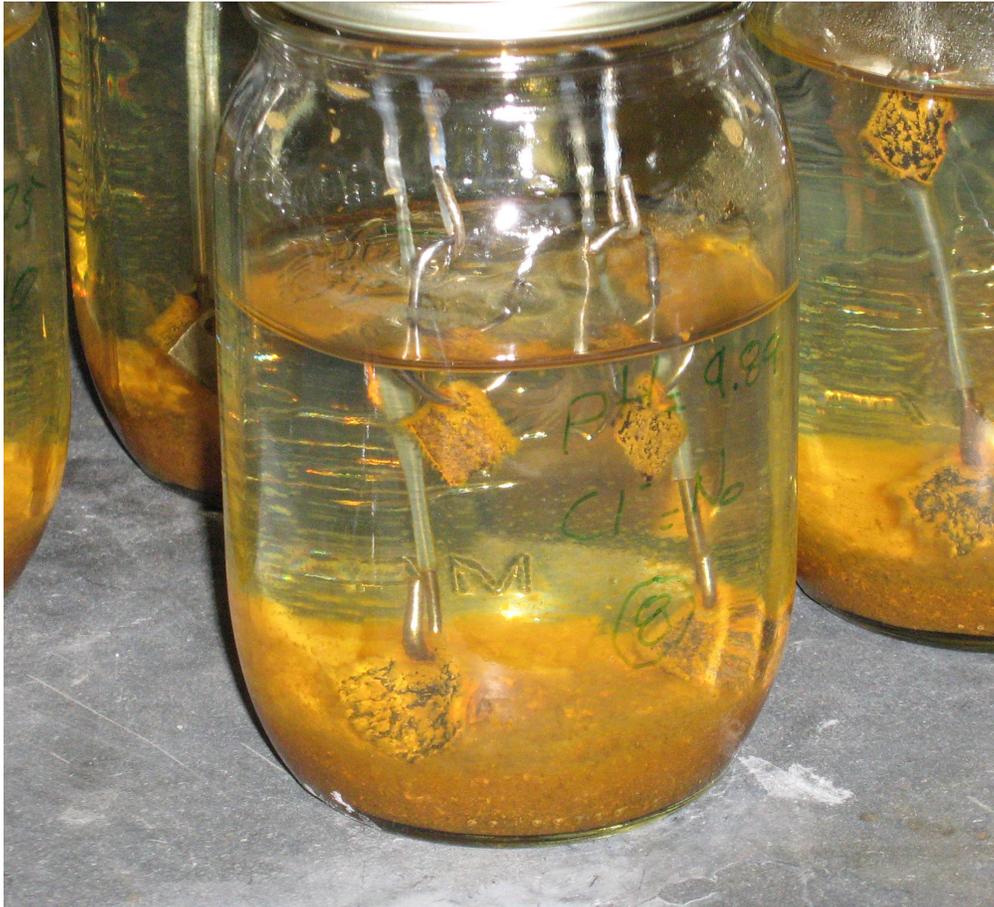
Figure 1 Carbon steel coupons in Mason jar after 91 days

The experiment ran for 56 days under weekly testing conditions for eight of the samples, and then for an additional 35 days during which none of the samples were displaced, giving a total of 91 days. During that time, the samples corroded significantly. An example of a Mason jar containing carbon steel coupons, after 56 days, is shown in Figure 1. From this figure, the oxide can be clearly observed on the coupons, as well as at the bottom of the jar. This photograph only illustrates one example; nonetheless, after 91 days, all 8 of the jars had a similar appearance. The oxide formation was actually quite significant as early as 10 days after beginning the experiment.

Also unclear in the photograph is the distinction between the samples that were descaled weekly and the undisturbed samples; however, measured corrosion rates demonstrate the effects of weekly descaling as opposed to allowing corrosion product build-up to form on the coupons.

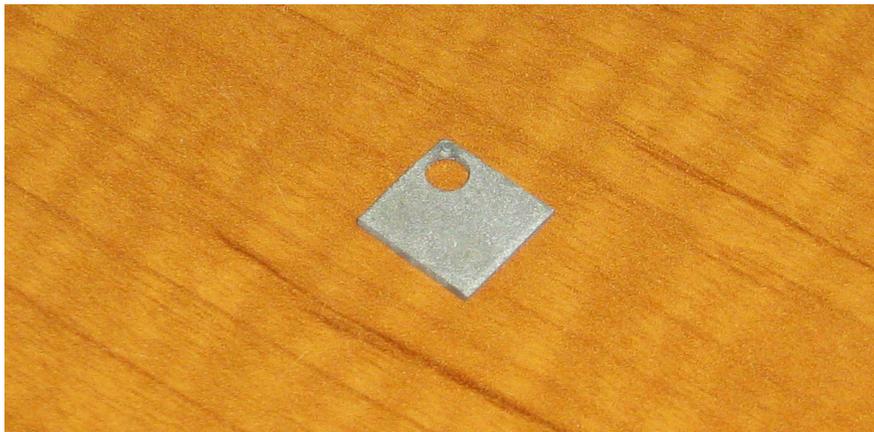
Figure 2 illustrates a carbon steel coupon after undergoing descaling procedure. After descaling, the coupons returned to a state similar in appearance to their initial conditions. Although it is not very clear from this photograph, after descaling the coupons it was evident that visible pitting did not occur in the carbon steel samples. This can be explained by the high corrosion rates obtained.

Figure 2 Carbon steel sample after descaling
