## **OVER-PACKING OF SPENT ION EXCHANGE RESIN CARBON STEEL LINERS AT ONTARIO POWER GENERATION'S WESTERN WASTE MANAGEMENT FACILITY**

This paper presents a summary of the overall project and achievements.

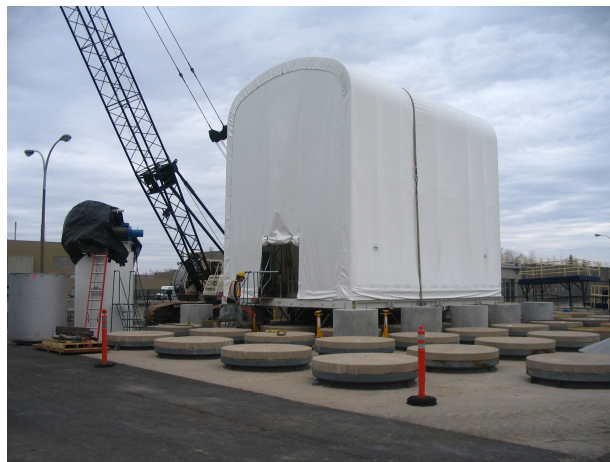
**Figure 2: Construction Island Showing the Enclosed Work Platform, Crawler Type Crane, Over-Pack and IC-18s**

The configuration of the IC storage area at the WWMF necessitated the use of a work platform to perform the lifting operations. The work platform was designed to span two adjacent IC's to reduce the number of relocations. An enclosure around the work platform provided a degree of protection from the weather and prevented precipitation from entering an open IC. Figure 2 presents a view of the Construction Island with the enclosed work platform installed over two ICs.

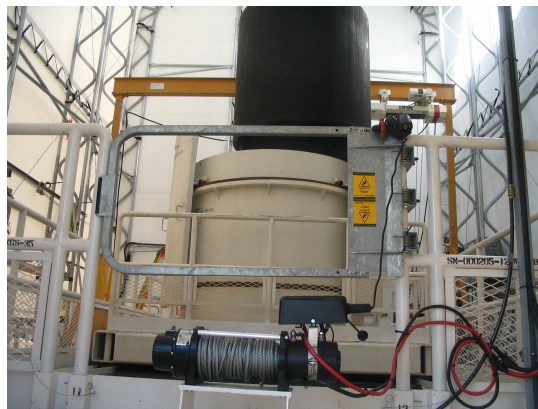
**Figure 3: Resin Liner being Lowered into Overpack Pre-Staged in Process Shield**

Steel and concrete shield designs routinely employed in Duratek's operations were modified for use on this project. A concrete/steel process shield was utilized to stage the empty over-pack for receiving the recovered resin liner (see Figure 3). Its design permitted the over-pack lid bolts to be inserted horizontally just above the shield wall. Rotating steel shields, mounted on a frame and casters, further reduced dose pick-up during the over-packing operations. Together, these design features provide an optimal degree of shielding to the working personnel.
