**DREDGING UP THE PAST**  
**– REMOVAL OF HISTORIC LOW-LEVEL RADIOACTIVE SEDIMENT FROM THE**  
**PORT HOPE HARBOUR**

**Glenn Case<sup>1</sup>, Mark Kolberg<sup>2</sup>**

<sup>1</sup> Atomic Energy of Canada Limited, Port Hope, Ontario, Canada

<sup>2</sup> Baird, Oakville, Ontario, Canada

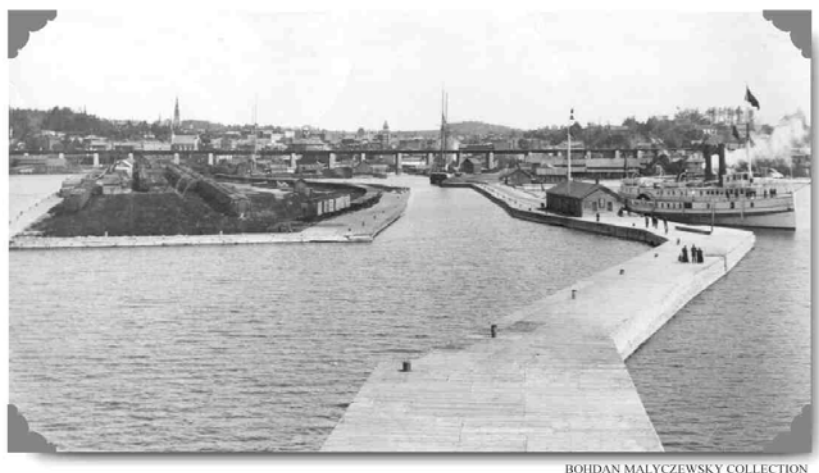
**Figure 1: Historic Photo of Port Hope Harbour Area Looking North from Eastern Spit (Pre-1900)**

in a poor state of repair, so the Town of Port Hope acquired the harbour from the Port Hope Harbour and Wharf Company and vested its interest in Commissioners acting as trustees for the benefit of the Town Council. The Commissioners immediately took steps to repair and enlarge the harbour to attract a new railroad that would connect the town to points to the north (see Figure 1).

The work of the Commissioners would result in an improved harbour extending over 2 hectares in size and projecting over 360 metres into Lake Ontario and 250 metres along the shoreline. The harbour would subsequently be reconstructed to include a Turning Basin, an Approach Channel and protective breakwalls. The Turning Basin walls were built in the mid 1800s as squared timber cribs set on rock or hard till and filled with large field stone ballast. With the exception of the concrete copewalls, these walls have remained essentially unaltered since that time.

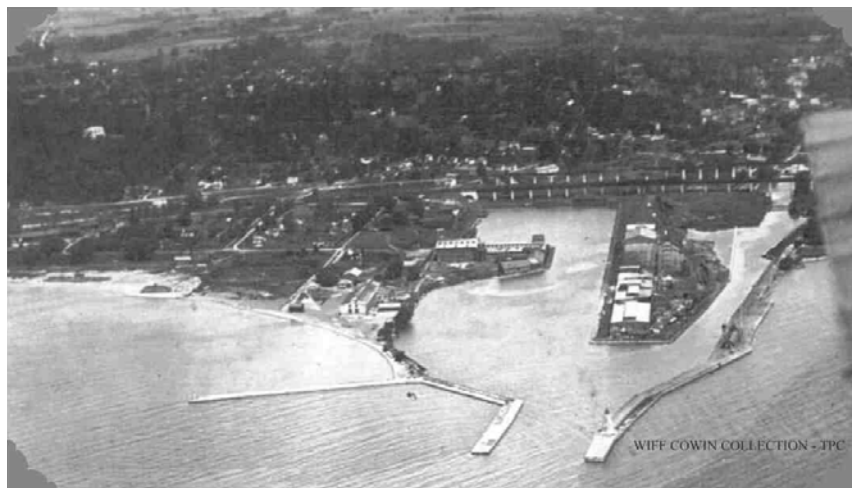
**Figure 2: Historic Aerial Photo of Port Hope Harbour Area (1923)**

Although a significant proportion of the harbour construction work was completed by the early 1900s, the current harbour configuration was not attained until 1953. Under the current configuration, the harbour comprises the Outer Harbour between the entrance breakwaters, an Approach Channel 40 metres wide by 305 metres long, providing access to a Turning Basin measuring 195 metres by 135 metres. The harbour no longer receives commercial traffic and is best described as a recreational harbour that serves as a boat mooring facility for the Port Hope Yacht Club. Figure 3 presents an aerial photo of the harbour area taken in the spring of 2010.

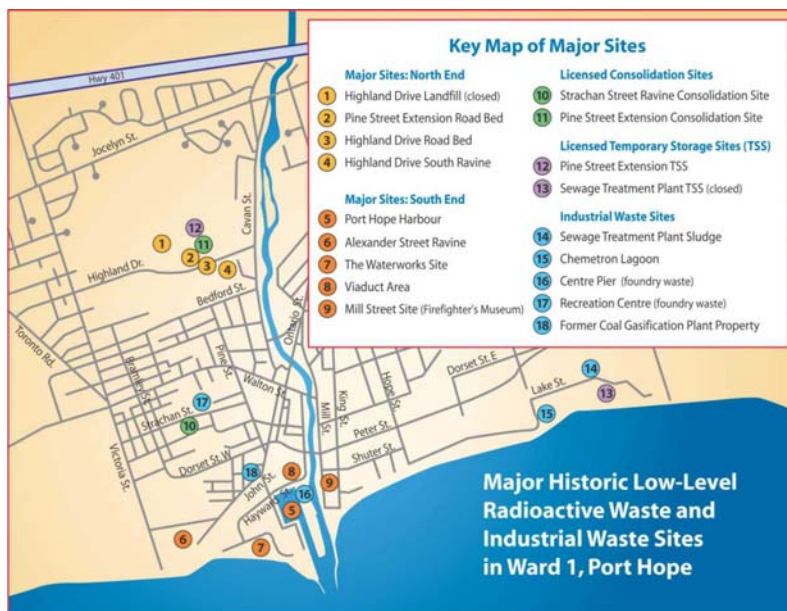
**Figure 5: Major Historic Low-Level Radioactive Waste Sites in Ward 1 of Port Hope**

Figure 5 depicts the major waste locations that currently remain in the urban area of Port Hope and are the focus of the PHAI and the Long-Term Waste Management Project.

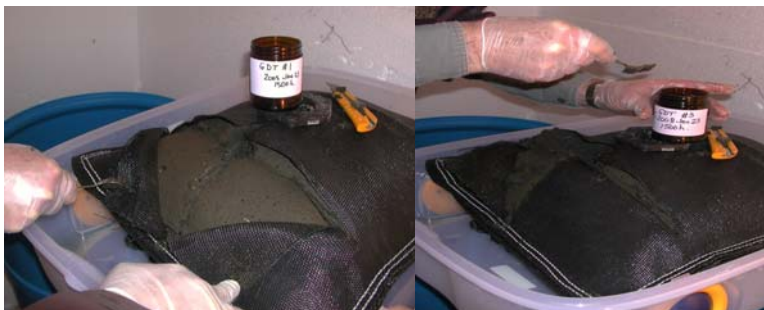
**Figure 7: Bench Scale Test of Polymer Additive and Sediment Containment Bag Dewatering System**

Bench scale investigations involving Port Hope harbour sediments demonstrated that the sediment-water slurry can be successfully mixed with polymers to promote flocculation and consolidation of the sediment within containment tubes.

Figure 7 presents a picture of the consolidated sediment in the bench scale containment bag and the form of collected sediment that will make it amenable for placement into standard haulage vehicles for transportation to the off-site long-term waste management facility.

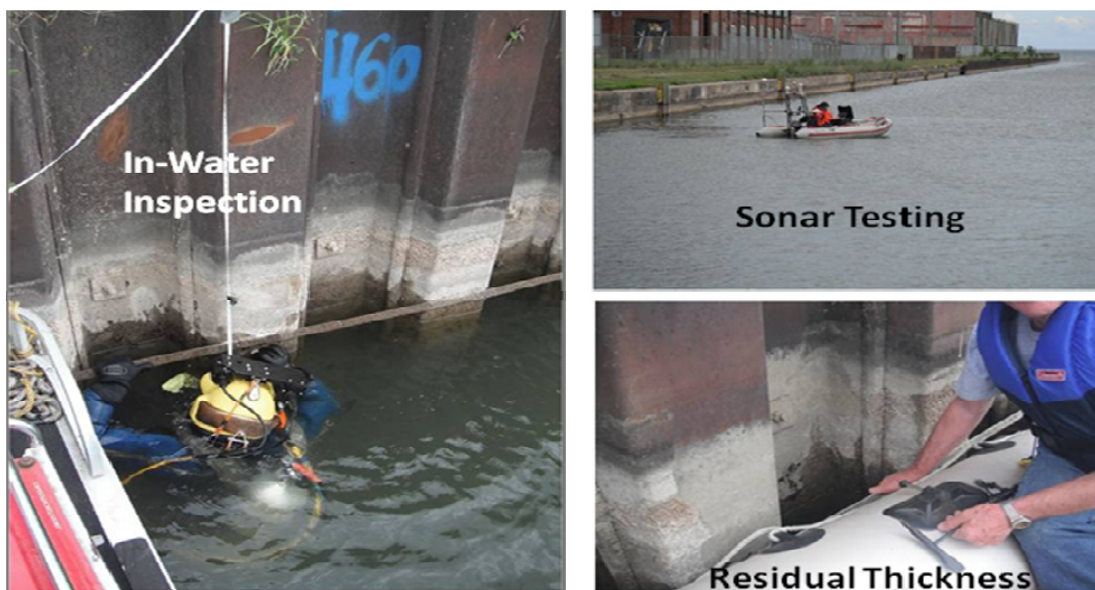
**Figure 9: Harbour Wall Condition Assessment Activities**

The design of the harbour remediation strategy has involved careful examination of the integrity and stability of the existing harbour walls, revealing that the removal to bedrock, or hard till, of the sediment located adjacent to the walls could compromise the wall structures. To address this concern, a harbour wall condition assessment was conducted during the summer of 2010 on over 1,800 metres of existing harbour wall structures which could be impacted by the dredging operation. The physical appearance and integrity of these walls were characterized (i.e., timber crib, steel sheet pile) as part of this study (see Figure 9).

Based on the results of this condition assessment, and the required depth of sediment removal to bedrock or hard till, a series of optional concepts for the repair, rehabilitation or replacement of specific sections of harbour walls potentially impacted by the dredging were developed. These concepts took the following factors into consideration:
