PIPING, PUBLIC OUTREACH, AND SOIL ASSAYING AT THE NASA PLUM BROOK REACTOR FACILITY

Keith M. Peacock, PE

National Aeronautics and Space Administration
Sandusky, Ohio, USA

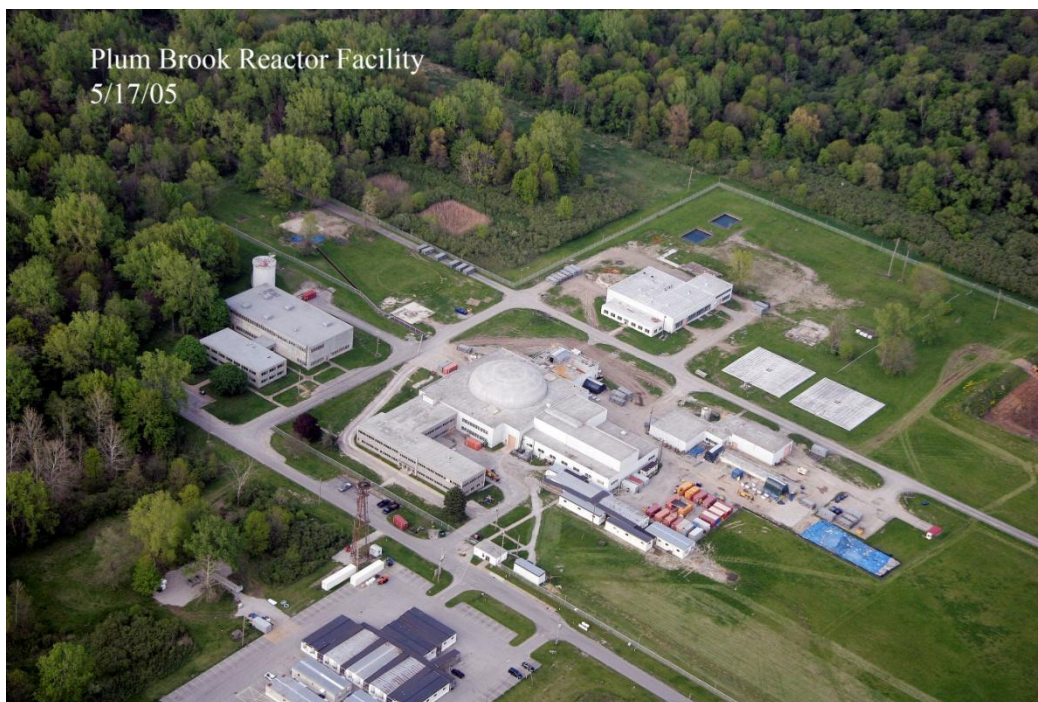
Figure 1. The NASA Plum Brook Reactor Facility – circa 2005

The NASA Glenn Research Center's PBRF is located at Plum Brook Station near Sandusky, Ohio. It is halfway between Toledo and Cleveland, five kilometers south of Lake Erie. There are two US Nuclear Regulatory Commission (NRC) licensed reactors on site. The main reactor is a 60 MW pressurized water reactor and the Mock-Up Reactor (MUR) is a 100 kW swimming pool type. Both were used to perform neutron exposure testing on materials in support of the nuclear rocket program.

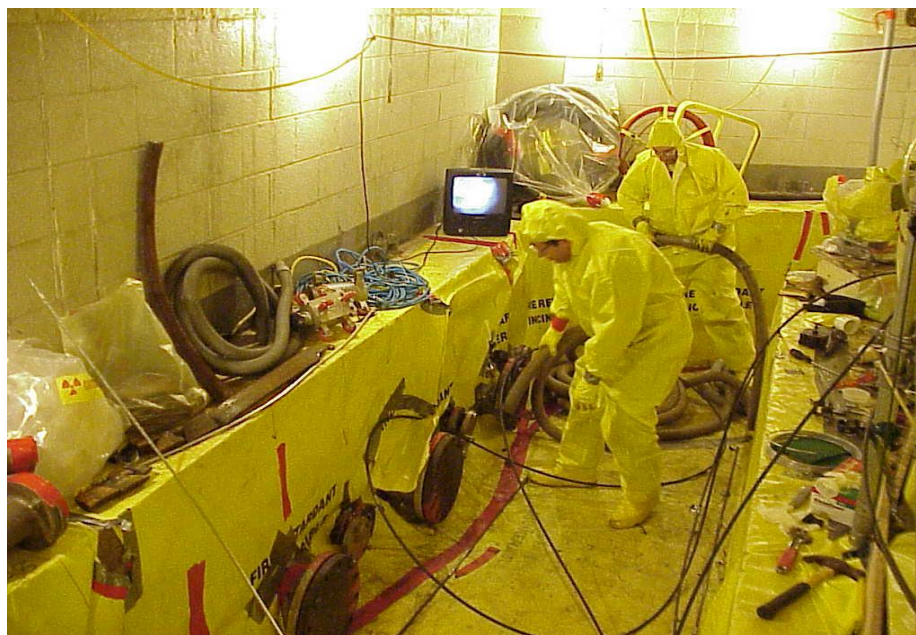
Figure 2. Workers Cleaning Embedded Piping

To clean the pipe, access points were identified and opened at each end. Typical lengths of pipe handled were 12 m, though single lengths as great as 30 m were successfully cleaned. A large vacuum was applied to one end of the pipe while a mechanical or abrasive cleaning device was fed in from the other. Figure 3 shows a 'flail' type mechanical cleaner. The motor on the cart would spin at several hundred rpm, and the chain was sized so that the rapidly moving weighted brushes, or flails, just reached the wall of the pipe. As the cleaner advanced the rust and scale was knocked loose and pulled out by the vacuum, leaving a 'white metal' surface to survey. One pass was sufficient for about 90% of the piping to reach the DCGL.

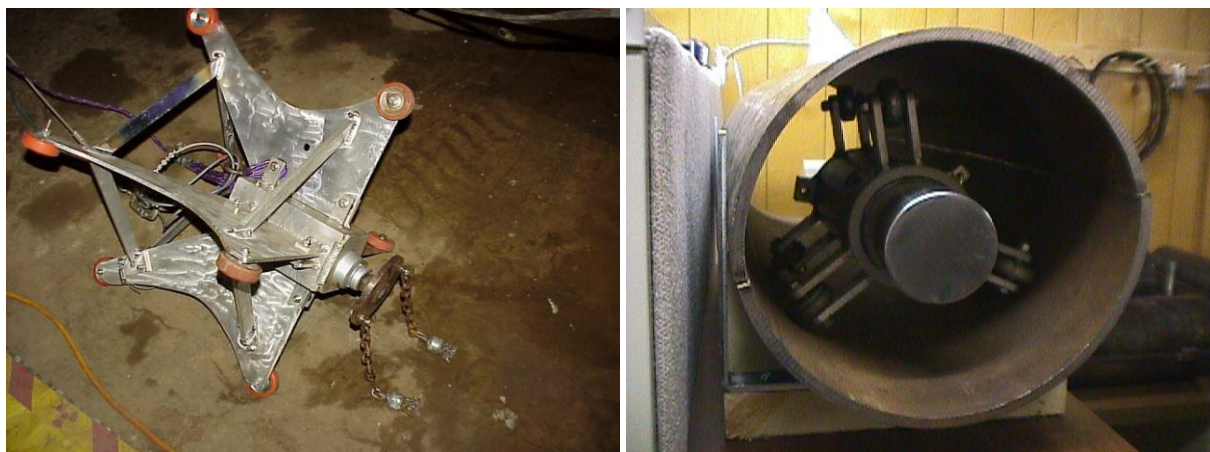
Figures 3 and 4. A Pipe Cleaning 'Flail' and a Pipe Radiation Probe

Surveys were performed both before and after cleaning, using detectors mounted in custom carts that traveled down the pipe. A typical probe is shown in Figure 4, being tested in a dummy length of pipe. Such mock ups were made for the various diameter piping, and were used to check out the fit of carts for cleaners and detectors. The mock ups were also used to calibrate the instruments, with the use of a flexible flat plane source mounted to the interior pipe wall.

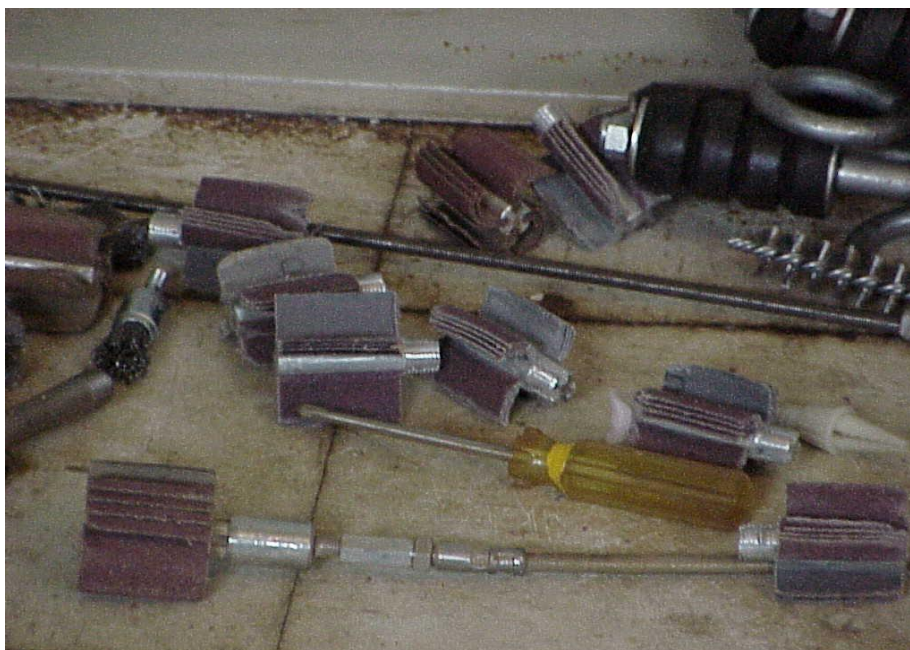
The same cleaning and surveying techniques were used, though the small size of much of the conduit required new tools yet again. Grit blasting, described in more detail in Reference [1], was also occasionally used. Figure 5 shows a selection of some of the abrasive tooling used.

Figure 5. Tooling used for Cleaning the Hot Cell Conduit

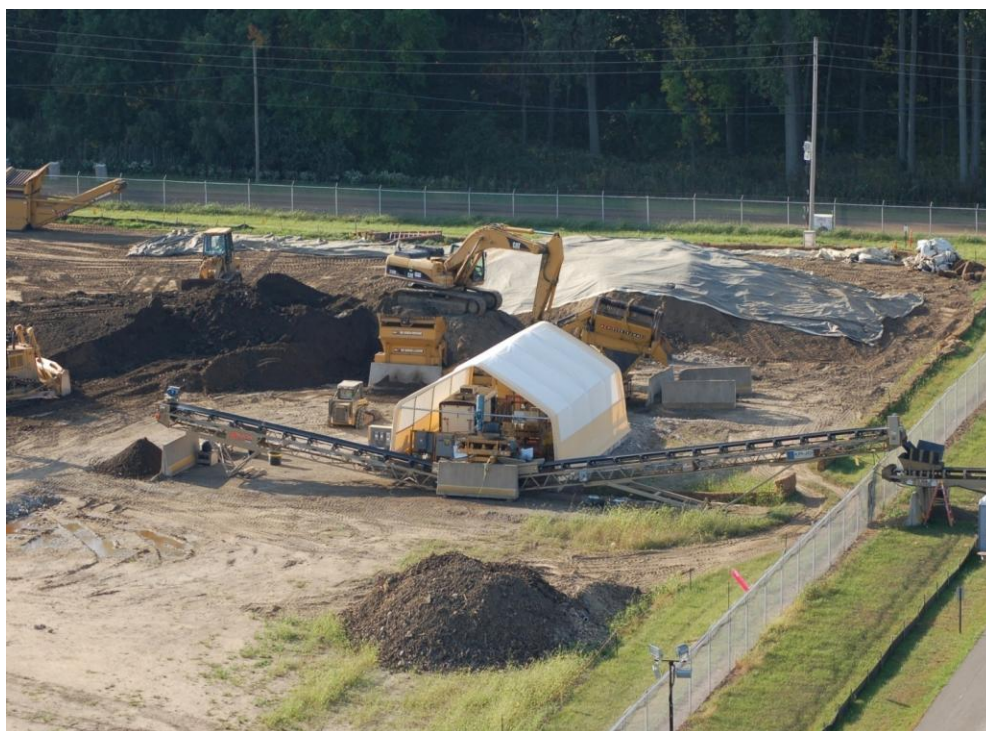
Figure 6. Soil Assay System

To handle this challenge NASA elected to employ soil assaying, using the MACTEC Orion Soil Sorting System. The system is shown in Figure 6. The soil to be assayed is passed through a trammel, which removes any rocks or other debris and places the soil evenly on a conveyor belt in a 15 cm thick layer. The belt carries the soil under a series of detectors. The soil then dumps onto a reversing belt. If the soil is within radiological limits then the reversing belt moves the soil towards the 'clean' pile. If it is above limits, or if the soil geometry is not within specs, the reversing belt immediately and automatically directs the soil to the 'dirty' pile. Once soil is back within limits the reversing belt changes directions again. With this system PBRF was able to process as much as 1,100 metric tons of soil during a 10 hour work day.

The system had previously been used at other NRC regulated sites (the Saxton reactor site in Pennsylvania, and a thorium contaminated rail yard in Tulsa, Oklahoma), but PBRF's NRC inspectors had not seen it before and had several concerns. The main question had to do with blending – how was NASA going to insure that soil contaminated above the DCGL was not intentionally mixed with clean soil in the excavation, transport, and soil processing steps prior to assay so as to be diluted to be within standard and so left on site? This was resolved administratively by ensuring all areas to be excavated were scanned and segregated first. Any soil found by field instruments to be above the DCGL would be removed and placed in the shipping pile. Only soil believed to be less than the DCGL would go through the assay process.

Since the results of this system were treated as FSS results it was necessary to meet all applicable FSS QA/QC standards. This included the requirement that at least 5% of the samples be validated. To accomplish this 'clean' soil was collected at the end of the belt in 453 metric ton piles. This size pile roughly corresponded to the amount of soil in a standard MARSSIM open field survey unit, measuring 2,000 m² by six inches deep. Grab samples were collected from each pile and analyzed to provide the necessary check. Once the sample results were shown to be acceptable the individual pile was moved into the 'clean' pile.
