URL CLOSURE: WHAT IT TAKES TO DECOMMISSION AN UNDERGROUND RESEARCH FACILITY

D.P. Onagi, J.B. Martino, C-S. Kim, D.A. Dixon, D.M. Bilinsky

Atomic Energy of Canada Limited, Whiteshell Laboratories
Pinawa, Manitoba, Canada

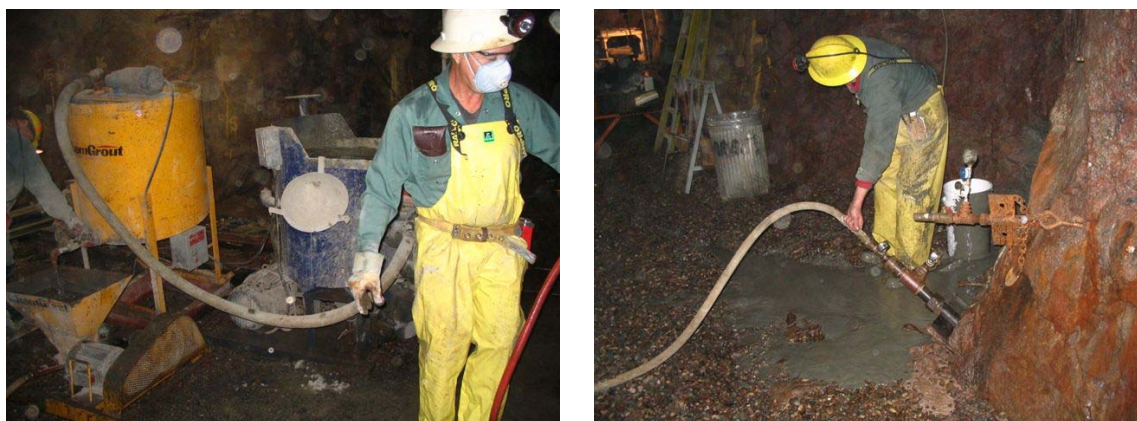
To limit the vertical movement of fluids and prevent the mixing of groundwater with differing chemistries, surface and underground boreholes were decommissioned and sealed (Fig. 3). Cement grout, clay pellets, or a combination of both were used to seal the boreholes depending on conditions. Where boreholes intersected hydraulically active zones, they were equipped with AECL designed multiple packer systems. A total of 177 surface boreholes, ranging in length from 3 to 1500 m, and 120 underground boreholes, ranging in length from 30 m to 700 m, were decommissioned.

Figure 3. Borehole grouting.

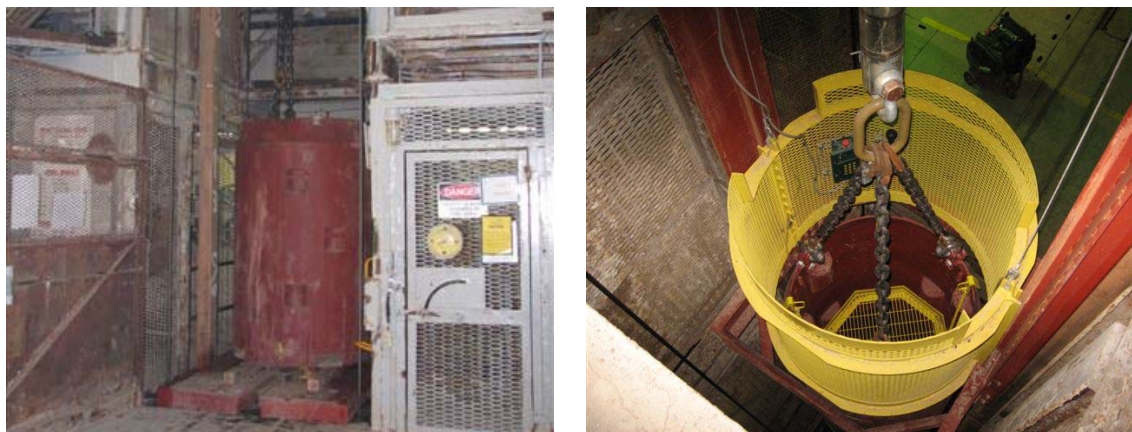
For shaft decommissioning, the URL hoist and shaft conveyance system had to be reconfigured. The cage conveyance normally used for travel in the shaft was removed and replaced with a sinking bucket to facilitate transport of personnel and decommissioned material (Fig. 5). The URL hoist was converted from a double rope system of cage and counterweight, to a single anti-spin rope with a clevis for attaching the bucket.

Figure 5. Sinking bucket and bird cage.

The sinking bucket would travel up and down the shaft within the framework of a crosshead. The crosshead provided stability for the bucket and prevented it from coming in to contact with the shaft furnishings during travel. The crosshead would chair just above the working level, allowing the bucket to descend unencumbered.

For protection of personnel while traveling in the bucket, a wire mesh “bird cage” was mounted in the crosshead. The bird cage could be lowered to mate with the sinking bucket, enclosing the personnel. A radio signal system and phone was installed on the bird cage to allow personnel in the bucket to communicate with the hoist operator on surface to direct the movement of the bucket.

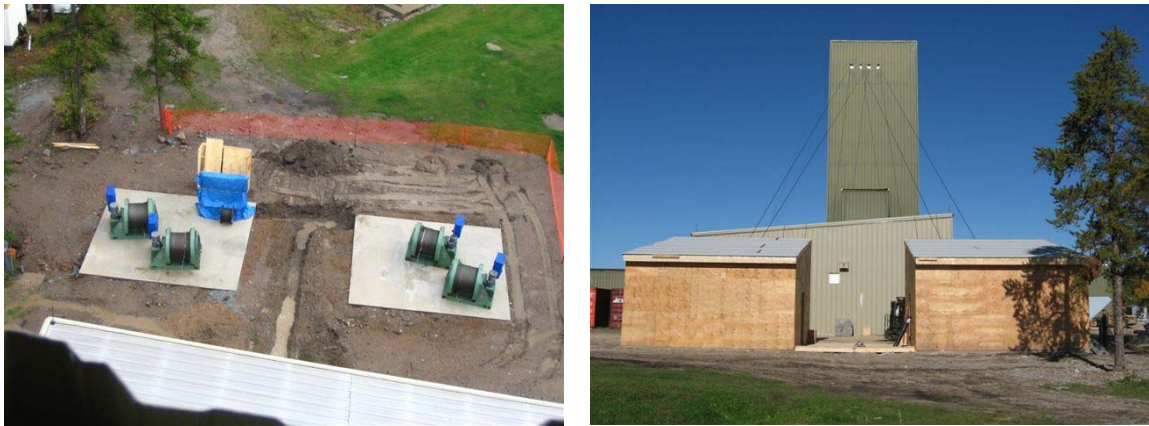
The main piece of equipment used in the shaft decommissioning was a movable, three-deck platform called a Galloway Stage (Fig. 6). The Galloway Stage was suspended on four wire ropes, each connected to a separate winch located on surface (Fig. 7). The four winches could be operated independently to allow precise leveling of the Galloway.

Figure 7. Galloway Stage winch installation.
