LESSONS LEARNED: THE EFFECT OF INCREASED PRODUCTION RATE ON OPERATION AND MAINTENANCE OF OPG'S WESTERN USED FUEL DRY STORAGE FACILITY

Lise Morton, Nathan Smith
Ontario Power Generation
Tiverton, Ontario, Canada

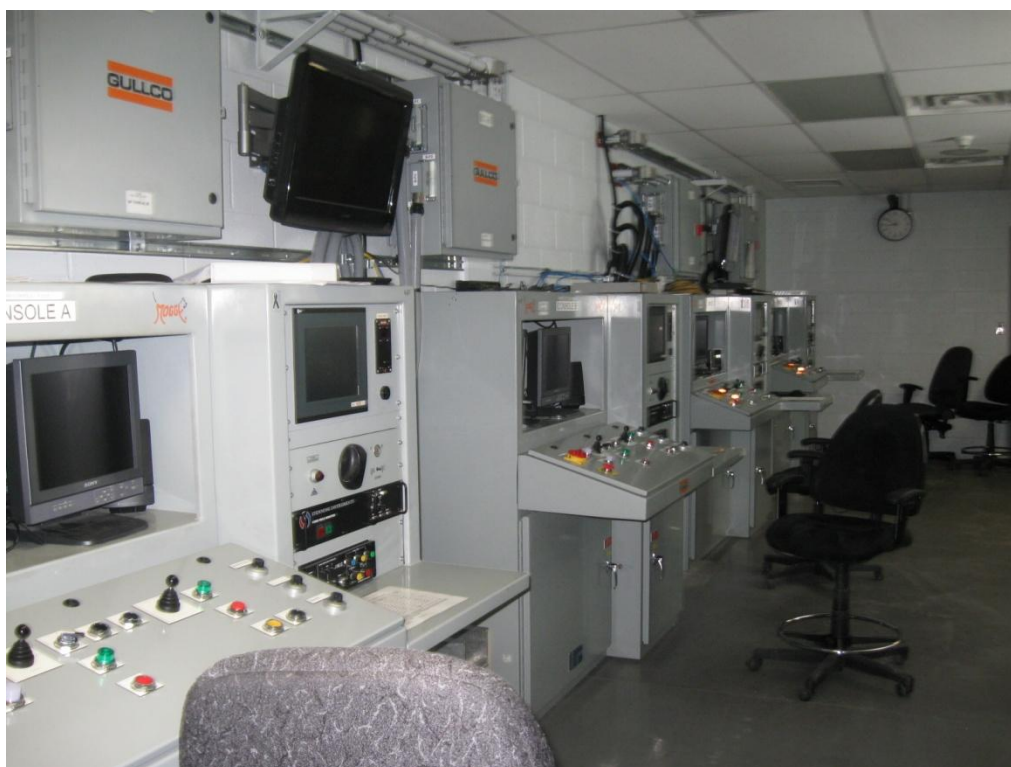
Figure 2. Welding Control Room, showing two pairs of welding consoles.

In 2008, a second set of welding consoles was procured, installed and commissioned (Figure 2). The used fuel dry storage process utilizes a Gas Metal Arc Welding semi-automatic welding system. The closure weld, which seals the DSC lid to the base, is a full penetration, multi-pass groove weld. The welding system is fitted with two metal inert gas shielded weld heads. Each weld head has its own remote camera system and separate monitoring and control console. The weld head assembly is hoisted by the overhead crane and rests on the DSC lid during the weld cycle.

There are three welding bays at WUFDSF. Prior to 2008, with only one welding console and weld head in service, it was only possible to weld one DSC at a time. The installation and commissioning of a second set of welding consoles enabled two DSC's to be welded simultaneously. In practice, it was not always practical to do so due to the time delays in receiving and preparing loaded DSC's for welding. However, the increased production rate often led to one DSC being prepared for welding (through the application of pre-heaters) in one weld bay, while another DSC was being welded in the other weld bay.

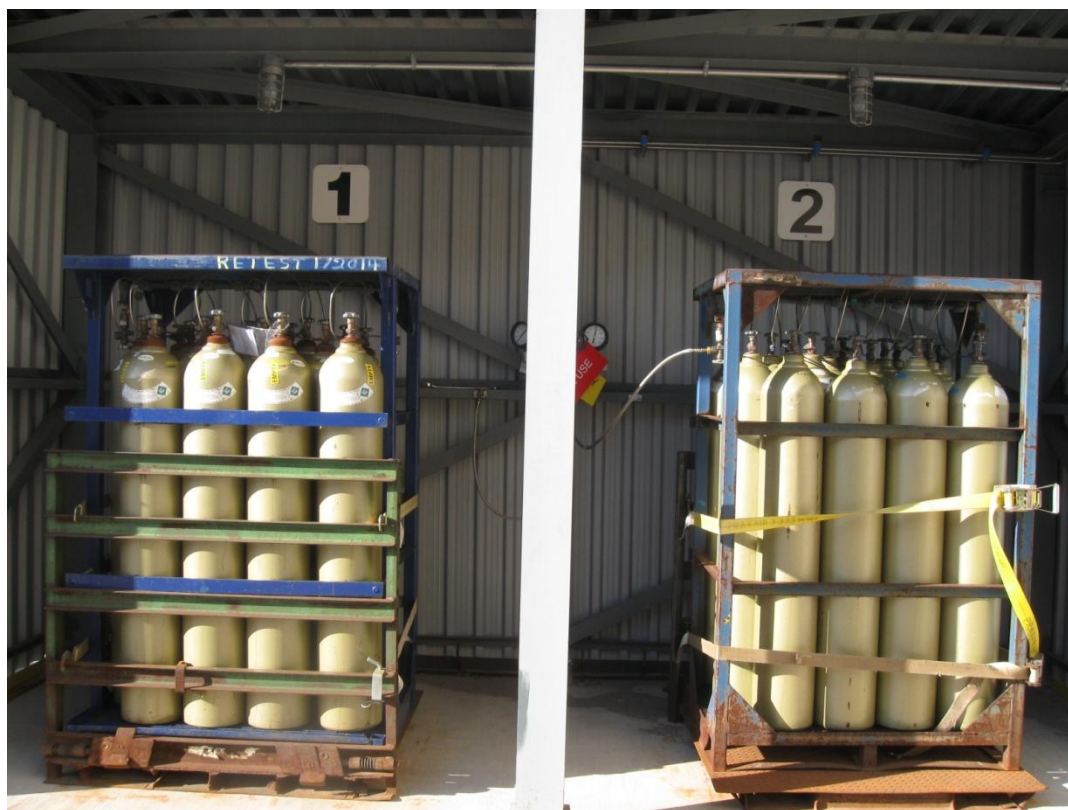
Figure 4. Two 16-cylinder packs containing Welding Cover Gas.

Therefore a bulk gas system was installed which consists of two 16-cylinder packs with automatic switchover capability between the two systems (Figure 4). In practice, it has been determined that one 16-cylinder pack is capable of completing the welding of approximately six DSC's. Therefore the entire cylinder pack is replaced every two weeks.

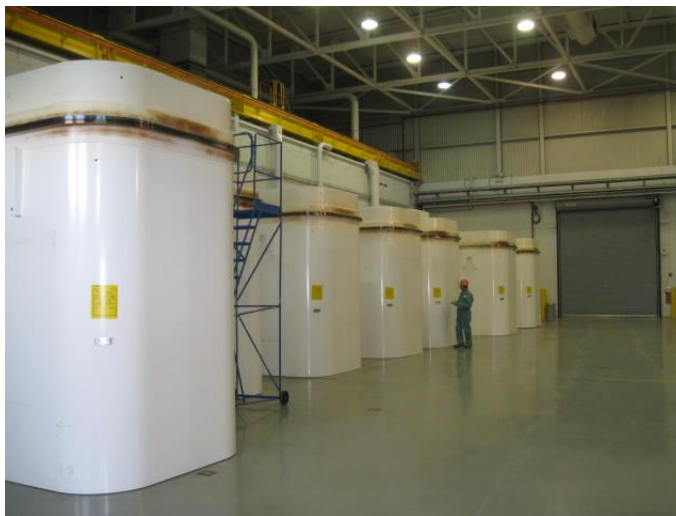
Figure 5. Picture of Processing Building floor with several DSCs waiting further processing.

At various times during 2010, the processing building floor was significantly congested with both loaded DSC's (waiting processing or at various stages of the process) and empty DSCs (awaiting preparation or delivery to the stations). (Figure 5). Significant effort was expended by the staff in order to ensure optimum usage of the floor space within that area.
