## **Feeder Bend Testing Project – A Decade in Review**

The Feeder Bend Testing Project has been funded by CANDU Owners Group (COG) from 2003 to 2012 to support the safe operation of degraded feeder piping in Canadian CANDU plants. The present paper summarizes this multi-million dollar project from a variety of aspects: background, project management, test setup and results, achievements, and lessons learned.

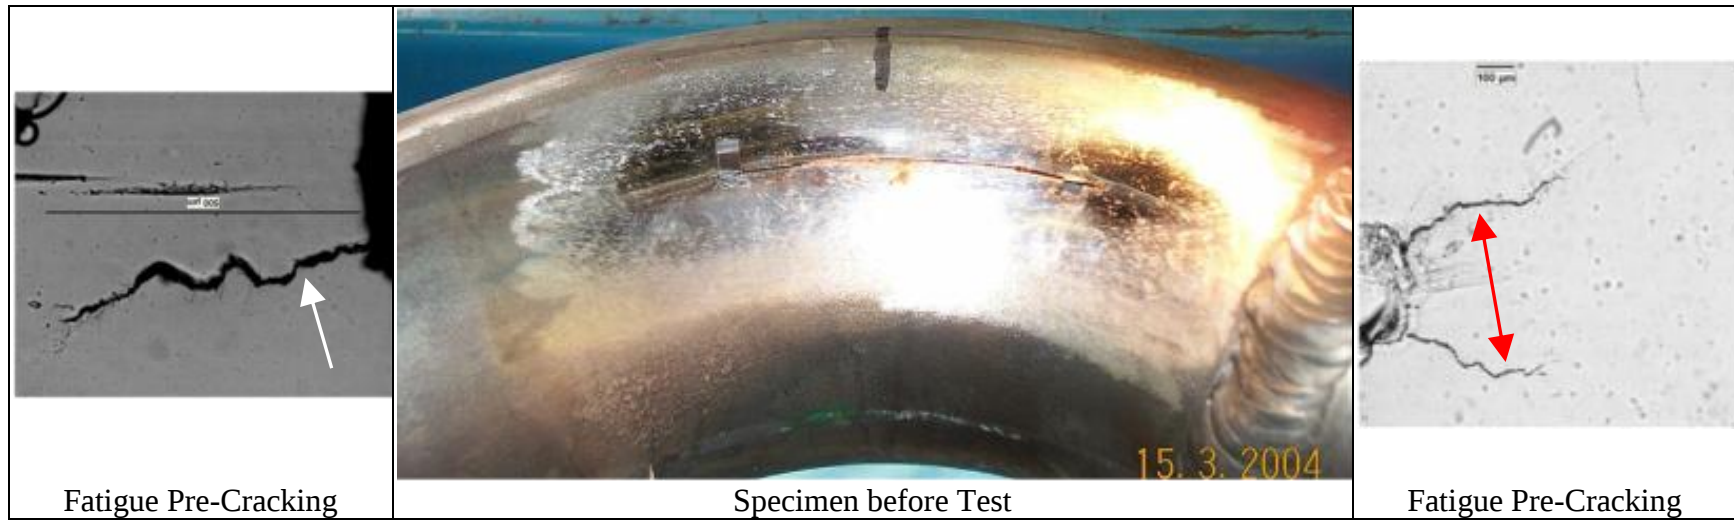
Figure 7: Test Specimen FBTP-1-060-1

- Phase 1 (FBTP-1): this phase of FBTP was managed under FIJP and tested six nominal thickness specimens with through-wall axial crack in the intrados/cheek region of the bend observed in PLGS S08 under design loads at elevated temperature. The testing of through-wall cracks introduced the challenge of developing a viable high-temperature liner. AECL Sheridan Park (Technical Advisor) was responsible for the overall technical quality and Kinectrics (Test Contractor) was responsible for conducting the tests in accordance with AECL's specification. Both AECL and Kinectrics reported to FIJP directly and budgets were fully supported by the Feeder Integrity Steering Committee (FISC).

Typical specimens for each phase of FBTP are shown in Figure 7 for FBTP-1, Figure 8 for FBTP-2, and Figure 9 for FBTP-3. Figure 10 shows examples of the range of failures observed in Phase 3 of FBTP, where DEGB stands for Double Ended Guillotine Break. Extensive plastic deformation were observed in all specimens in spite of the measured low fracture toughness  $J_{Ic}$  from sub-sized compact toughness tests that varied from 13 kJ/m<sup>2</sup> to 30 kJ/m<sup>2</sup> at 265°C. The test of the ex-service feeder bend with a deep surface crack (<75%tw) demonstrated large margins against rupture [4]. The failure pressure for all burst-pressure tests of specimens with severe local thinning tested under FBTP-3 were at least 5 times the design pressure [5].

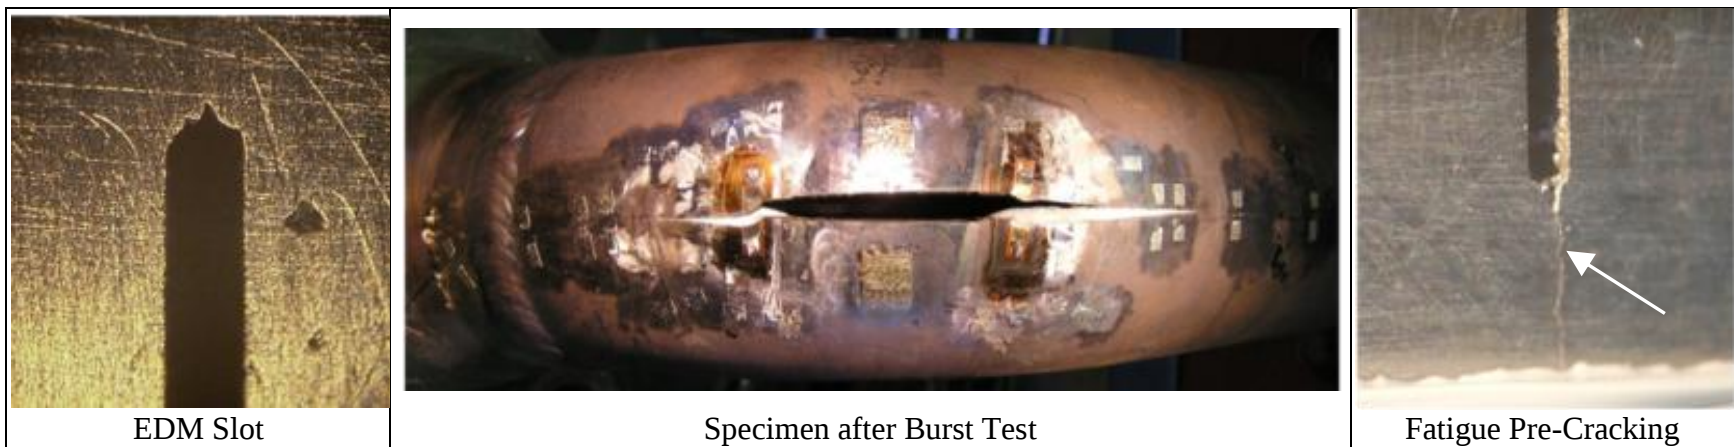
Figure 8: Test Specimen FBTP-2-040-1

- Phase 2 (FBTP-2): this phase of FBTP was also managed under FIJP and tested seven thinned test specimens with through-wall cracks in the extrados and in the intrados/cheek region of the bend under bounding monotonic loads. The testing of thinned specimens introduced the challenge of developing a viable electro-chemical thinning process. AECL Sheridan Park was responsible for the overall technical quality and Kinectrics was responsible for conducting the tests per AECL's specification. Both AECL and Kinectrics reported to FIJP directly and budgets were fully supported by the Feeder Integrity Steering Committee (FISC).

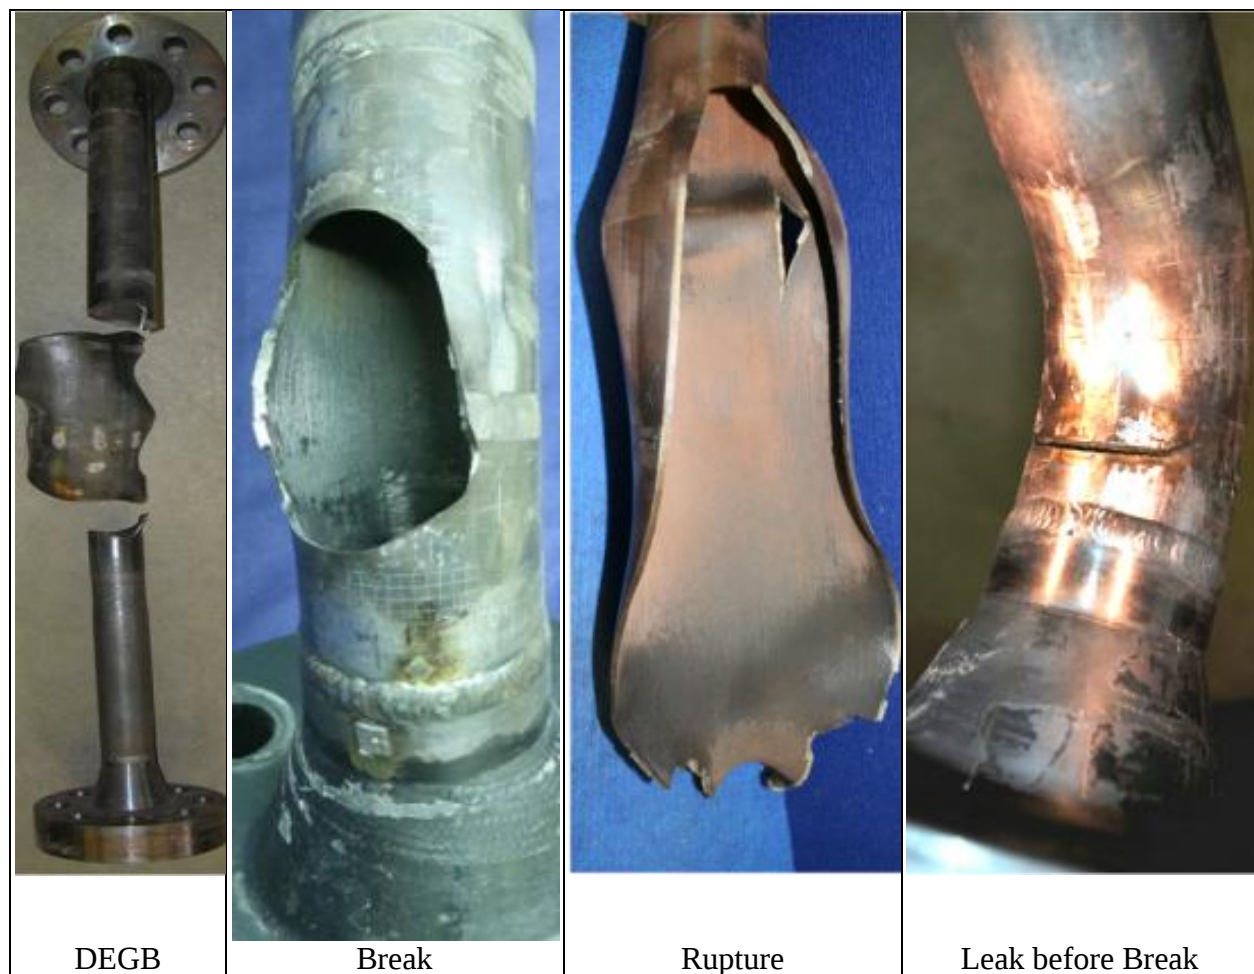
Figure 10: Mode of Failure of Specimens with Severe Local Thinning Tested under FBTP-3
