## W.B. Lewis Lecture

# Cleaning-Up Abandoned Uranium Mines in Saskatchewan's North

By Laurier L. Schramm, President and CEO, Saskatchewan Research Council

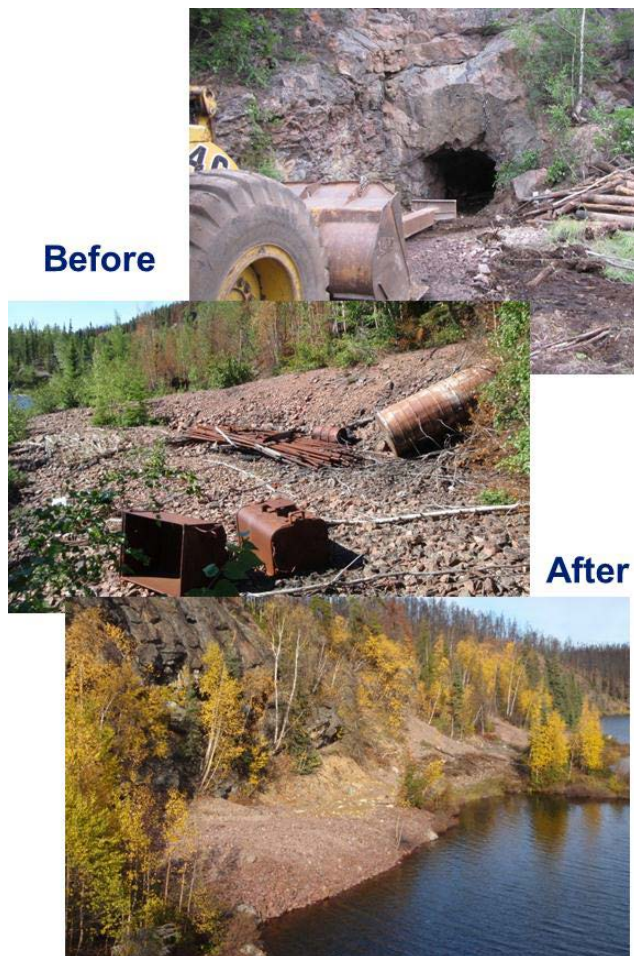
Figure 2. Example of “before” and “after” views of an abandoned satellite uranium mine site in Northern Saskatchewan (Baska Uranium Mine, 2009.)

The first 8 satellite sites were substantially cleaned-up in 2009, the next 5 in 2010, and this work continues, although at a slower pace in 2011 and 2012 due to the ramp-up in clean-up activities at the large Gunnar site as will be discussed below. Figure 2 shows a “before” and “after” illustration of work at one of the satellite sites.

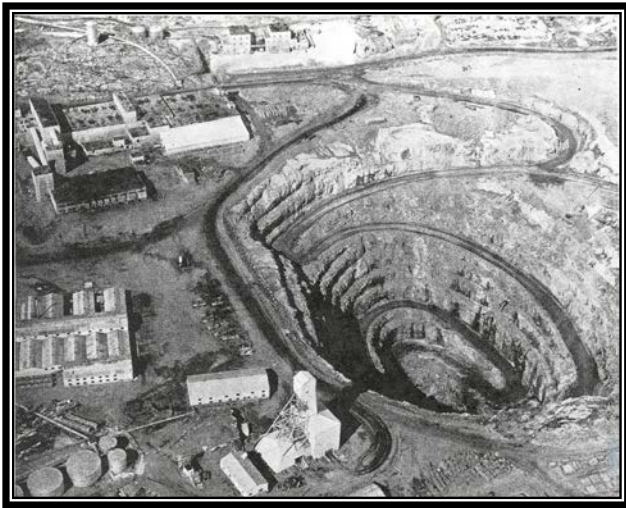
Figure 3. Gunnar Mine; open pit, circa 1962.

The open pit mine was approximately 300 m long, 250 m wide, and ultimately 116 m deep (Figure 3). The underground mine began production in 1957 and was operated until 1963, by which time it was over 600m deep. The mined ore averaged about 0.15% uranium content, and ultimately nearly 5 million tonnes were produced. Upon closure in 1964, decommissioning was limited to flooding the pit (Figure 4) and capping the shaft. Left behind were:

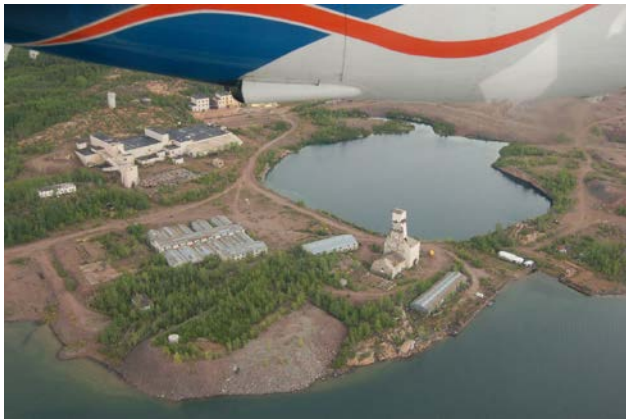
Figure 4. Gunnar Mine; flooded open pit in 2006.

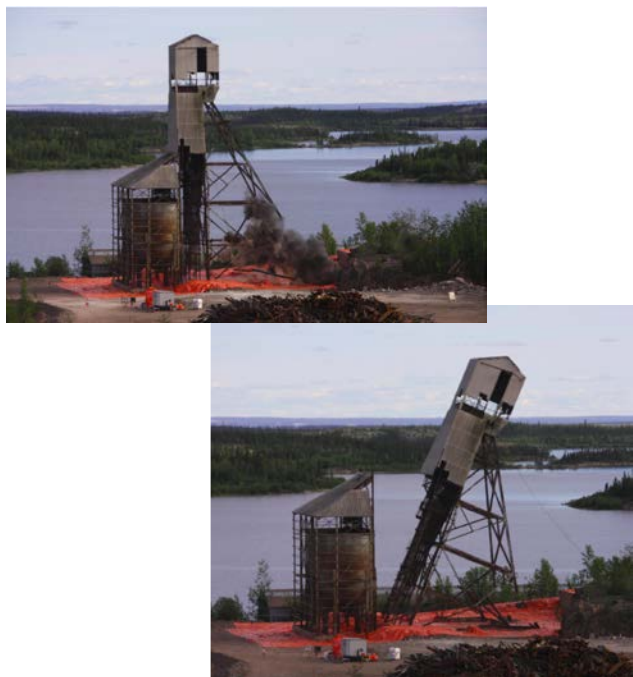
Figure 5. Demolishing the Gunnar Head-Frame in 2011.

These demolitions included the mine, mill, and plant buildings, school, residences, above-ground utilidors and, of course, the iconic Gunnar head-frame structure (Figure 5).

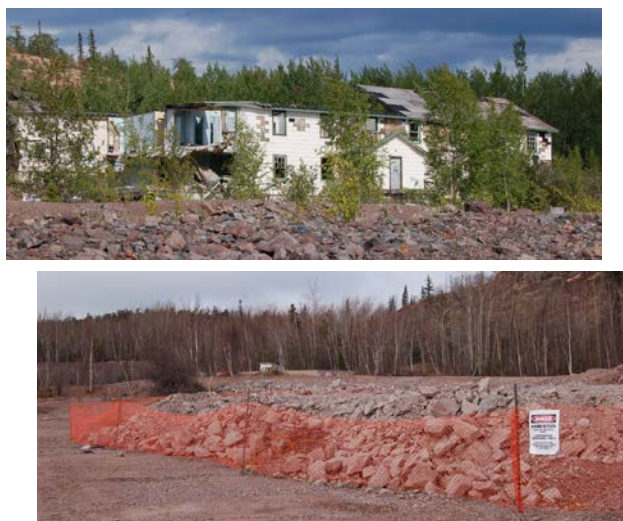
Figure 6. Example of “before” and “after” views of building demolition at the Gunnar site (2010).

During this process, constant care had to be taken to protect workers from asbestos, let alone the other hazards, and in many cases buildings had to be maintained under negative air pressure during indoor work (to guard against radon and asbestos), and then constantly sprayed during demolition (to knock-down asbestos dust and fibres). Following demolition the building and chemical materials were collected and transported to holding sites pending ultimate disposal, and the ground covered-over with clean fill (Figure 6).
