**Fifth International Conference on CANDU Fuel
1997, September 21-25
Toronto, CANADA**

**NUCLEAR FUEL PERFORMANCE IN EMBALSE NPP,
DESIGN OPTIMIZATIOS AND MANUFACTURING IMPROVEMENTS**

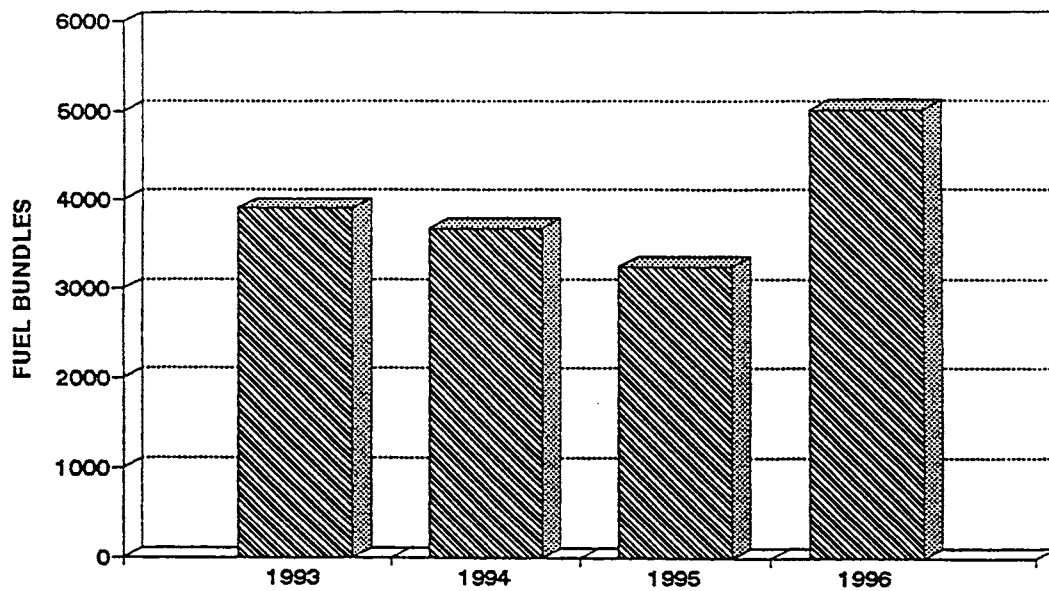
Relevant data regarding the domestic supply of fuels to Embalse NPP during the last four years is presented in Figures 1 and 2. More than 3000 fuel bundles were delivered by the fuel manufacturer to the power station each year. Figure 2 shows the cumulative number of failed fuel bundles in this period and the failure rate for each year. This rate was less than 0.2 % in 1993 and then jumped to 0.4 % in 1995. In 1996 the failure rate was again very low. Although some fuels manufactured during 1996 are still into the reactor, the activity level of the primary coolant is very low so we expect that the good performance of these fuels will remain at that level until the end of their irradiation.

Figure 1: Fuel bundles supplied to Embalse NPP by the commercial fuel manufacturer during the last four years.

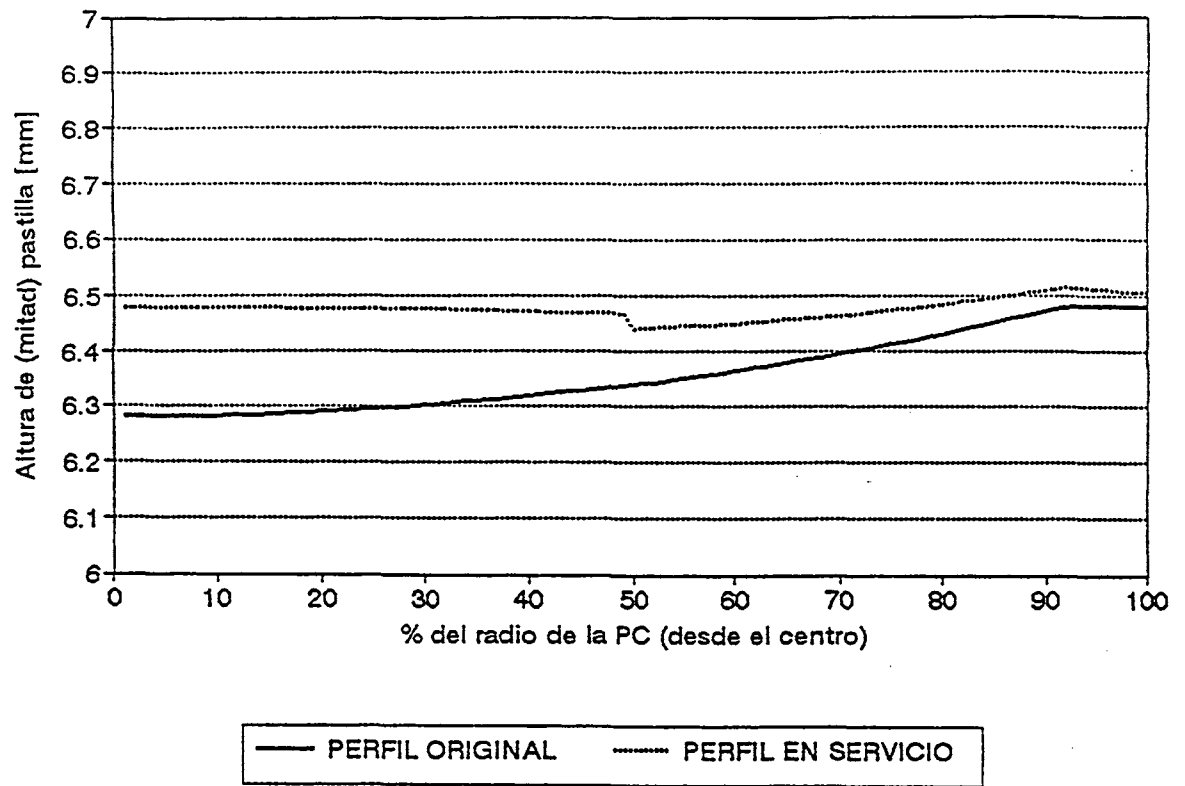
All optimizations were analyzed by CNEA's Fuel Engineering & Design Branch and calculations with ELESIM Mod.9 and Mod.10 were performed to evaluate the operational parameters. As an example, Figure 5 shows results for the effectiveness of the new dishing volume.

Figure 5: Effectiveness of the dishing volume for the new design of fuel pellets
