# RTD PROBLEMS AT DARLINGTON

### Abstract

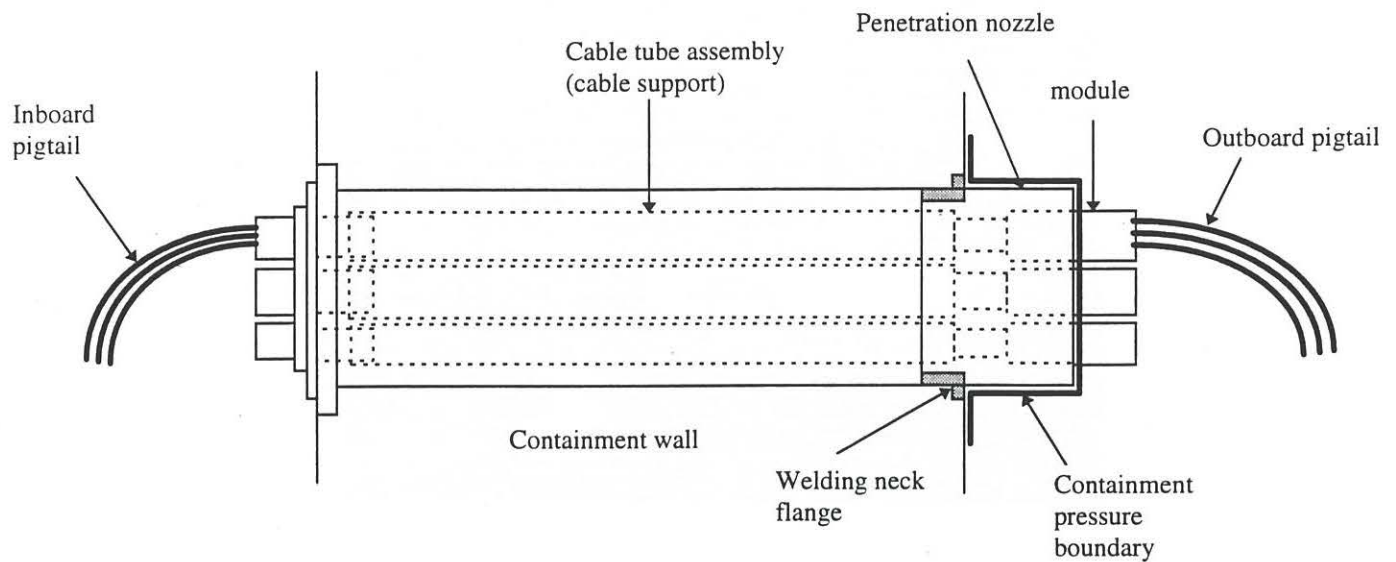
Figure 5. Electrical Penetration Diagram

The electrical penetrations used in Darlington are pre-built by Imaging and Sensing Technology Corporation (IST), a Westinghouse company. A drawing of a penetration is shown in Figure 5. The penetration structure is a carbon steel cylinder with end plates containing seven holes for modules (only three shown in cross-section). On the outside of the vault, the penetration nozzle is welded on in-situ. Internally, a structure of tubes supports the cables as they cross the containment wall.

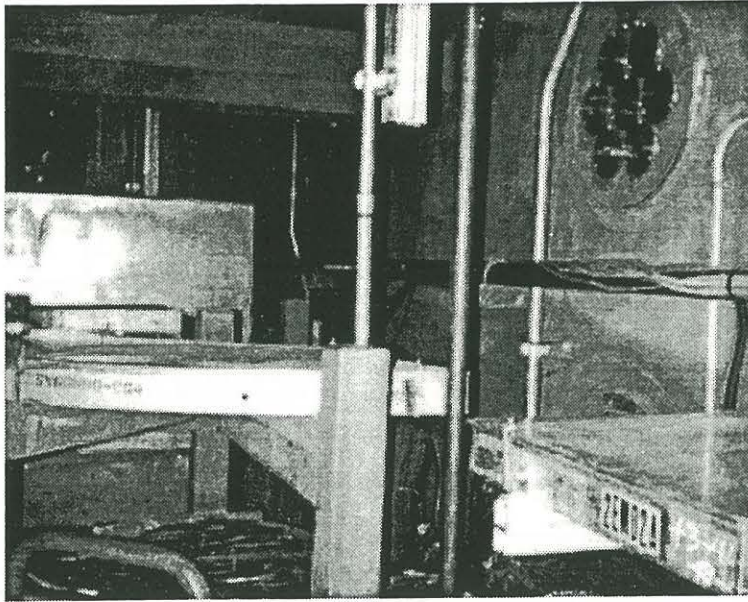
Figure 7. Electrical Penetration Layout Inside the Vault

There were existing blank electrical penetrations installed directly over the electrical penetrations for the RTD circuits. See Figure 7 for the layout of the penetration inside the vault. These electrical penetrations had structure, but no modules. It was decided that new modules, built to a new specification that increased the quality requirements on the crimps, would be installed in the spare penetrations. New crimp technology is used, but the most important change is that the quality assurance of the modules is increased.
