An Overview of the Metallurgical Investigations
into the Failure of Darlington NGS Unit 2
Fuel Bundle End Plates

E.G. Price
AECL CANDU
2251 Speakman Drive
Mississauga, Ontario L5K 1B2
Canada

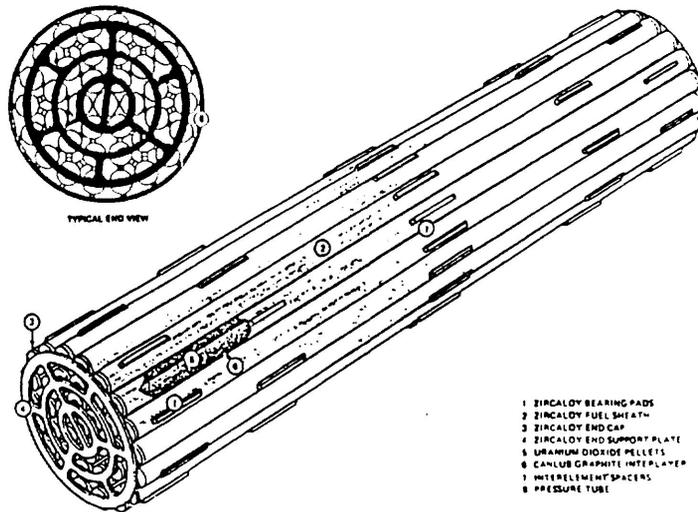
Figure 2: Darlington Fuel Bundle

A typical Darlington fuel bundle is shown in Figure 2. This bundle design flat shoulders on the end caps to accommodate the outlet end holding latch and a staggered bearing pad arrangement on alternate outer elements. The element end caps are welded to the end plate in a slightly non-symmetrical pattern which differs from manufacturer to manufacturer.
