New Brunswick Power Point Lepreau Generating Station

Information Report

Events Leading To Foreign Material Being Left in the Primary Heat Transport System

IR-33100-15 Rev. 0

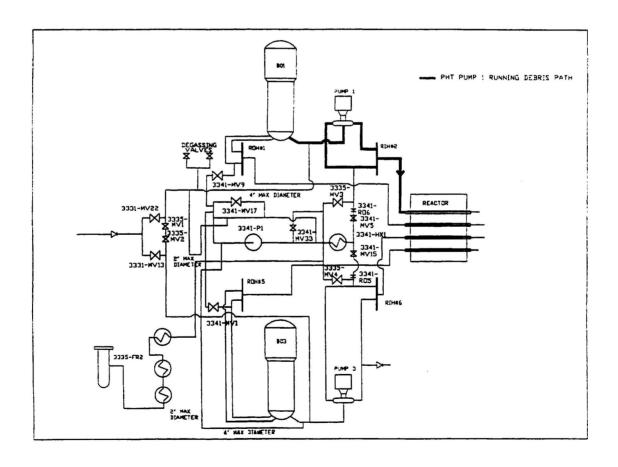
Figure 5 Modified Cover

The debris found in the impeller of PHT Pump 1 (P1), and within other areas of the PHT system, was determined to be from a modified wooden cover used in the cold leg nozzle during maintenance of Boiler B01. A sketch of the modified cover (the cover involved in this incident) is shown in Figure 5. The purpose of this cover was to provide temporary closure of the cold leg nozzle of the boilers. It had been used sequentially in all of the boilers during the performance of maintenance activities.
