LESSONS LEARNED FROM TUBES PULLED FROM FRENCH STEAM GENERATORS

Ph. BERGE, J.M. BOURSIER, D. DALLERY, F. de KEROULAS, Y. ROUILLON
Electricité de France
Generating and Transmission Division

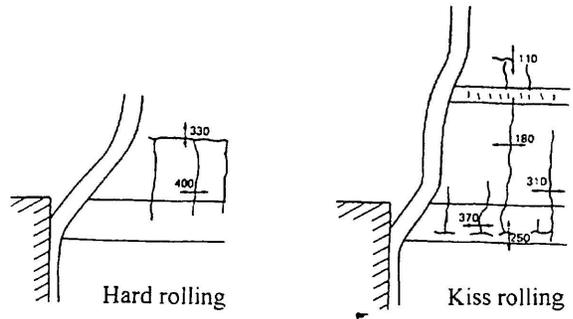
Generally, the longitudinal cracks are located in the rolled transition zone between the two expanded regions (Figure 1). In some cases, a very long crack was found propagating in the kiss rolled area. The location of the longitudinal cracks is consistent with the evaluation of the stress level [5-6], which showed a high circumferential stress in the rolled transition zone (Figure 2, Table 1).

Figure 2 : Evaluation of the inner stresses

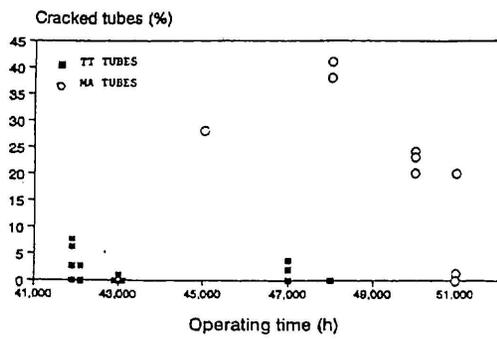
In the field, the behavior of thermally treated Alloy 600 tubes is better than that for mill-annealed tubes (Figure 5) [18], although the improvement depends markedly on the carbon content [12]. The beneficial effect of this heat treatment is extremely clear for material without cold work, with a carbon content lower than 0.033 %.

Figure 5 : Comparison of PWSCC rate on Alloy 600 MA and TT versus operating time.

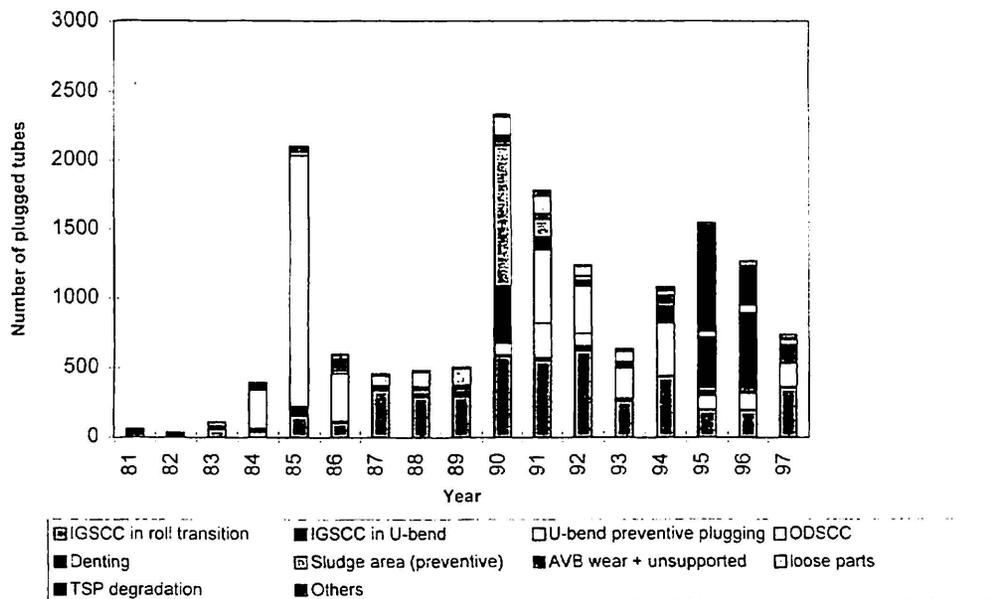
Figure 9 summarizes the total number of plugged tubes per year for 900 MWe nuclear power plants, for each type of degradation. Firstly, it can be seen that, since 1990, the number of plugged tubes has decreased year after year. Secondly, the number of preventive plugging operations (AVB unsupported, TSP degradation) is still large and represents in 1996 more than 65% of the total number of plugged tubes. Thirdly, by the fall of 1997, the PWSCC plug tube amount is higher than the secondary side plug tube amount. The main reason is preventive plugging operations concerning primary side degradation.

Figure 9 : Number of plugged tubes per year on french 900 MWe steam generators.

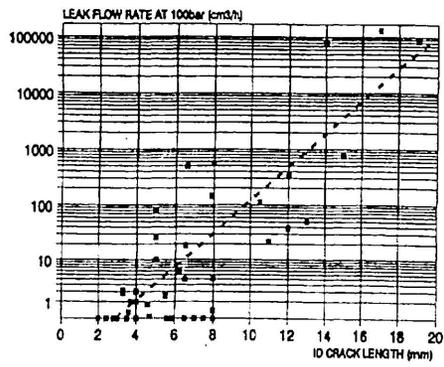
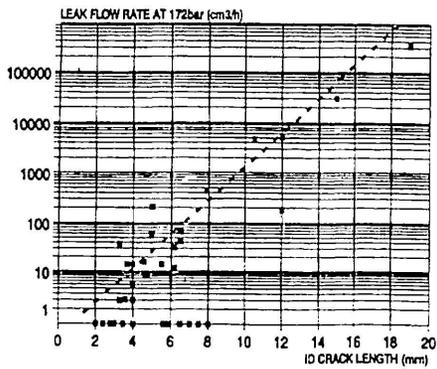
The variation of the leak flow rate at 100 and 172 bar with the extent of *internal longitudinal stress corrosion cracking located in the rolled transition area* is given in Figure 10. Although we have to be very prudent when considering the following assessment, we observe that the leak rates measured on the pulled tubes appear greatly overestimated when compared to the end-of-life primary to secondary leaks in steam generators. In order to explain this behavior, the following hypotheses seem the most plausible:

Figure 10 : Evolution of the leak flow rate at
 a) 100 bar
 b) 172 bar
 versus the length of the longitudinal inner corrosion cracks.

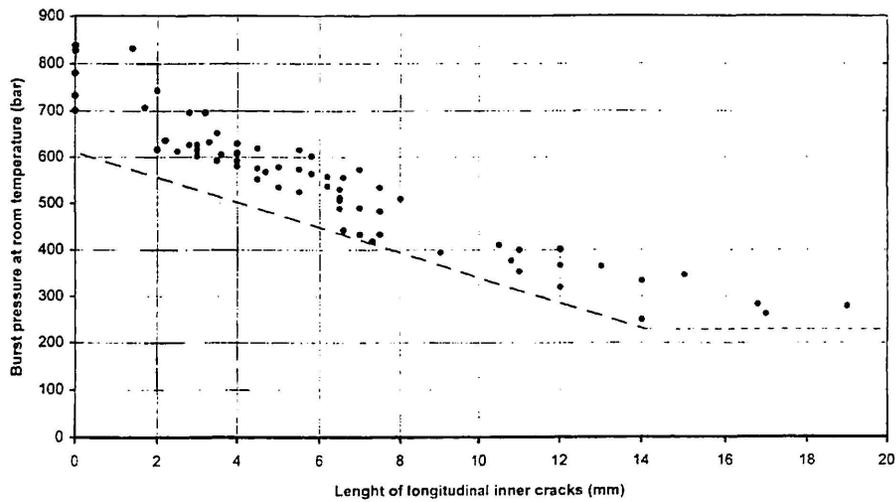
Although tests were performed with *longitudinal internal cracks* much longer than those defined in the plugging criteria (up to 19 mm), no burst pressures less than 250 bar have been measured (Figure 11).

Figure 11 : Relation between the burst pressure at room temperature and the length of longitudinal inner corrosion cracks on pulled tubes.

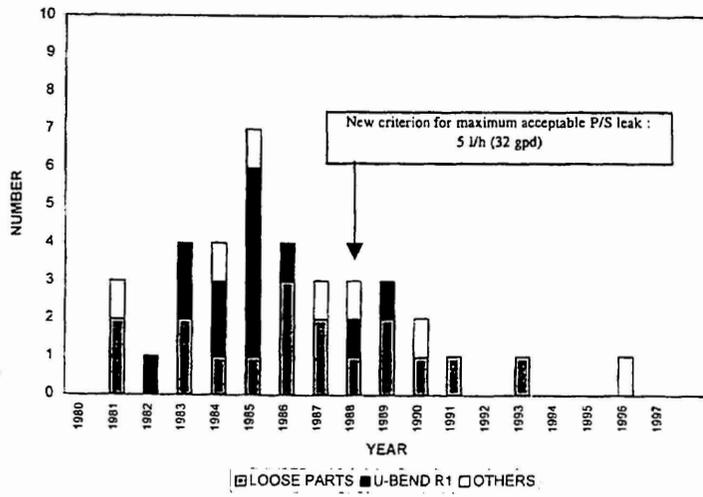
- on the forced outages (Figure 12),
- on maintenance costs.

Figure 12 : Number of forced outages due to Primary to Secondary leak per year.
