POST-IRRADIATION EXAMINATION RESULTS FROM THE BTF-105A LOCA/LOECC TEST

VALLIANT, P.J., IRISH, J.D. and CRAIG, S.T.

Fuel Safety Branch
Reactor Safety Division
AECL, Chalk River Laboratories
Chalk River, Ontario, CANADA K0J 1J0

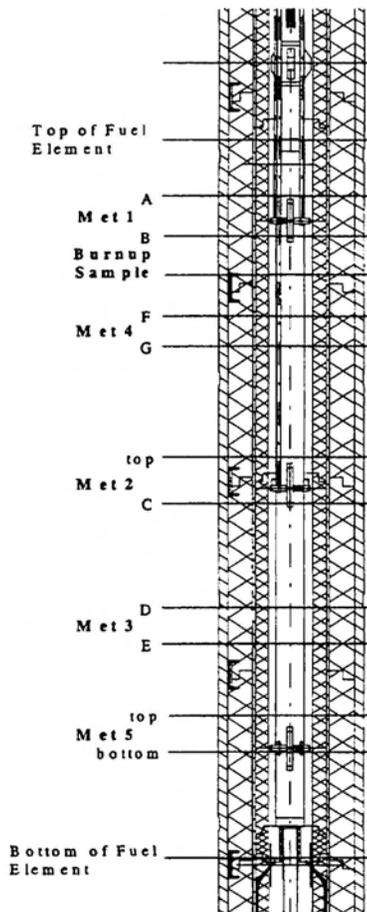
Figure 7: BTF-105A Post-Irradiation Examination Sections

The fuel element and the NILCRA liner and Zircaloy tube of the thermal shroud were cast in epoxy. Transverse sections were taken at 5 elevations over the length of the fuel element, and the sections were examined metallographically (Figure 7). At each cross-section elevation, fuel-sheath-oxide thicknesses were measured along with UO_2 grain size at the centre, mid radius and periphery of the fuel (Table 1). The UO_2 grain size has remained relatively unchanged from as fabricated due to the low temperature (fuel-centreline temperature $\sim 1400^\circ C$) during the 10-day irradiation in pressurized water and due to the short time that the fuel element was at high temperature during the transient. Sheath oxidation ranged from minimal at the top of the fuel element (Figure 8) to through-wall oxidation over the whole bottom half of the fuel element (Figure 9). The UO_2 fuel was heavily cracked throughout the fuel element with fuel relocation in the lower elevations. Figure 10 illustrates the totally oxidized sheath at the lower element elevation. The lower bearing pad (Figure 11) shows the extent of oxidation and sheath transformation. Near the end of the transient, liquid water passed through the test section. At this time the temperature indicated by TFS03 dropped $1200^\circ C$ in 10 seconds. The thermal shock from this quench resulted in a shattered appearance of the fuel, sheathing and NILCRA insulation at the lower elevations (Figure 9). It has been hypothesized [2] that this quench contributed to fuel sheath failure. Metallography at various elevations showed the rhenium clad thermocouples remained intact, confirming that they survived the transient in reasonable mechanical condition. Figure 8 shows the fuel-centreline thermocouple, TFC01, and external sheath thermocouples, TFS01 and TFS02, from the upper bearing pad location. They appear to be mechanically sound with no apparent sign of damage. TFS03, seen in Figure 9, remains intact and is surrounded by relocated fuel sheathing and UO_2 fuel. The good performance of thermocouples TFS02 and TFS03 [1] attached with Zircaloy clamps, together with the good mechanical condition of the thermocouples as indicated by PIE, showed that thermocouples of this type and the method of attachment should be used for future BTF tests.
