# PRIMARY SEPARATOR REPLACEMENT FOR BRUCE UNIT 8 STEAM GENERATORS

## ABSTRACT

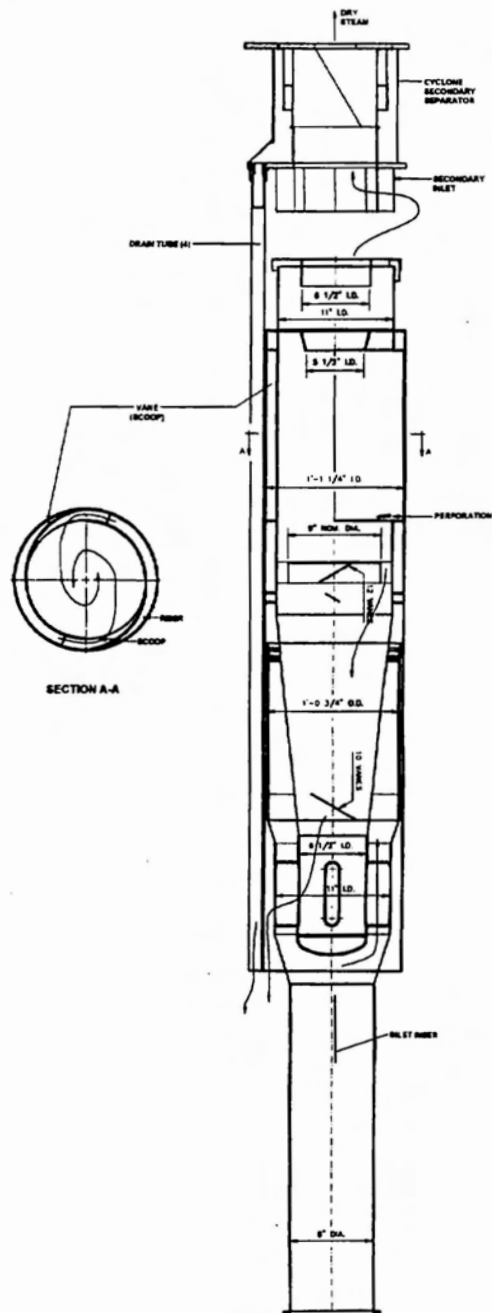
FIGURE 1:  
Bruce 'B' Steam Drum  
Arrangement

The steam generators at Bruce B are of the vertical U-tube type with integral steam drums (Figure 1). Each steam generator incorporates 4,200 U-tubes of Alloy 600 (1/2"). Fifty-six sets of steam separators are located in the steam drum. The separator sets incorporate GXP type centrifugal primary steam separators and the corresponding number of secondary cyclone separators (Figure 2). These relatively small steam separators are designed to allow full scale performance testing of each primary/ secondary separator set at full prototypic conditions of steam flow, water flow, pressure etc.

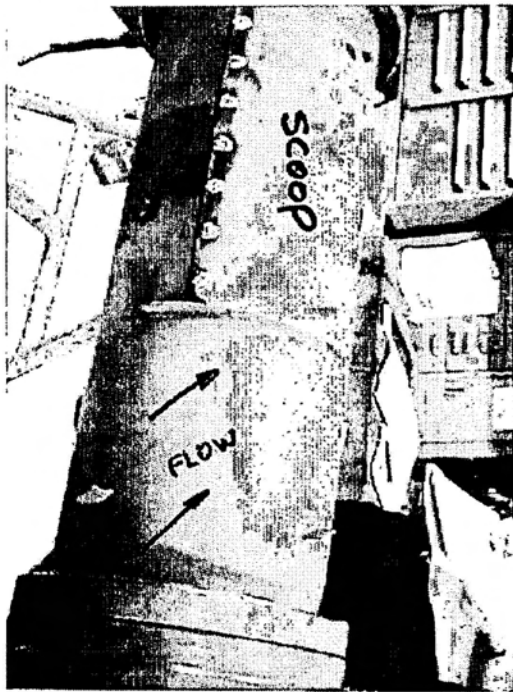
Figure 3  
GXP Separator— Outer Can Removed to Show Inner Flow Scoop.

The degradation was first noticed in the removable primary separators on BO 3 and BO 8 of Unit 8. Erosion damage was observed to be primarily in the outershell and the internal flow baffles in the region where these internal flow baffles or scoops (Figure 3) direct the flow from the annulus into the inner separation chamber. Through wall perforations were found in the outer cans of four of the eight separators (Figures 4 and 6). In situ inspection of the fixed separators confirmed the damage extent to be about 90% and 100% perforation in BO 3 and BO 8 respectively. The secondary separators were not damaged. One separator was disassembled and the outer and inner cans were removed for detailed examination (Figure 4). Metallographic examination, thickness survey and visual inspection were carried out on the removed sections.
