Fuel Experience in QinShan CANDU

Mingjun. Chen

Third Qinshan Nuclear Power Company Ltd,

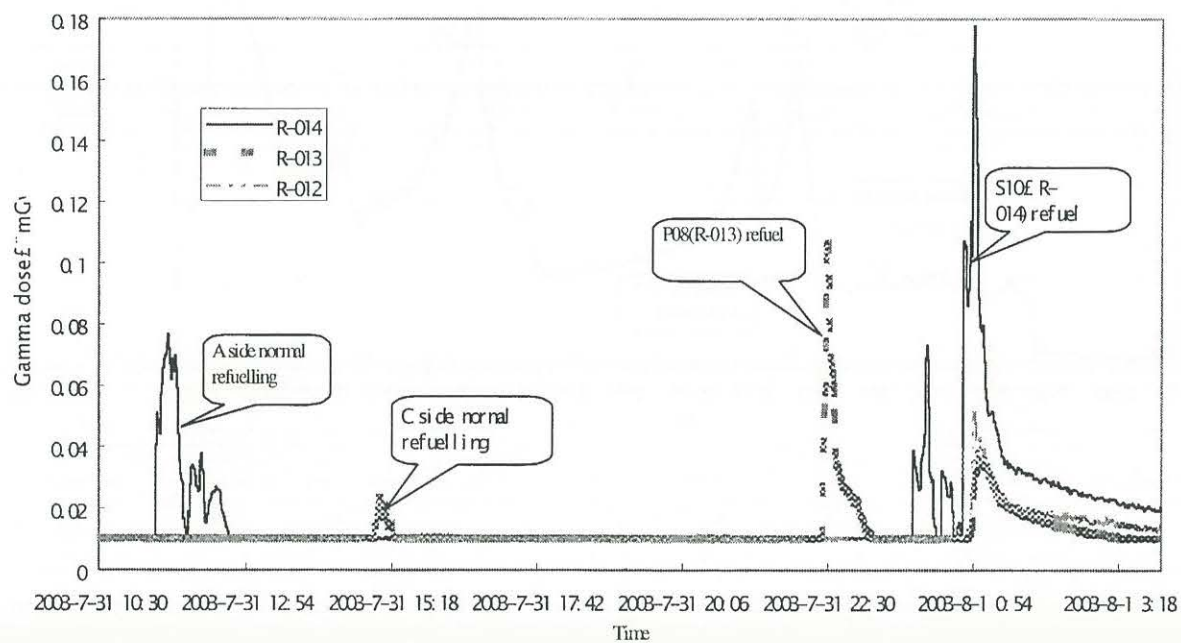
Figure 8

TQNPC successfully located the position of defect bundle by GFP and FFL and Gamma Monitoring System. During refueling, we can easily confirm whether defect fuel has been taken out, based on analysis of history data and trend for GFP and delayed neutron and Gamma dose in R012, R013, R014 and R001 (figure 7,8). During discharging spent fuel in discharge bay room (R001), we monitor Gamma trend in R001 in order to locate which pair of bundle is defective. A few days after spent fuel discharged in R001, further investigation was taken to identify the exact position of defect bundle from the pair of fuel bundles, which have been confirmed defect during discharging. The two bundles have been back transfer (out of and into the water in discharge bay) in order to monitor the Gamma trend in R001. In all the defective fuels bundles, ZPI fabricated three and domestic manufacturer fabricated the others. All fuel defects occurred to the lower power bundles.

Gamma dose monitored in R-012/013/014
