## **EVOLUTION OF MANAGEMENT ACTIVITIES AND PERFORMANCE OF THE POINT LEPREAU STEAM GENERATORS**

**John Slade, Janice Keating,  
NB Power Nuclear  
Tracy Gendron,  
Atomic Energy of Canada Ltd.**

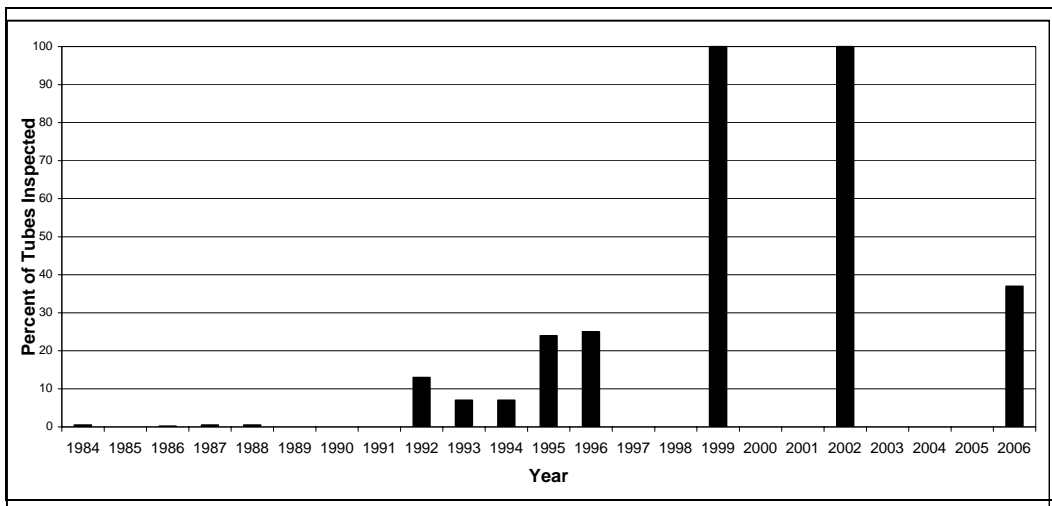
**Figure 5: PLGS Steam Generator Tube Inspection History**

Figure 5 shows history of tube inspections. In response to the tube fretting and localized corrosion observed in the first decade of operation, tube inspection was substantially increased. 100% of tubes were inspected in 1999 and 2002. In 2006, a risk-based inspection program was introduced which focuses on regular inspection of highest risk tubes. These tubes were identified based on an understanding of the steam generator operating conditions and key factors driving degradation, and also from internal and external operating experience. At the same time, a risk-based inspection scope for the internal components was also implemented. As a result, for example, after 2006, inspection of the EWS header will decrease to levels that satisfy the minimum requirements of CSA N285.4-05, whereas inspection of the feedwater box and nozzles is raised in priority in upcoming outages.

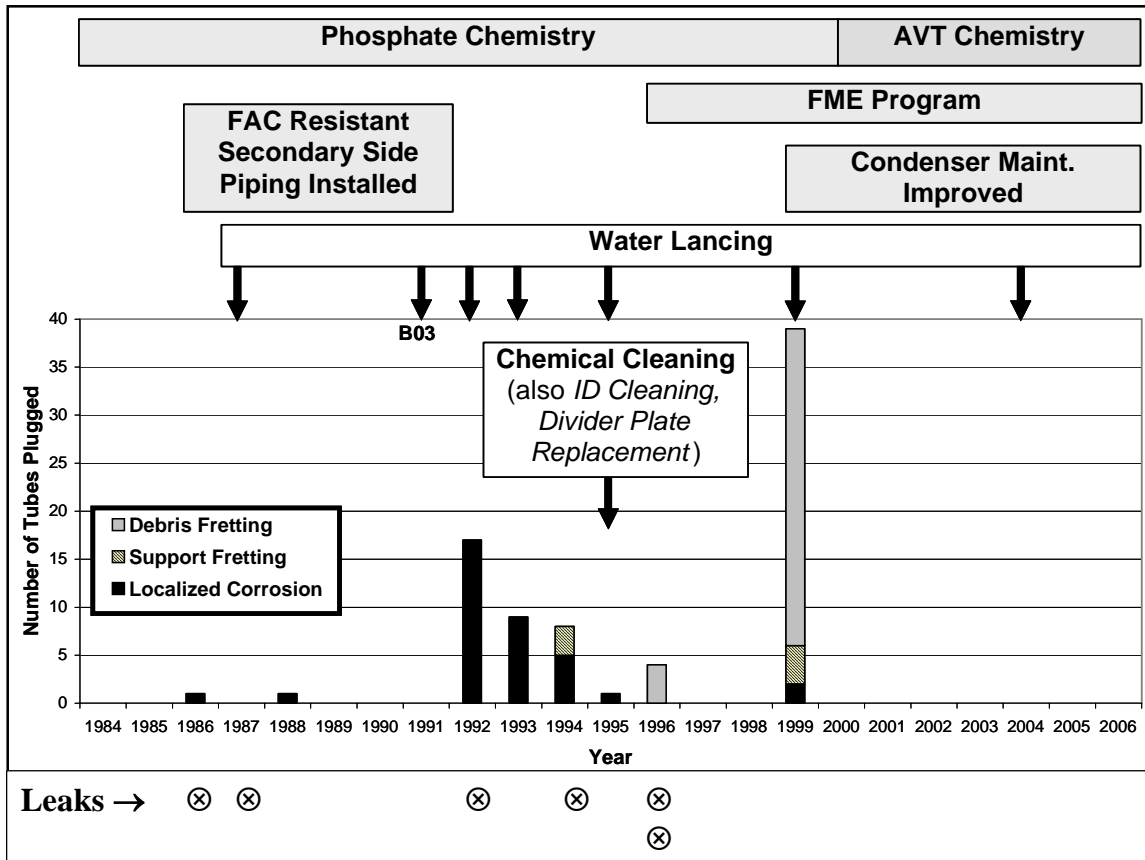
**Figure 7: PLGS Steam Generator Tube Plugging and Management Activity History**

The tube plugging history illustrated in Figure 7 indicates a clear reduction in tube degradation since 1999. Pitting and phosphate-wastage has been practically arrested. There have been no tubes plugged because of localized corrosion since 1999 and eddy current results show for existing defects indicate minimal growth (~1% through-wall per year). This good performance is attributed mainly to the significant reduction in deposit loading since 1995, reductions in impurity ingress to the steam generators by elimination of condenser leaks, and suspension of phosphate chemistry. Condensate polishing and improved blowdown are also believed to contribute.

Following the debris-fret leaks in 1996, the risk associated with debris was reduced by implementing improvements to the steam generator foreign material exclusion program in 1996, by inspecting 100% of tubing in 1999 and plugging those at high risk of debris fretting, implementing a plant wide foreign material exclusion program and a more rigorous secondary side inspection and loose parts/foreign object removal program. Since 1999, there have been no additional tubes plugged because of debris. Figure 6 (right image) illustrates the effectiveness of video inspection to identify locations with foreign material.
