## **MAINTENANCE AND LIFE ASSESSMENT OF STEAM GENERATORS AT EMBALSE NUCLEAR STATION**

**Pablo Luna, Gustavo Díaz, Hugo Sveruga, Ricardo Saínz,  
*Embalse NGS***

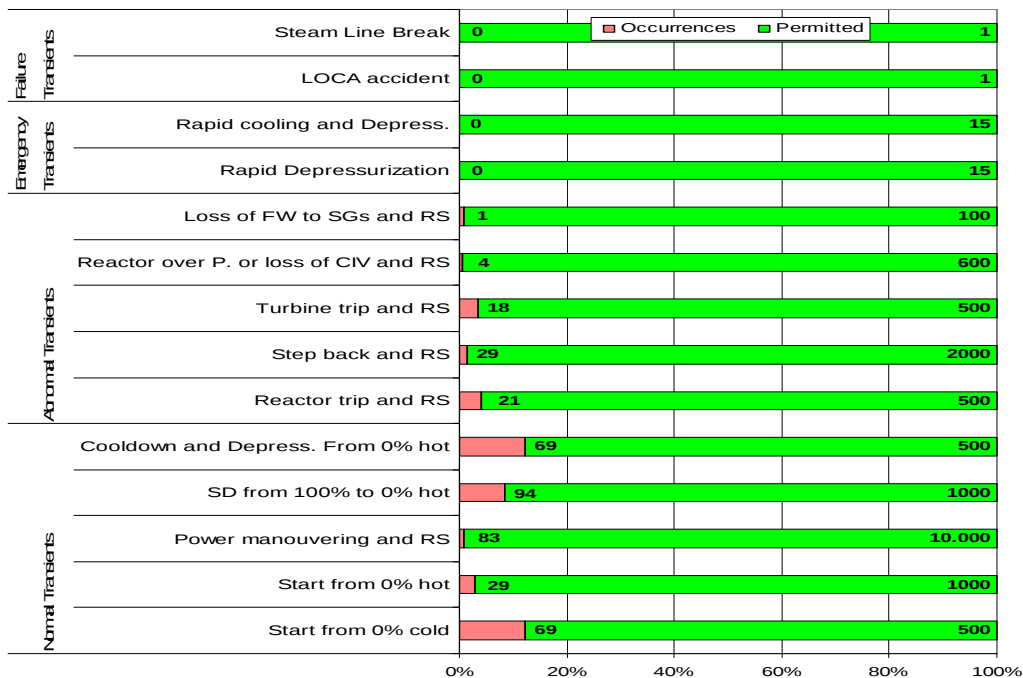
Figure 10: Comparison between the occurred operating transients and the specified permitted transients.

The permitted operating transients is another limit for SG life-extension even design-life attainment. Embalse SGs transients have always been tracked and there is no evidence that this could be a limitation for the extended life operation. Figure 10 shows a comparison between the occurred operating transients and the specified permitted transients.
