## SOME RECENT OBSERVATIONS ON STEAM GENERATOR TUBING DEGRADATION

**Gabriel Ogundele, Malcolm Clark, Guylaine Goszczynski, Amy Lloyd,  
*Kinectrics Inc.*  
Sandra Pagan,  
*Ontario Power Generation*  
Ken Sedman,  
*Bruce Power*  
Peter King,  
*Babcock & Wilcox Canada***

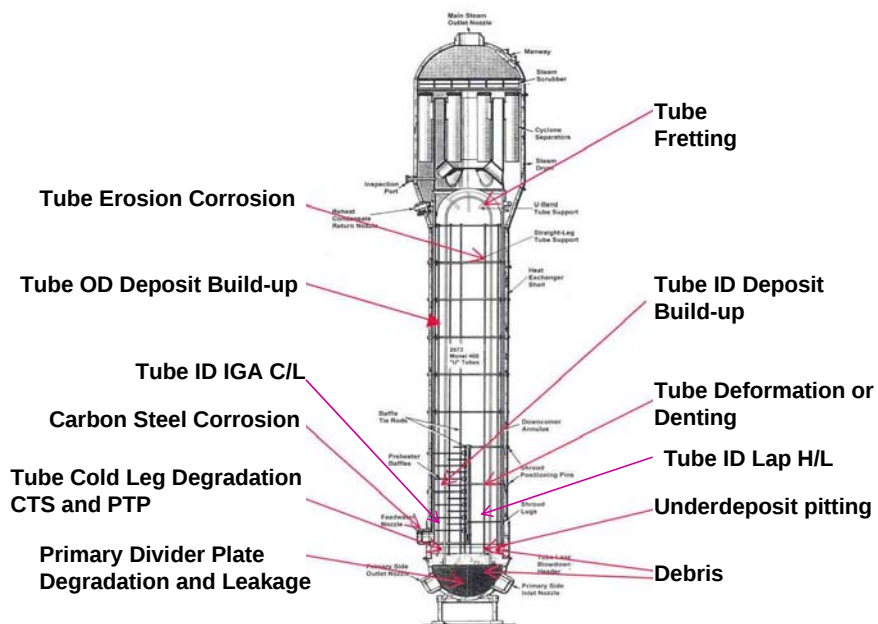
(a) Steam generator design at OPG stations

Figure 1: Locations of degradation mechanisms observed in CANDU Steam Generators
