# CASE STUDIES IN ROOT CAUSE ANALYSIS: IDENTIFYING OPPORTUNITIES FOR IMPROVED MAINTENANCE OF CANDU FUELLING MACHINES

M. SCHIPPKE, K. ELLISON, A. JÄRVINE<sup>1</sup>, and K. PICKLES<sup>2</sup>

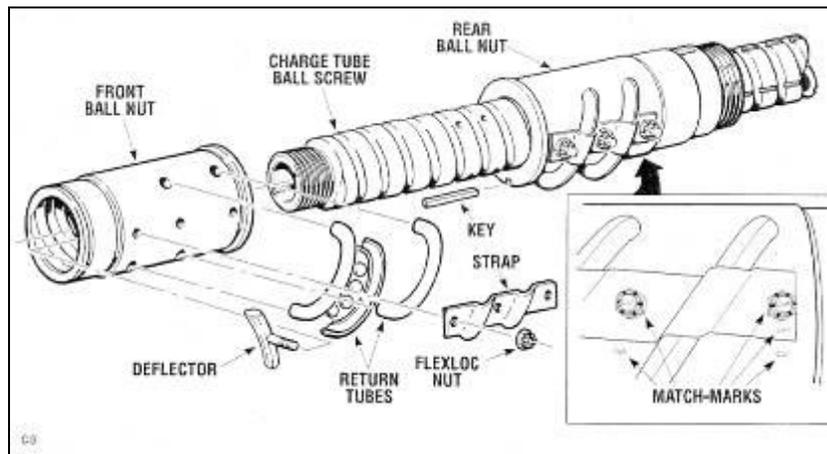
A drawing of the charge tube ball nuts is provided in Figure 2.1. The charge tube ball lead screw and nuts are manufactured from UNS-S45500 stainless steel to ASTM A-750-80 Type XM-16. The cobalt-base balls are investment castings manufactured from Haynes Stellite Star-J alloy. The ball deflectors are manufactured from type 440C high carbon martensitic stainless steel. When assembled, the front and rear ball nuts are separated by a Belleville washer which provides pre-tension on the ball nuts to aid in fine positioning of the charge tube during operation.

Figure 2.1: Drawing of the charge tube ball nuts and related hardware. The inboard (reactor) end is on the left.
