SI – DRESDEN SERVICE WATER ENGINEERING EVALUATIONS AND G-Scan™ INSPECTIONS

George J. Licina
Kenneth R. Rach
Structural Integrity Associates, Inc.
San Jose, CA 95118
glicina@structint.com

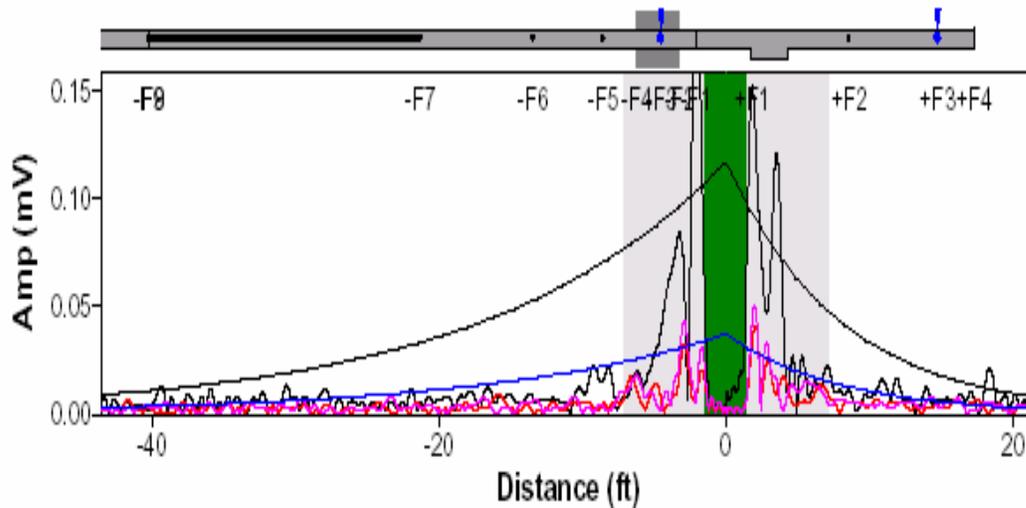
Figure 6. G-Scan Outputs

Feature	Location	ECL	Class	Notes
+F1	19"	-	Y	
+F2	87"	13	Minor	70% Circ. Affected Estimated 19% wall loss
+F3	149"	12	Medium	50% Circ. Affected Estimated 24% wall loss
+F4	173"	-	Flange	
-F1	-2'1"	-	Weld	
-F2	-3'3"	-	Entrance	Concrete Wall starts
-F3	-4'6"	18	Medium	70% Circ. Affected Estimated 25% wall loss
-F4	-6'3"	-	Exit	Concrete Wall ends
-F5	-8'7"	11	Minor	60% Circ. Affected Estimated 18% wall loss
