Assessment of Causes for Degrading Fuel Performance at Darlington NGS

Jonathan Judah (consultant) and Steve Goodchild

Reactor Safety Department, Darlington NGS, Ontario Power Generation

Paper submitted to: 12th International Conference on CANDU Fuel, 15 to 18 September 2013, Kingston Ontario

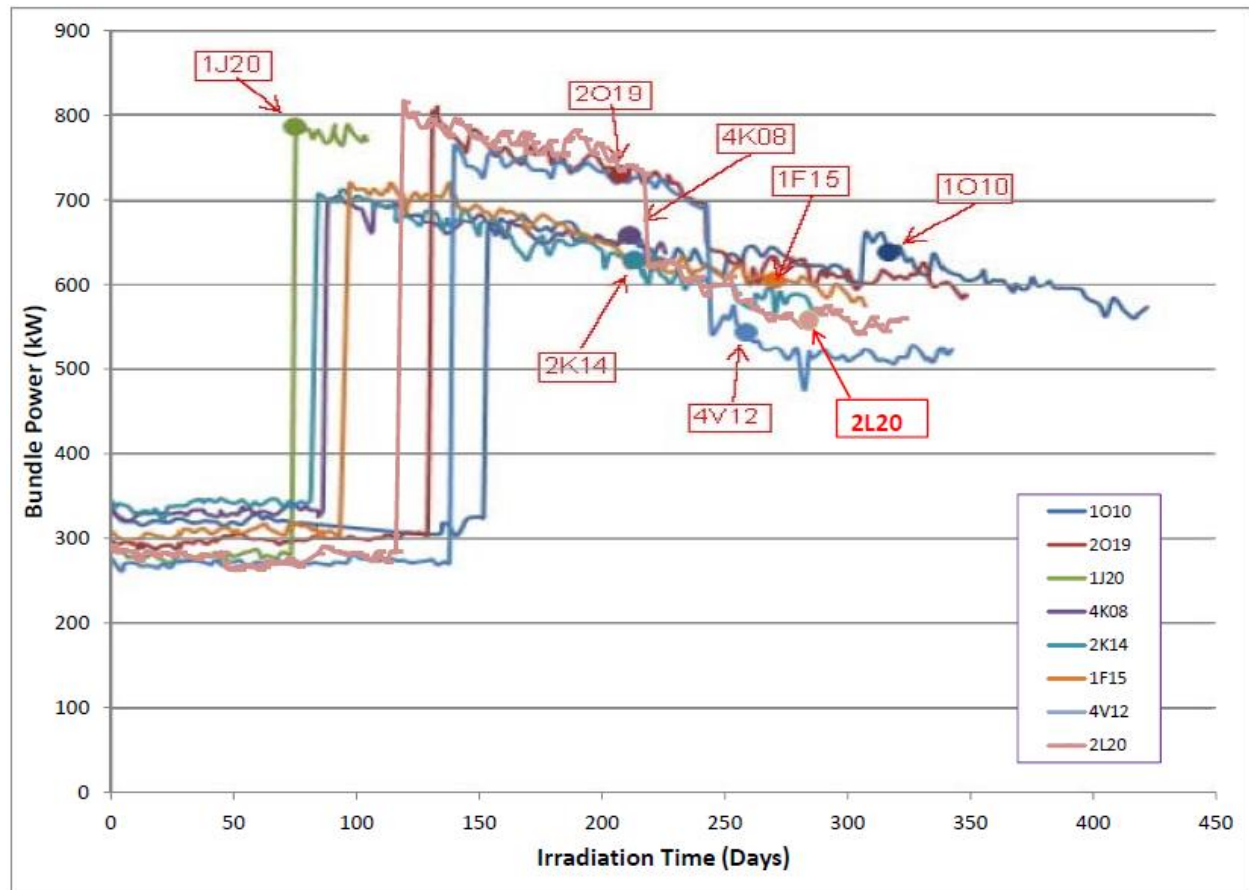
Figure 1: Irradiation histories and post-defect residence times

Irradiation histories are provided in Figure 1. The times of the first defect indications are also provided. Timelines for residence of these bundles in-core in the defected condition are provided in Figure 2.
