## **CRACKING OF 304L STAINLESS STEEL OBSERVED WITHIN CANDU NUCLEAR POWER PLANTS UNDER CYCLIC MOIST ENVIRONMENTS**

**R. G. Allen, G. I. Ogundele, A. C. Lloyd, D. K. Jain, and A. K. Järvine**  
Kinectrics Inc., Ontario, Canada

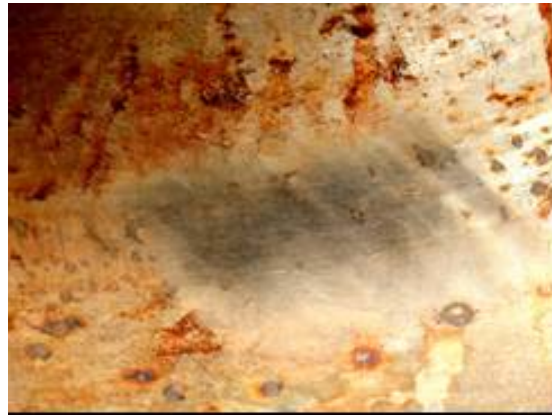
In addition, the inside of one of the 18"Ø relief ducts was inspected and found to be discoloured and contained axial cracks as identified in the field using liquid penetrant inspection (LPI). The inspection revealed that the surfaces of the 18"Ø, schedule 40, 304L stainless steel duct were covered with brownish corrosion products with evidence of a condensation trail through the pipe and evidence of preferential weld corrosion (Figure 3). An array of axial cracks, oriented in the inside diameter of the 18"Ø relief duct directly below the attachment field weld between the shield tank and the outer diameter of the 18"Ø relief duct were visible. The appearance of the inside surface of the duct suggested that a contaminated and/or carbon steel grinding tool may have been used to grind the welds and other areas of the pipe surface during manufacture or installation. The use of carbon steel grinding tools can lead to a large quantity of Fe contamination in these areas, which is well known to cause significant corrosion of austenitic stainless steels.

Figure 3: Photographs illustrating the typical corrosion pattern on the inside surface of the 18"Ø relief duct piping below the flange in the affected unit.

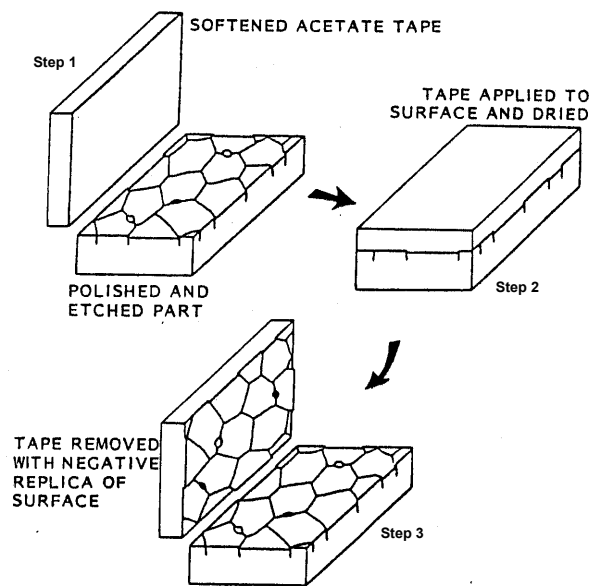
(a) Schematic diagram of the replication process

Figure 5: Replica images of the axial cracks on the inside surface of the 18"  $\varnothing$  relief duct piping; these images were taken on the ID of the 18" duct directly below attachment weld to shield tank wall on the OD of the duct (as shown in Figure 1).
