Hydro-Québec METAR Inspection Bracelet

This paper will present the Gentilly-2 Inspection program targeting outlet feeder pipe thinning caused by FAC. The focus of the paper will be on the METAR inspection bracelet development and qualification process, as well as highlights of the 2000 outage inspection campaign.

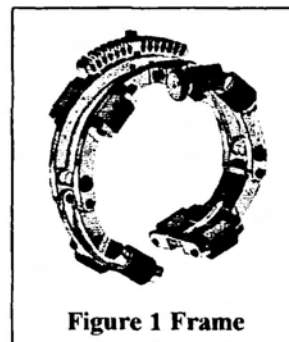
Figure 1 Frame

The frame is the rigid part of the bracelet. It maintains the collar in place and is attached to the feeder. Two different frames were used for the 2 and 2.5-inch

feeders. Each frame has 8 rollers in order to move freely in the longitudinal direction of the feeder while limiting unwanted circumferential displacement. The frame holding the collar and the encoder is installed on the TAR via a ski boot type attachment that permits a very

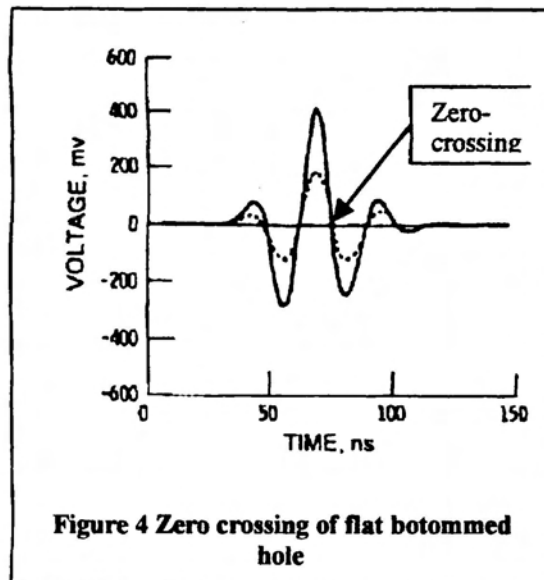
Ultrasonic system for METAR

Conventional ultrasonic flaw detection equipment which displays the waveform in an A-scan is commonly utilized for routine wall thickness measurement. Time-of-flight mea-
