STATUS REPORT ABOUT CANDU TYPE FUEL ACTIVITIES IN ARGENTINA

L. Alvarez ⁽¹⁾, J.A. Casario ⁽²⁾ and C. Moreno ⁽³⁾

ABSTRACT

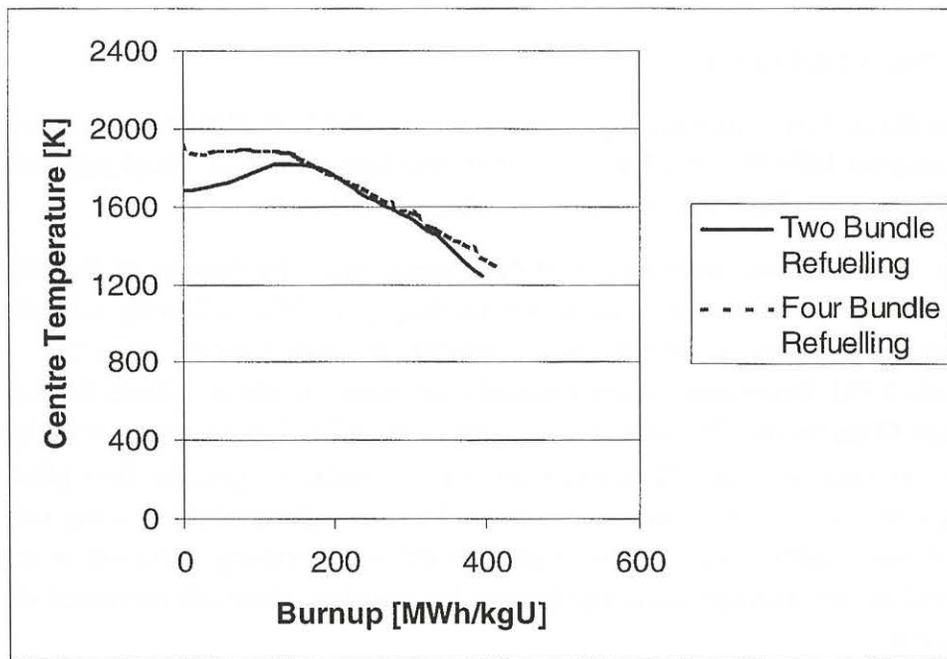
Figure 8: Center temperature calculations

Main parameters analyzed were fuel center temperature, internal gas pressure and cladding strains. Fuel calculations were performed using ELESIM mod.9 and mod.10 codes. These preliminary results are encouraging and allow to predict a very limited impact of the higher burnup on the fuel performance for the current design conditions. As an example Figure 8 shows the evolution of central temperature for both power histories.
