## EXAMINING THE VIABILITY OF ULTRASONIC INSPECTION OF DISCHARGED CANDU<sup>®</sup> FUEL BUNDLES

T.W. Krause<sup>1</sup>, W.H. Huang<sup>2</sup>, and B.J. Lewis<sup>3</sup>

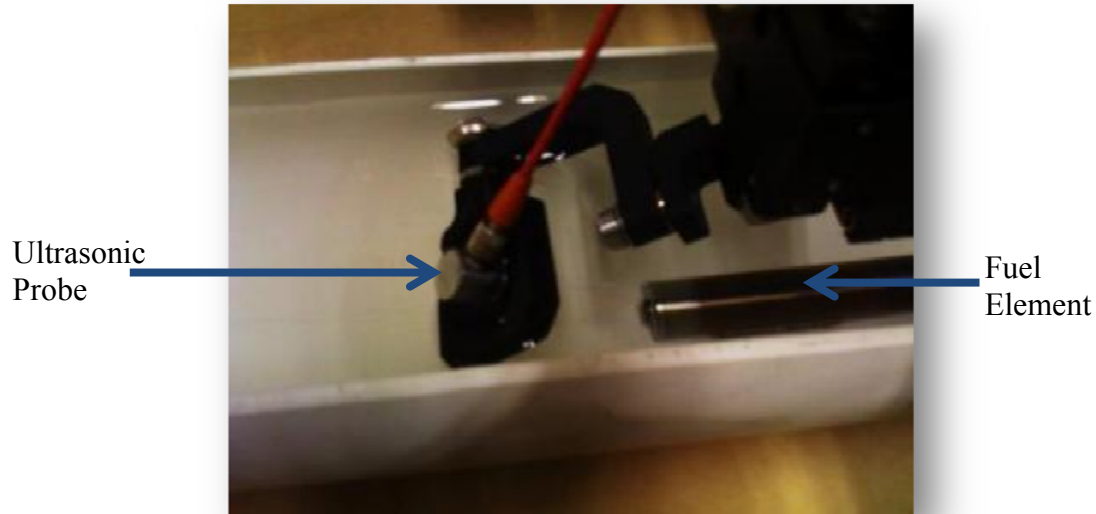
**Figure 3: Inspection Set-up with Ultrasonic Probe Adjusted for Oblique Incidence**

The ultrasonic inspection system (TecScan of Boucherville, Quebec), was composed of three components: (i) X-Y axis actuators, (ii) a system amplifier, and (iii) a processor/display. Figure 3 shows the inspection set-up with the probe adjusted for oblique incidence. During operation, two axis controllers moved the probe, allowing it to traverse and inspect the surface of the specimen. The UT inspection software (TecView), installed on a PC with a Windows operating system, controlled the motion of the two axis actuator system and recorded the calibrated position of the probe. Data was acquired as a single line scan along the fuel element. Measurements were performed at Stern Laboratories, Hamilton.
