# CANDU MAINTENANCE CONFERENCE 1987

## OVERVIEW OF PICKERING NGS UNITS 1 AND 2 RETUBE OUTAGE

K.H. TALBOT AND B.J. MURDOCH

Ontario Hydro, Pickering Nuclear Generating Station  
Pickering, Ontario

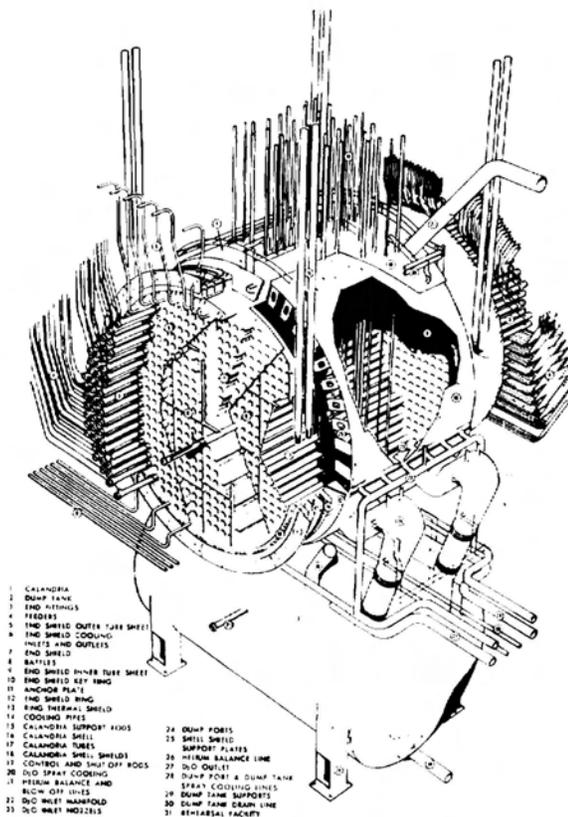
FIGURE 1: CANDU REACTOR ASSEMBLY

Pickering NGS is an 8 x 540 MWe CANDU station situated approximately 30 miles east of Toronto on the shore of Lake Ontario. Unit 1 was placed in service in 1971 and Unit 8 in 1986. Figure 1 shows the schematic of Pickering NGS-A CANDU reactor core. In 1974, the first leakage from a pressure tube resulting in replacement occurred in Pickering Unit 3. Figure 2 shows the Pickering fuel channel assembly. Location and replacement of that single channel consumed over 100 man-rem and took 6 weeks. Subsequent to that failure an additional 16 channels in Unit 3 and 52 in Unit 4 were replaced over the following 2 years. The dose received per channel was gradually reduced to approximately 16 man-rem over the last few replacements. Based on this actual performance, and using the same techniques, replacement of an entire core would consume over 6,000 man-rem and take over 4 years to carry out.

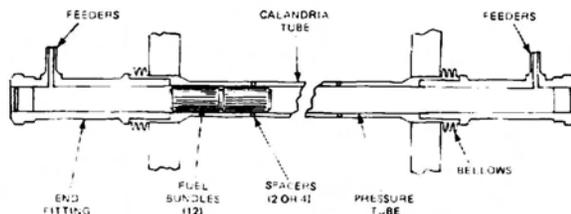
FIGURE 2: FUEL CHANNEL ASSEMBLY

Although the only component which needed to be replaced was the pressure tube, at least one of the steel end fittings (Figure 2) was also removed to gain access to the pressure tube. This a total of 780 end fittings and 780 pressure tubes, all highly radio active weighing a total of approximately 100 metric tons were removed.

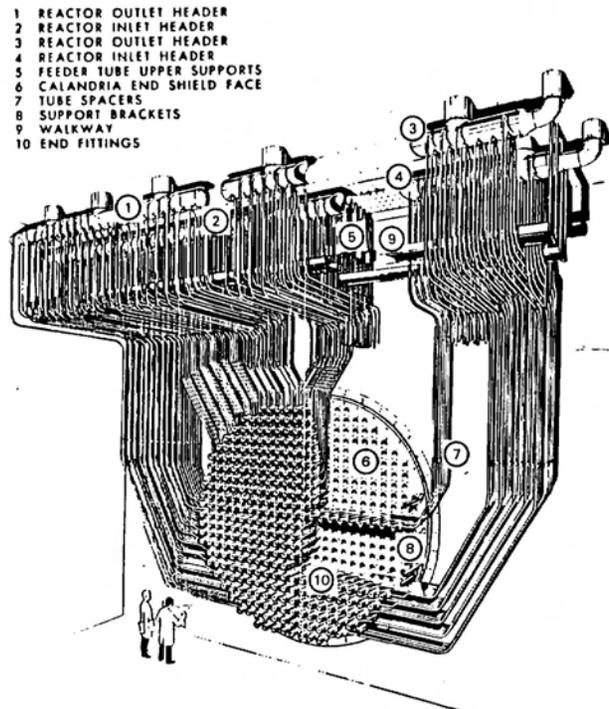
FIGURE 3: FEEDER TUBE ARRANGEMENT

After defuelling the units were drained of D<sub>2</sub>O to the headers (Figure 3). Each fuel channel was when individually drained via the fuelling machines. The heat transport system was then refilled with light water, flushed and drained again (2).

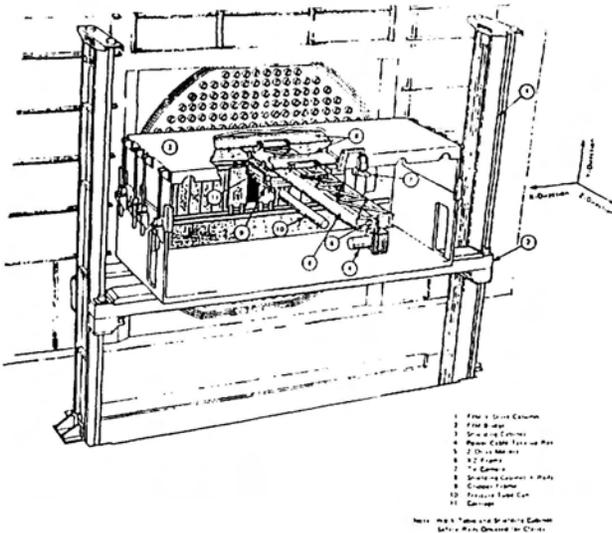
FIGURE 4: RETUBING TOOL CARRIER AT REACTOR FACE

**Equipment Set-up.** A key feature in establishing a suitable working environment was the 35 metric ton shielding cabinet which was placed on each fuelling machine bridge (Figure 4, 5 and 6). This shielding cabinet was effective in reducing

the radiation fields by a further factor of 10. (6) Within the roof of the shielding cabinet was located either a 1,400 kg capacity hoist, or a retubing tooling carrier (Figure 4). The retubing tooling carrier is a remotely controlled crane with 6 degrees of freedom. A manually operated work table was located on tracks in the floor of the cabinet. The work table provided a 5 degree of freedom platform on which tools were affixed and aligned with each fuel channel.

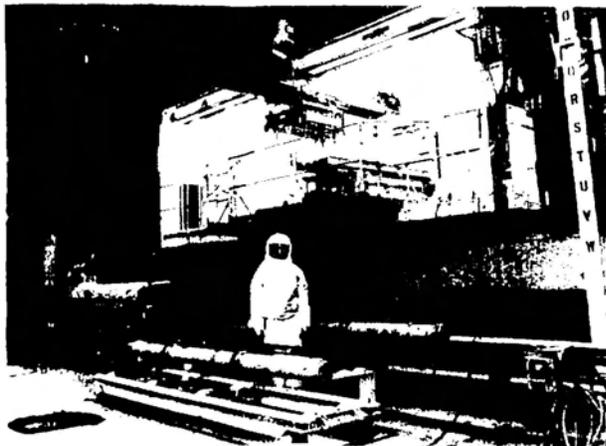
FIGURE 5: PICKERING REACTOR FACE WORK

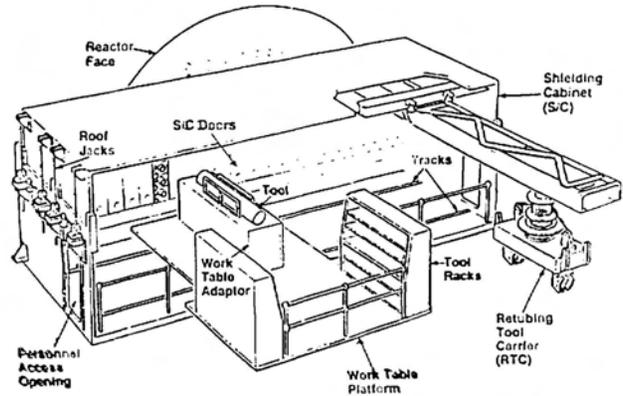
FIGURE 6: SHIELDING CABINET ARRANGEMENT

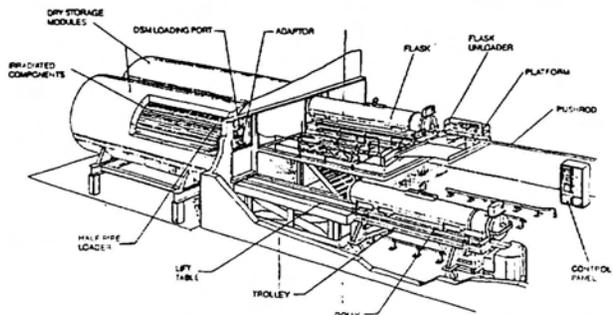
FIGURE 7: ICMS TRANSFER STATION

**Active Component Removal.** Removal of the irradiated end fittings and pressure tubes was accomplished using the remotely controlled retubing tooling carrier (7). The retubing tooling carrier gripped tooling which was attached to the irradiated components while they were still located inside the reactor. Once the vaults were clear of workers, the retubing tooling carrier pulled the component out horizontally and lowered it to the vault floor where it is pushed into an awaiting flask. The flask was then moved through the plant to a transfer area where the irradiated component is pushed into large (175 metric tons) concrete canisters for storage (Figure 7). Eighteen such canisters were required to contain all the components (3). Each canister measured 4 m in diameter and 8 m in length.

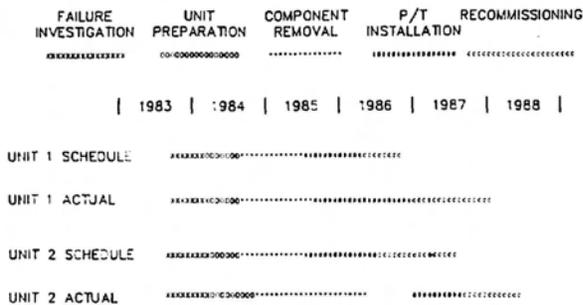
FIGURE 9: PICKERING UNITS 1 AND 2 RETUBING SCHEDULE

The original schedule had Unit 1 returning to service in November 1986 and Unit 2 in February 1987. In actual fact Unit 1 returned to service in October 1987 (11 months late) and Unit 2 is scheduled to be returned to service in May 1988 (13 months late) (Figure 9).
