# INVESTIGATION OF THE ROOT CAUSE OF FLOW DIPS AT PICKERING B

by  
H.W. Hinds  
Atomic Energy of Canada Ltd.  
Chalk River, ONT

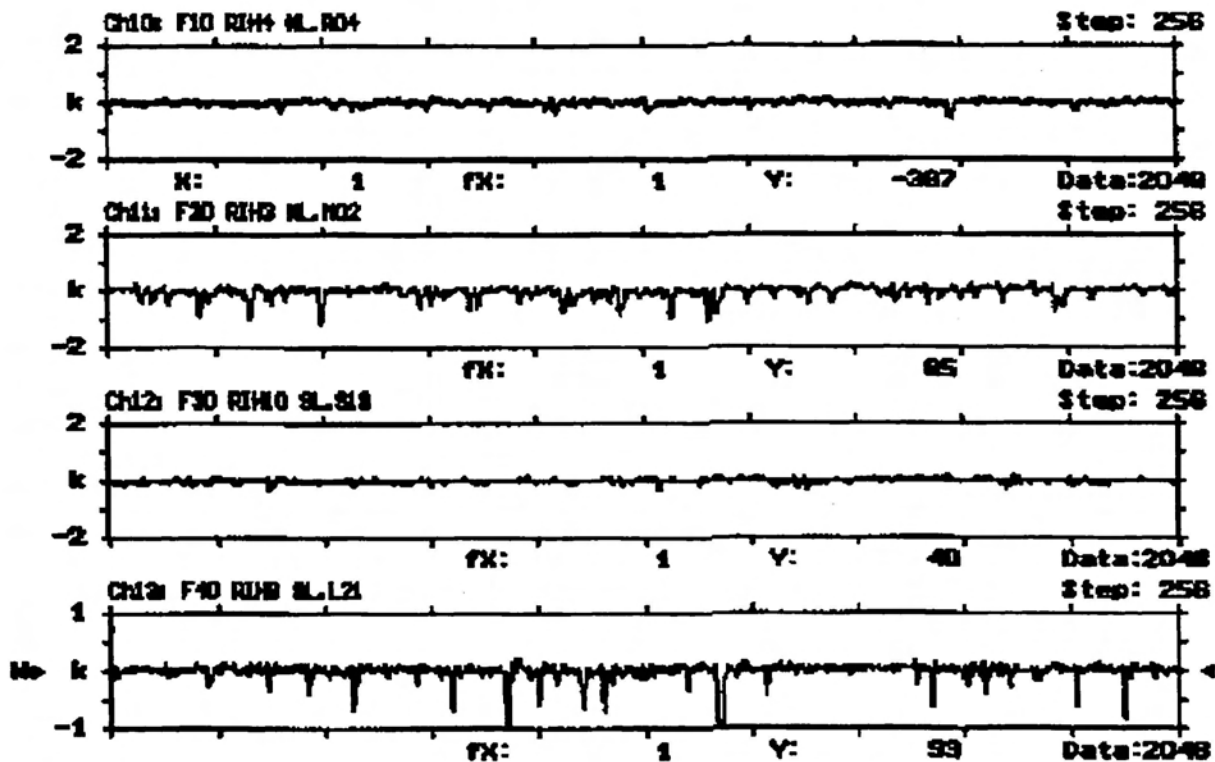
Figure 1 [1, Fig 2.3]: DP transmitter output as a function of time for four DP transmitters in PNGS unit 6. The bottom of each trace is approximately the alarm point. The time axis is 0 to 20.48 s. Flow dips are clearly evident in the second and fourth traces. Two of the flow dips in the fourth trace might have caused low gross flow alarms.

transmitters is shown in Figure 1 [1]. These alarms are caused by the very short (70 ms) but fairly large (up to 22%) drops in measured DP as is evident in the second and fourth traces. This short deep drop in DP is termed a flow dip. If these "flow dips" were a true interruption of flow (and as discussed below, they are not), a 22% drop in DP translates to an 12% drop in flow [2].

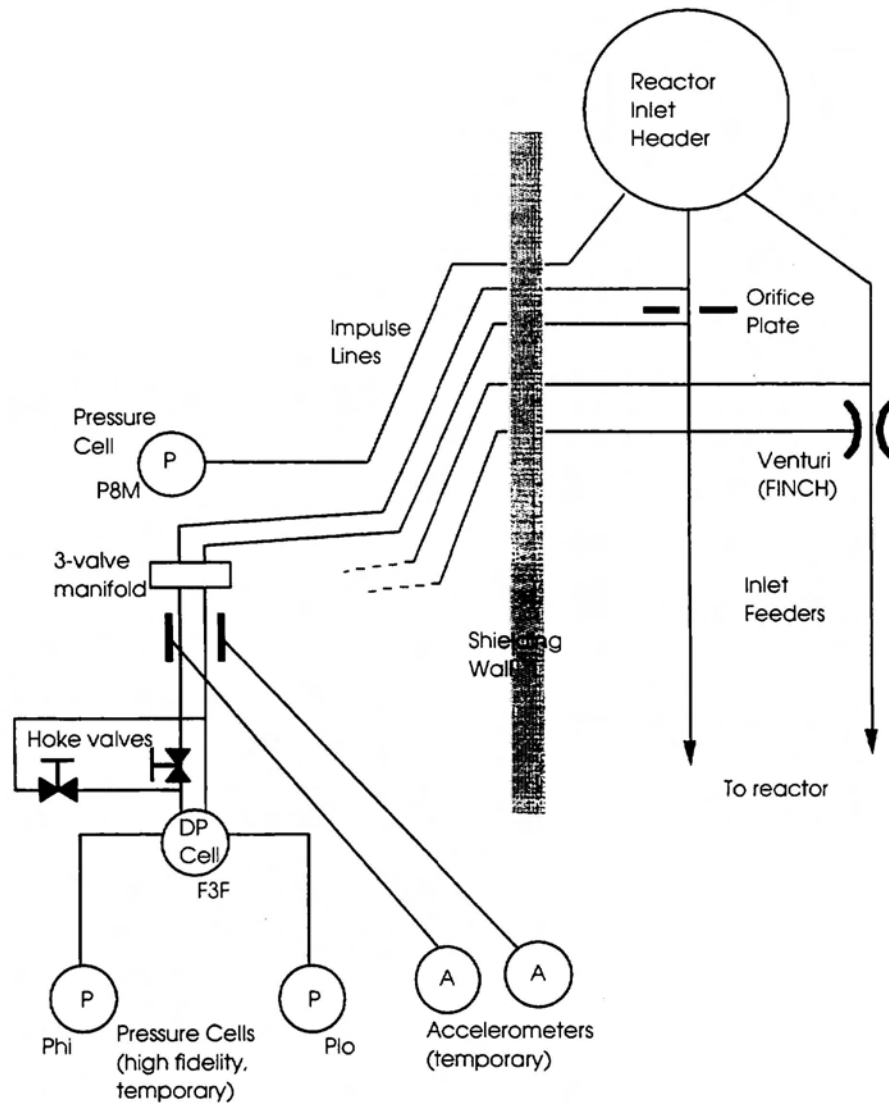
Figure 2: Simplified schematic of a typical DP cell arrangement also showing the location of temporarily-installed pressure cells and accelerometers.

The pressures on the two sides of the F3F and FINCH transmitters (variables 3 through 6) were measured with temporary high-bandwidth piezoelectric sensors, which can withstand high static pressure while having high sensitivity to small pressure changes. They operate as a band-pass filter, with both a low-frequency breakpoint (50 s time constant) and a high-frequency limit (>100 kHz). They were installed using about 250 mm of tubing to the drain holes of the DP cells (Figure 2).

The accelerometers (variables 9 through 16) were temporarily installed by Ontario Hydro Research on the impulse lines a few feet from the DP cells (Figure 2).

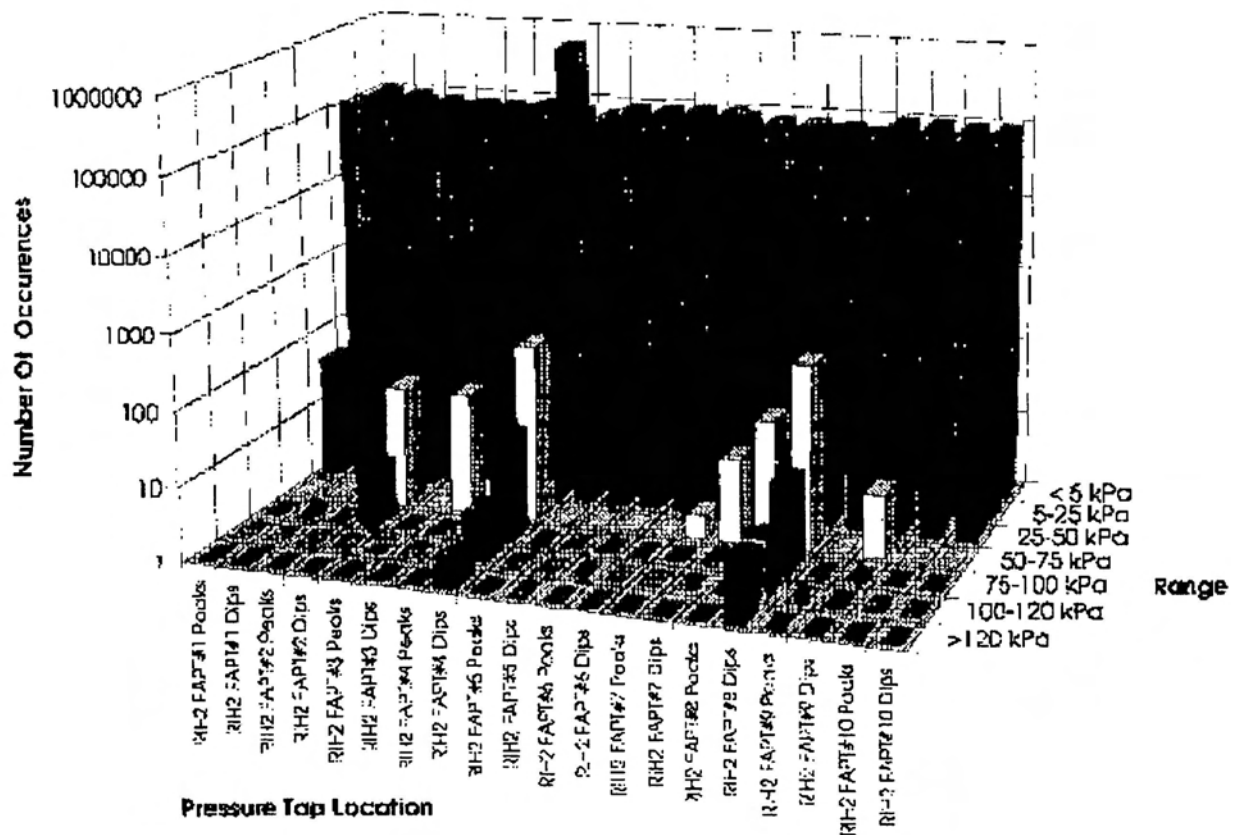
Figure 3 [11, Fig 2.2.2]: Histogram of pressure peaks and dips in a 400 second sample as a function of peak/dip amplitude and location along the header

In particular, large pressure dips (and also some pressure peaks) at certain locations in the inlet headers were found (Figure 3). The dips were considerably larger ( $>120$  kPa) near the inlet turrets than at other locations; the pressure noise at other locations in the inlet headers was found to be generally less than 50 kPa peak. Thus, there are large pressure dips at certain locations in the inlet headers that do not occur at other locations, even within the same header. Randomly-spaced pressure pulses (e.g., 120 kPa amplitude) were also found to be travelling down feeder R13 at acoustic velocity; these pressure pulses start with a negative-going cycle.

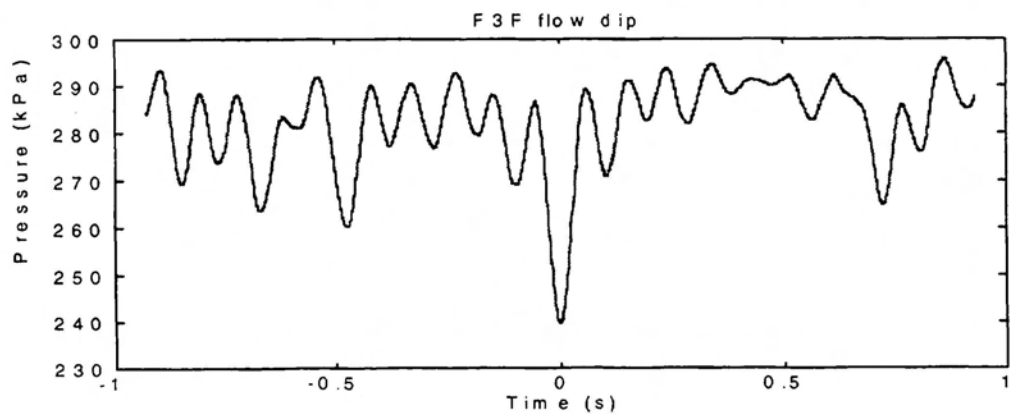
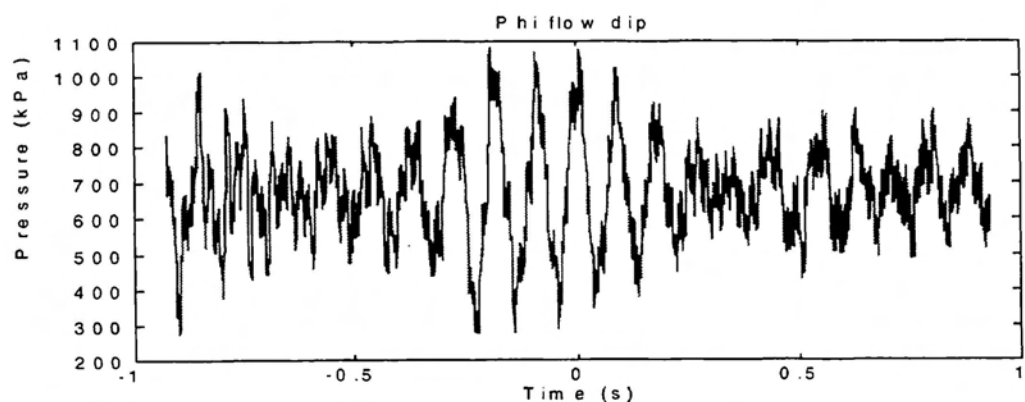
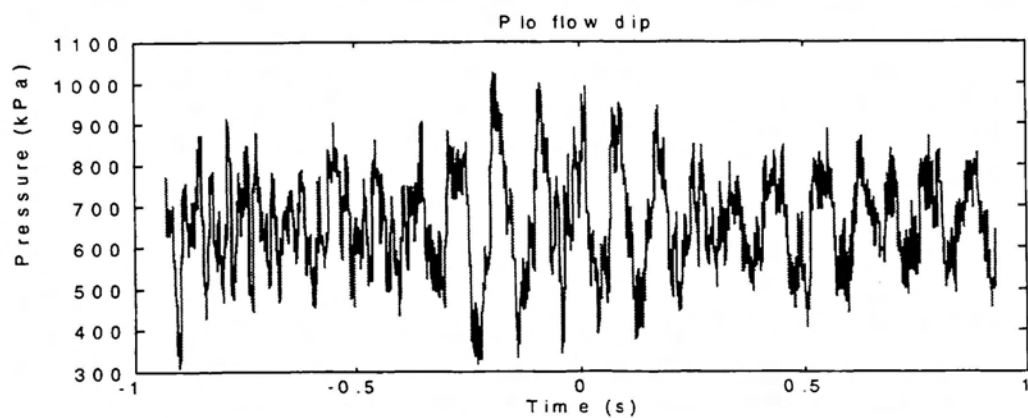
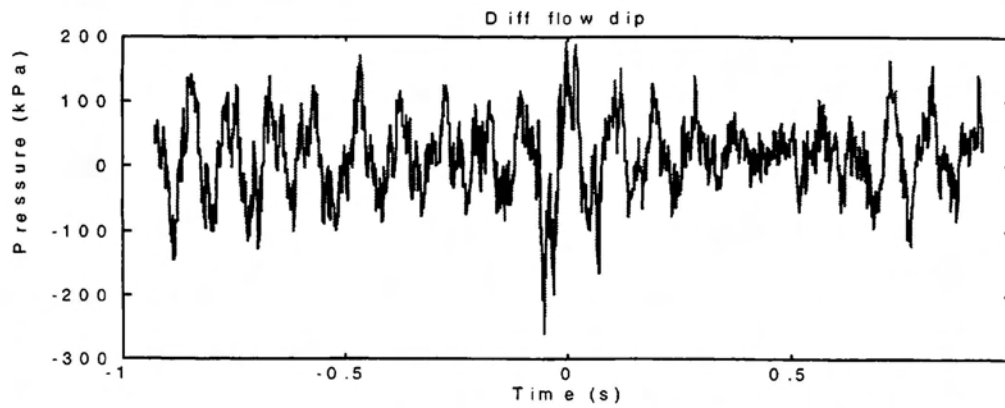
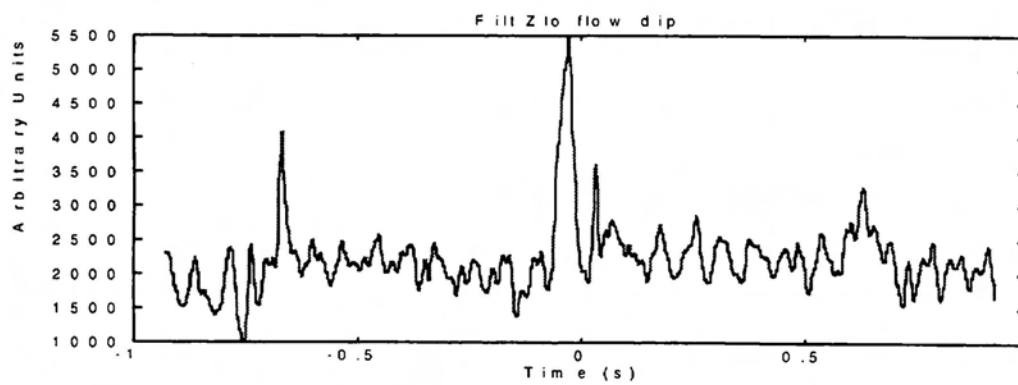
Figure 4a: Plot of F3F, the output of the standard PNGS B DP cell, near a flow dip.

Figure 4b: Plot of Phi, the high-fidelity pressure on the high side of F3F, near a flow dip.

Figure 4c: Plot of Plo, the high-fidelity pressure on the low side of F3F, near a flow dip.

Figure 4d: Plot of Diff (=  $\Phi_i - P_{lo}$ ) near a flow dip.

Figure 4e: Plot of FiltZlo, the envelope of the Zlo accelerometer response, near a flow dip.

Figure 4 shows plots of several key variables on an expanded scale about a typical flow dip. The dip in the output of F3F, the standard PNGS B DP cell, is about -50 kPa (Figure 4a). The corresponding Diff signal has a minimum of about -250 kPa, which implies that the actual pressure difference across the DP cell is nearly zero (Figure 4d). The largest dip discovered to date was -500 kPa in Diff, which implies that the pressure difference across the DP cell was actually significantly negative (i.e., reversed from normal). The dip in the output of F3F (Figure 4a) occurs somewhat later than the corresponding dip in Diff (Figure 4d); in fact, the two signals appear to be almost out of phase. These features are both due to the low-pass filtering action of the F3F transmitter. The Phi and Plo signals from the temporary high-fidelity pressure cells both show a lot of noise, up to 800 kPa peak-to-peak (Figures 4b and 4c). The patterns for the accelerometer signals Xhi and Zhi, which are practically identical to each other, do not exhibit any consistently obvious features near the flow dips, while those for Xlo and Zlo, which are also practically identical to each other, appear to have a burst of activity at about the same time as the flow dips (Figure 4e); this mechanical motion activity has been shown to be of high frequency (>250 Hz).

When looking at a large set of individual dips, it is difficult to distinguish those features that are common and significant from those that are just "noise" (see Figures 4b and 4c). This is especially true in this case, as the noise appears to be at least as large as some of the dip features.

Note that the ensemble-averaged dip in F3F (Figure 7a) is more pronounced than a single dip (Figure 4a). The Phi and Plo signals (Figure 7b) both have sudden increases in their 10 Hz signal to an amplitude of about  $\pm 100$  kPa, at  $t = -0.25$  s (i.e., just prior to the flow dip), starting with a negative-going cycle. This increased amplitude of Phi decays in about seven cycles back to the background level. The Plo signal is similar to that of Phi most of the time. However, the increase in the 10 Hz signal for Plo **lasts only two cycles**, and then it drops suddenly back to the background level.

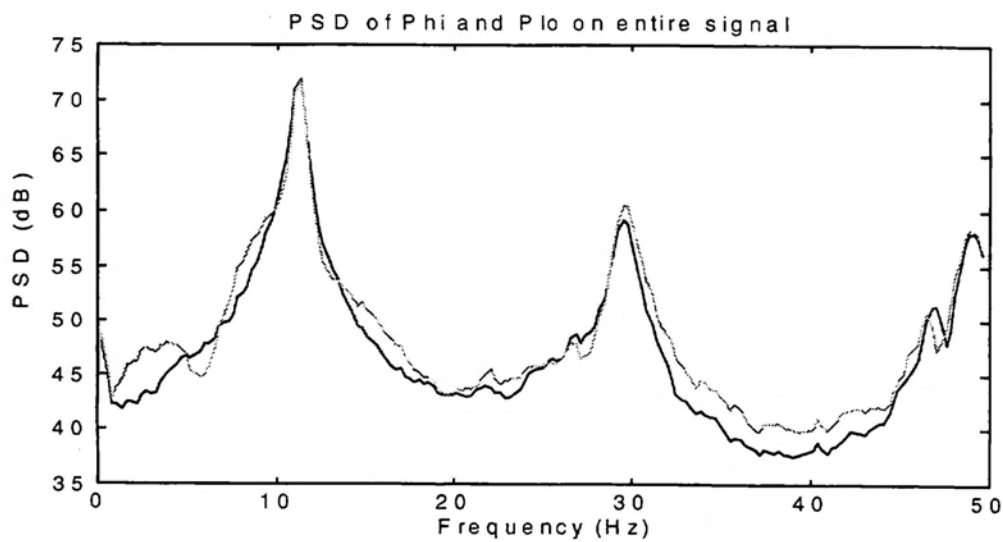
Figure 5: PSDs of  $\Phi_i$  (black line) and  $P_{lo}$  (grey line).

Power spectral densities (PSDs) were found for each signal and those for Phi and Plo are shown in Figure 5 over the first 50 Hz. There are large peaks at 10, 30, 50 Hz, etc. in all pressure signals. These expected peaks are due to the hydraulic-acoustic resonances of the impulse lines based on their lengths and the velocity of sound in water. The small dip in the Plo PSD at 6 Hz was not expected; it is a consequence of the Plo/Phi transfer function discussed below.

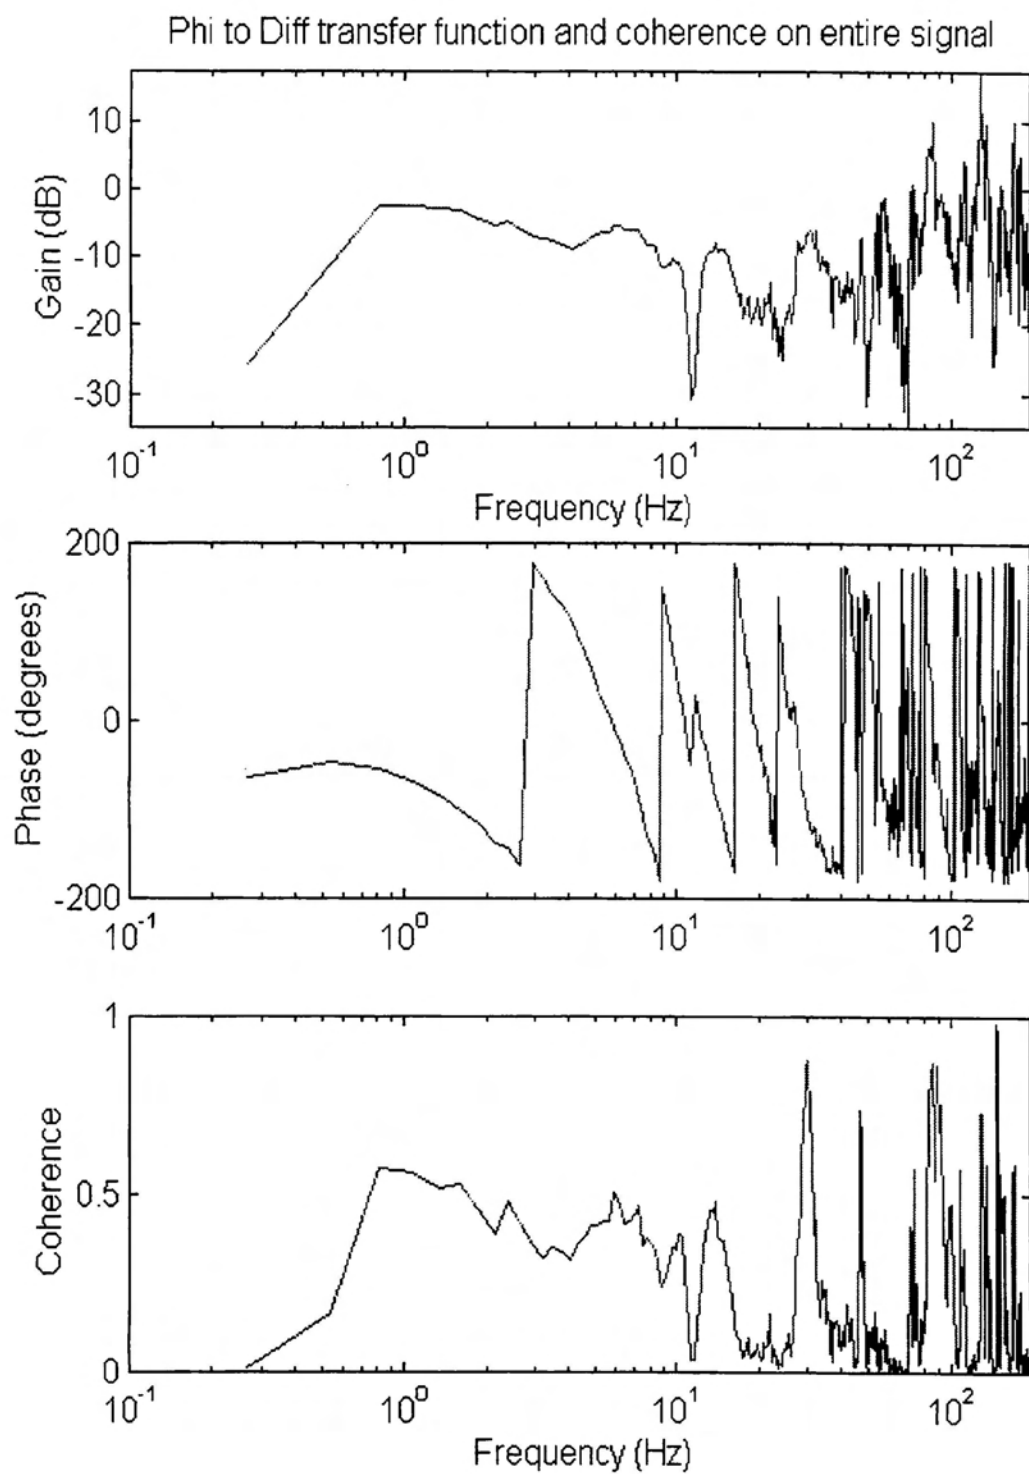
Figure 6: Phi to Diff transfer function.

Transfer functions and coherence functions were calculated for several input-output combinations. The transfer function relating Phi and Diff (Figure 6) can be approximated by equation (2):

The Phi-to-Plo transfer function implies that the pressure disturbances initially hit both Phi and Plo almost equally, but that they return after 0.18 s, with the opposite sign and slightly reduced gain, to hit Plo only a second time. This creates a dip in the Plo PSD at about 6 Hz. Several possible theories for this behaviour are presented below.

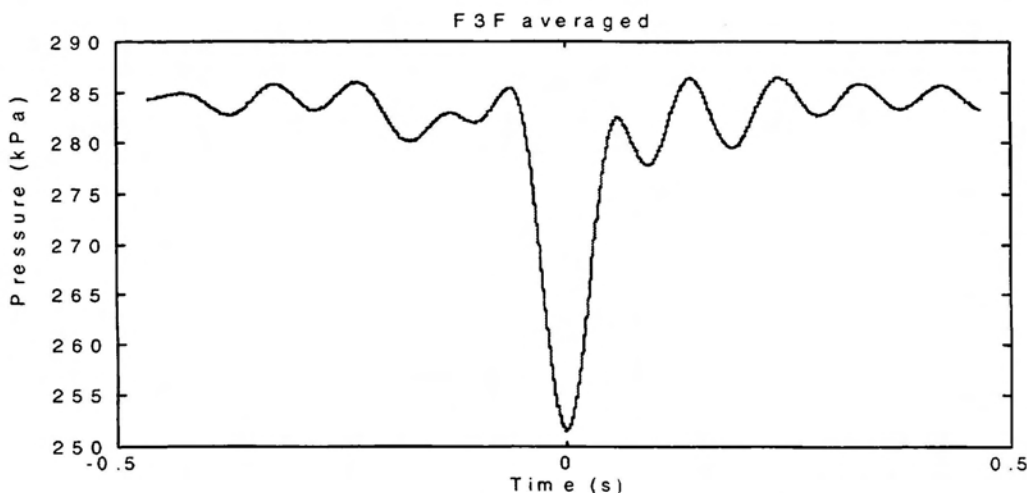
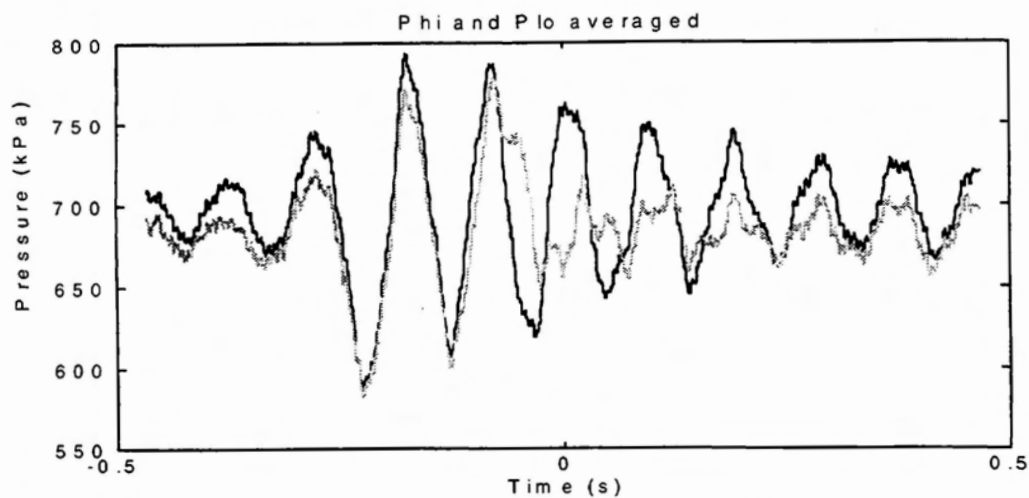
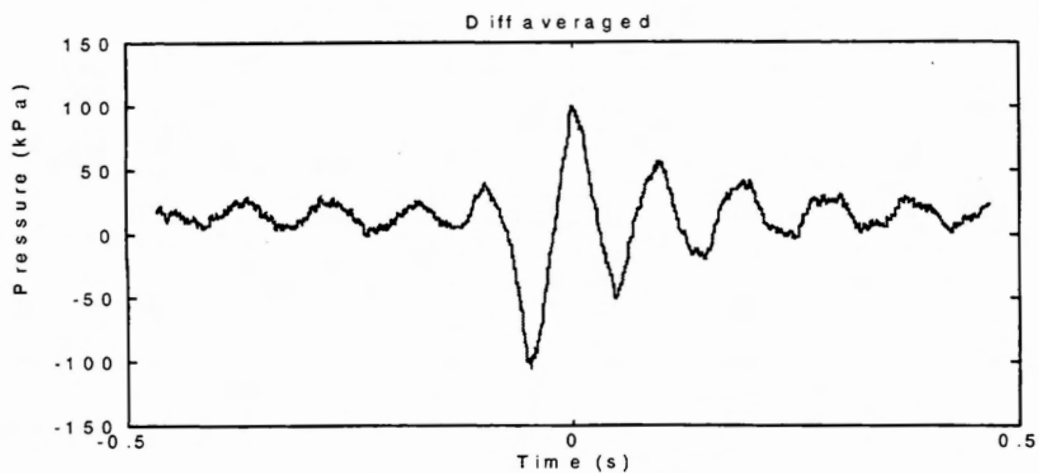
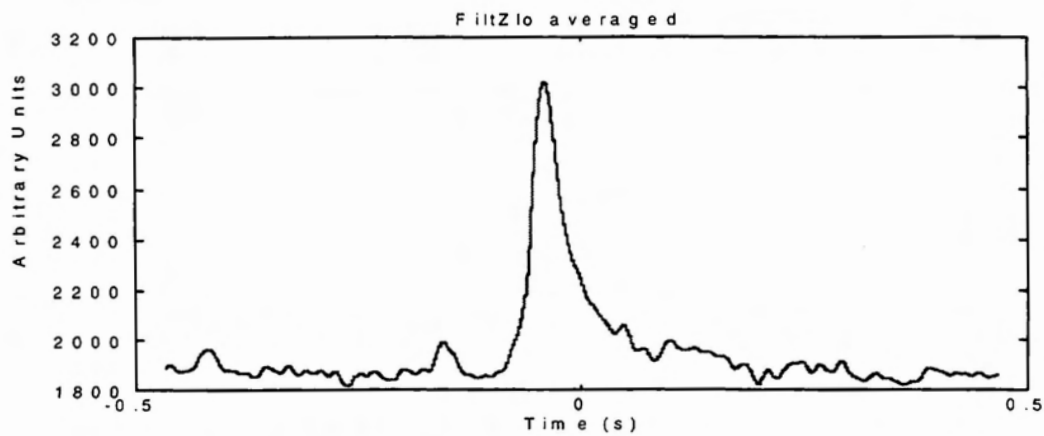
Figure 7a: Average F3F signal expanded about dip.

Figure 7b: Average Phi (black line) and Plo (grey line) signal expanded about dip.

Figure 7c: Average Diff signal expanded about dip.

Figure 7d: Average envelope of Zlo (FiltZlo) expanded about dip.

After selecting the dips using the above criterion, the data before and after each flow dip point for all signals were then ensemble averaged (Figure 7). By ensemble averaging, signal features that are consistently related to the dip will appear in full strength; signal features that are not consistently related to the dip are attenuated due to the averaging process. Completely random noise is attenuated by a factor of "square root of N", which in our case is about 15 (-24 dB). The dip point in the F3F signal was arbitrarily set to 0 s.

The Diff signal (Figure 8c) has very little noise ( $\pm 5$  kPa), but just before the dip point at  $-0.1$  s, it exhibits a large, exponentially-decaying, sinusoid with a peak value of  $-100$  kPa. This decaying sinusoid starts on the **third** cycle of the Phi and Plo pressure changes. The first two cycles of Phi and Plo approximately balance, giving little Diff signal, but because the Plo signal drops suddenly, rather than decaying exponentially as the Phi signal does, the Diff signal increases dramatically on the third cycle. The  $-100$  kPa rapid drop in the Diff signal at  $-0.1$  s is then filtered by the response of the slow-acting DP cell to give a  $-30$  kPa flow dip at  $0$  s.

The average accelerator envelope signals associated with flow dips have some interesting features. Those associated with the low-side accelerometers (Figure 8d) show a peak **coincident with the lost third cycle of Plo**. This peak is especially large for the high-frequency band (above 250 Hz) signal, while being practically non-existent for the mid-frequency (50 - 250 Hz) band. Those associated with the high-side accelerator also show a similar peak in the high-frequency band component but it is much smaller than that of the low-side accelerometers.
