**STICKING OF THE AL-CAN CONTAINING IRRADIATED TeO<sub>2</sub> TARGET TO  
THE BOTTOM OF THE DRY IRRADIATION CHANNEL OF THE 3MW TRIGA  
MK-II RESEARCH REACTOR OF BANGLADESH ATOMIC ENERGY  
COMMISSION**

**Md. Shafiqul Islam**

Director, Central Engineering Facilities  
& Principal Scientific Officer, Reactor Operation and Maintenance Unit  
Atomic Energy Research Establishment (AERE), DEPZ, Ganakbari, Savar,  
Dhaka-1000, Bangladesh  
Email:shafiq12@dhaka.net

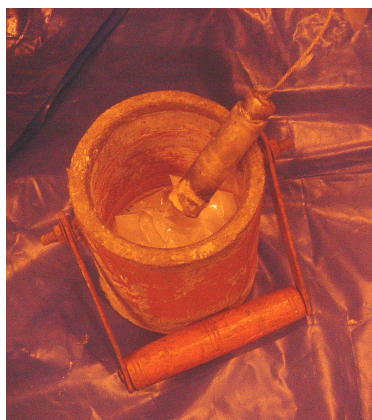
Again to review and analyze the causes of the another major vial failure incident of 2008, as the Al-can came out with the help of the innovative but very simple, appropriate, and effective handling tool (cost around 10 USD), it was seen through physical and visual investigations that a scale like sintered material, white in color, caused the Al-can to remain stuck to the Dry CT tube bottom plug. This can be seen in Fig. 5. Investigations have also revealed that the upper part of the Al-can was marked with black stains while the lower part was covered with a scale like white colored material, which is thought to be coming from the  $\text{TeO}_2$  powder that deposited at the bottom of the Dry CT tube from previous incidents that resulted failure of quartz vials containing  $\text{TeO}_2$  powder. The powder formed a layer between the Al-can and the bottom stopper plug of the Dry CT tube and offered significant resistance to the flow of heat. With the rise of temperature, the powder was melted and made the Al-can sticking to the bottom of the Dry CT tube. During irradiation at 3MW, nuclear heating (neutron + gamma) gradually heated up the target, which did not have good heat dissipation path connected to the reactor cooling water. Most of the heat generated in the  $\text{TeO}_2$  target first flows through the  $\text{TeO}_2$  itself, then through the bottom part of the quartz vial, then through the bottom of the Al-can and after that through the bottom stopper plug of the Dry CT tube, which is a piece of Al-plate having a thickness of about 3.81cm.

Figure 5 Lifted Al-can with some white materials sticking to its bottom.

The incident did not make any damage to the reactor core or cause any significant release of radioactivity to the environment. The surface gamma dose rate of the removed Al-can (with the quartz vial containing 40g  $\text{TeO}_2$  in it) was about 4.29 mSv/hr. The incident was timely informed to the regulatory authority. Necessary cleaning up operation was carried out jointly by the reactor operation personnel and the health physics group so as to make the Dry CT tube ready again for irradiation of  $\text{TeO}_2$  powder for I-131 production.

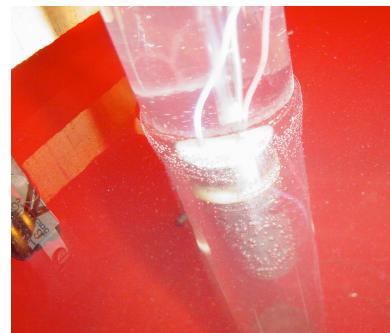
simulated target was kept inside the transparent plastic tube with filled in water instead of Al-tube. The measured temperatures at different locations over the target are given in Table 1.

c. Boiling phenomenon
