# WIPP PREPARATIONS FOR RESTART OF OPERATIONS IN LATE 2016

**T. Shrader and S.C. Dunagan**

Carlsbad Field Office, U.S. Department of Energy, Carlsbad, New Mexico, USA

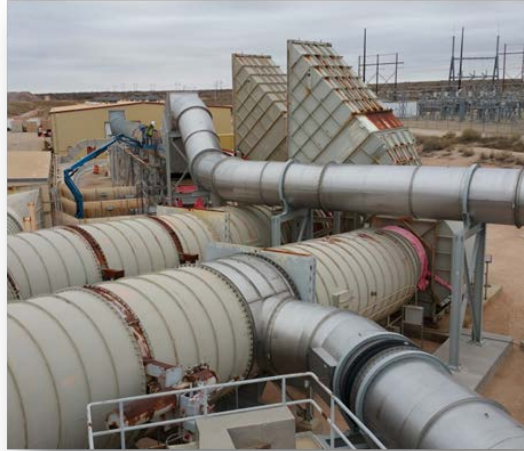
In order to allow waste emplacement to occur, an Interim Ventilation System (IVS) was installed to work in conjunction with the UVS to support waste operations and to allow additional diesel operated equipment including ground control machinery. IVS is to add 54 Kcfm (25 m<sup>3</sup>/s) for a combined total of 114 Kcfm (54 m<sup>3</sup>/s). Figure 1 shows the IVS tied into the UVS to add supplemental flow through new filter banks.

Figure 1. Interim Ventilation System is tied into the Underground Ventilation System to supplement total airflow

The current system is called the Underground Ventilation System (UVS) and as long as it is running in filtration mode it can support some recovery activities, ground control activities, and limited maintenance work. The total underground airflow is 60,000 cubic feet per minute (60 Kcfm), or 28 cubic meters per second (m<sup>3</sup>/s). This is insufficient airflow to allow waste emplacement operations.

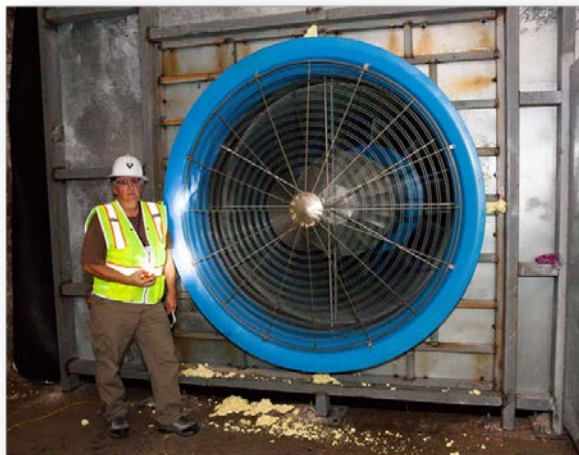
A Supplemental Ventilation System (SVS) was also installed to support limited mining activities, and to provide additional air to the north area of the mine where there is a maintenance shop and an experimental area. SVS adds about 70 Kcfm (33 m<sup>3</sup>/s). Figure 2 shows the SVS, a single fan that draws additional air into the underground and exhausts it without going through the waste disposal area of the repository,

Figure 2. The Supplemental Ventilation System, a fan and additional louvers and baffles to increase airflow through the north part of the mine

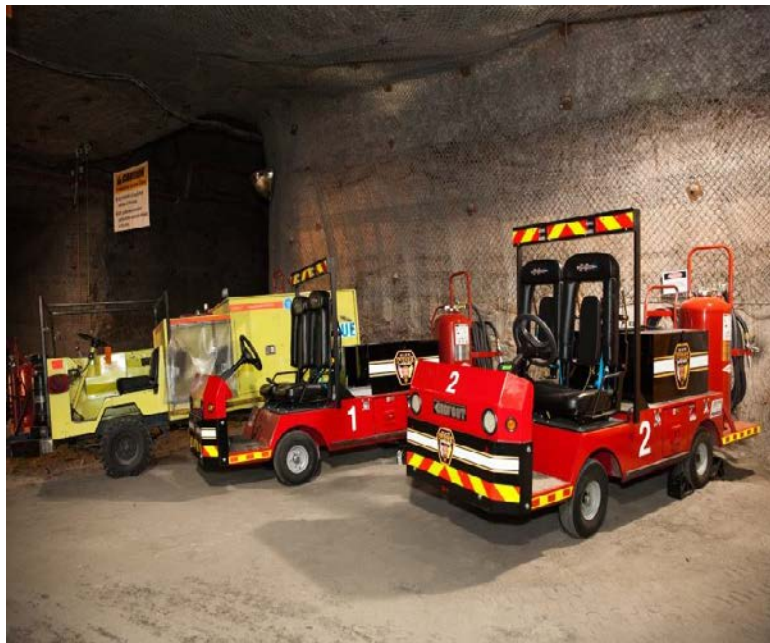
New fire suppression and emergency response equipment has been obtained and tested. Figure 3 shows some of this new equipment ready for use in the underground. In addition, however, and in direct response to AIB recommendations, a robust combustibles control program is in place and being exercised as a matter of daily business practice.

Figure 3. New fire suppression and emergency response equipment in the underground

Automatic fire suppression systems have been installed on liquid fueled equipment and higher risk areas of the underground. Also, additional visual emergency egress strobes and reflectors have been added to enhance personnel egress safety in case of fire or other emergency.

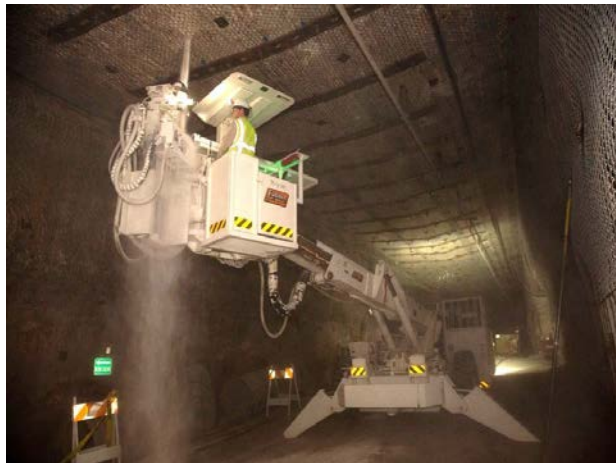
The salt formation at the depth of the repository is under considerable lithostatic pressure and deforms plastically to attempt to fill in any void spaces. This is one of the most attractive qualities of using salt as a host rock, eventually it encapsulates the waste in rocksalt, a barrier that is impermeable to water. During the operational phase, however, it presents a well-known and readily coped with maintenance problem: keeping the excavations open and assuring no rock falls occur. During the recovery from the February 2014 events there was limited opportunity to keep up the routine maintenance of the mined openings, since then a program of catch-up rock bolting was set in motion as underground access was re-established. Limited airflow hampered that effort until two new hybrid rock bolters were purchased. They move from location to location using diesel power, but they do their bolting using electric power, thus allowing multiple activities while bolting is in progress. Figure 4 shows a new hybrid bolter in action.

Figure 4. A hybrid (diesel and electric) bolting machine conserves breathable air while bolting, allowing more simultaneous underground recovery activity

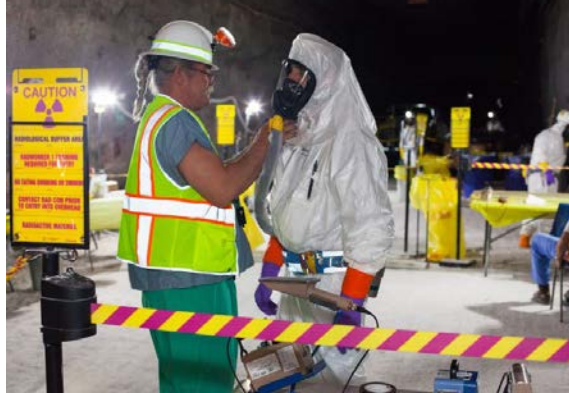
Another aspect of underground habitability is assuring worker risk avoidance through exposure control. The type of equipment shown in Figure 5, and being used to assure worker safety when entering a contaminated area, can be reduced by cleaning that area, reducing the level of contamination and hence the risk of exposure.

Figure 5. Underground worker being outfitted for work in a contamination area

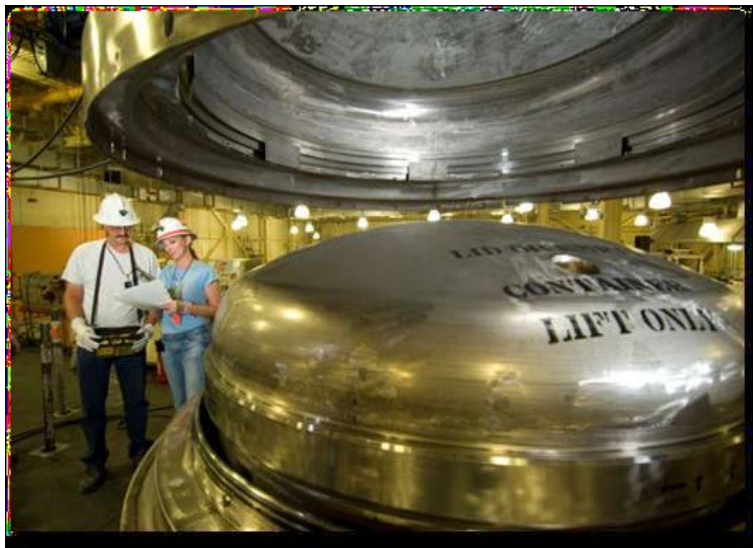
Figure 7. Shows personnel reviewing new operating procedures looking at familiar waste container components

The first phase is the contractor practicing its new work processes and procedures with the equipment they have been used to using for years. Figure 7 shows personnel reviewing new procedures standing by very familiar equipment.

This phase of the recovery process is called Integrated Cold Operations. It involves eight weeks during which workers will practice using new equipment, procedures and processes for receipt, downloading and placement of waste. To demonstrate readiness to do waste handling work the waste handlers will use empty containers and conduct drills and exercises on scenarios designed to test knowledge and develop proficiency.
